NALCO

Corrosion in the Petroleum Industry

TABLE OF CONTENTS

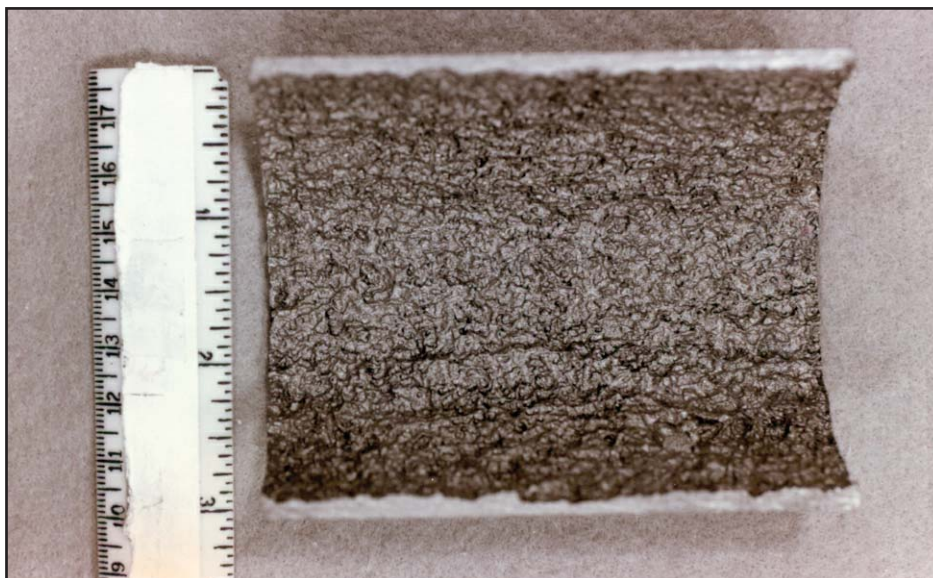
Figure I-2: Uniform Corrosion in Tubing

An example of uniform CO_2 corrosion from tubing is shown in Figure I-2.

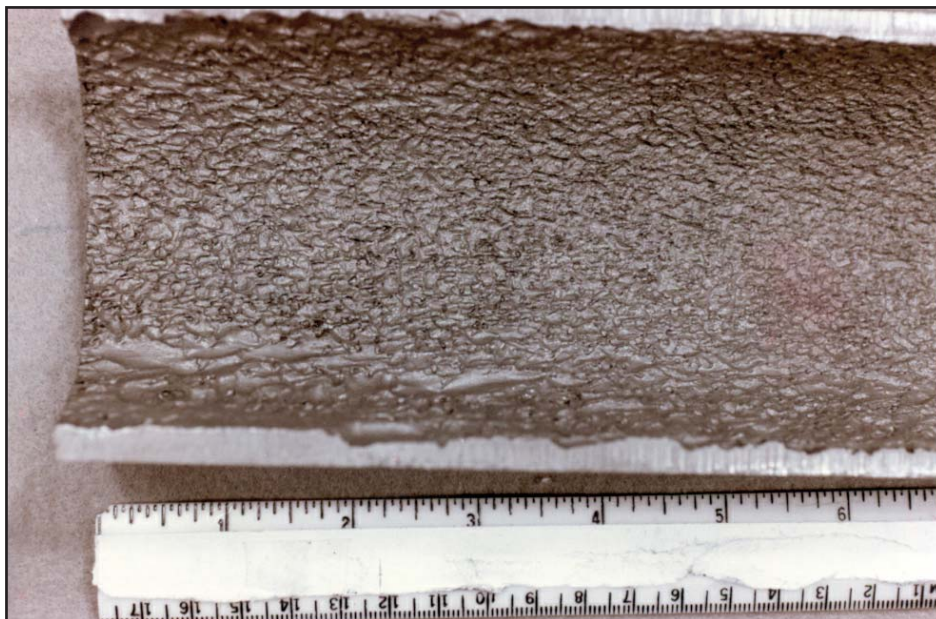
Figure I-4: Uniform Corrosion Showing Hills and Valleys

Figure I-4 and Figure I-5 show additional examples of uniform corrosion, leaving a distinctive hill and valley texture.

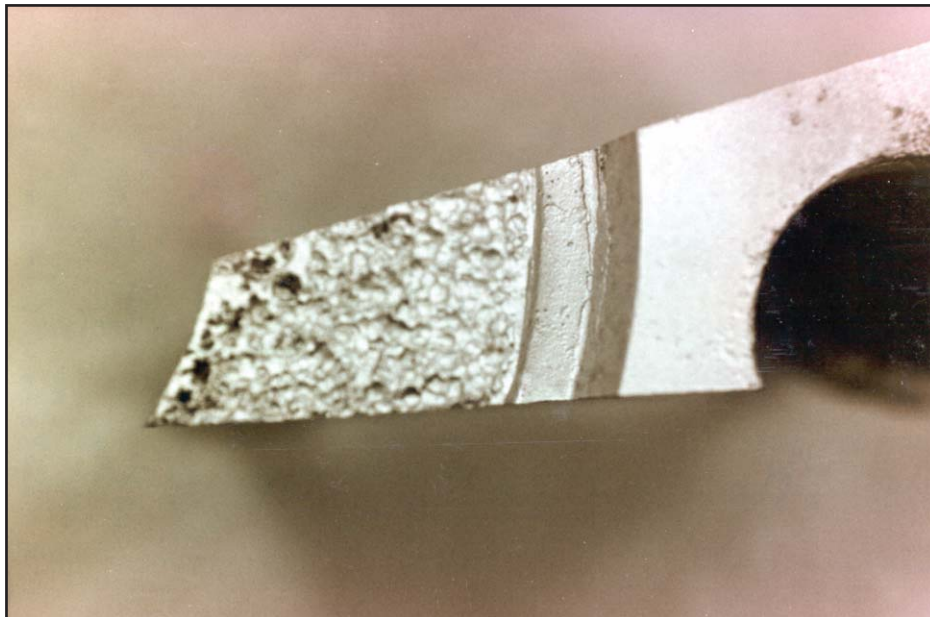
Figure I-6: CO₂ Attack — Honeycomb Pattern

Another form of CO₂ attack has been observed on exposed faces of high-pressure wells, taking the form of an intricate honeycomb (Figure I-6 and Figure I-7).

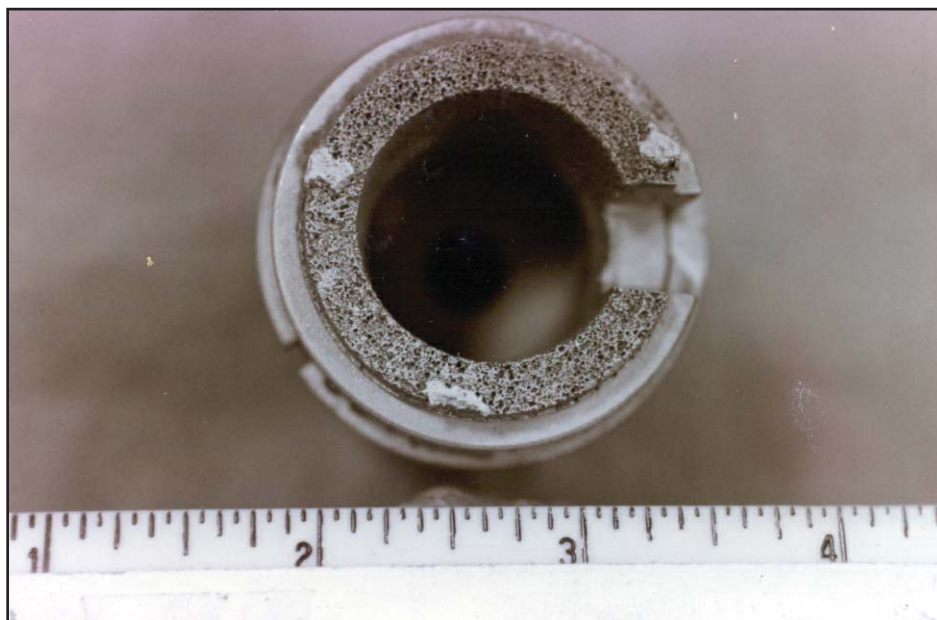
Figure I-8: Honeycomb Attack in a Choke Body

Another example of honeycomb attack can be seen on a choke body (Figure I-8).

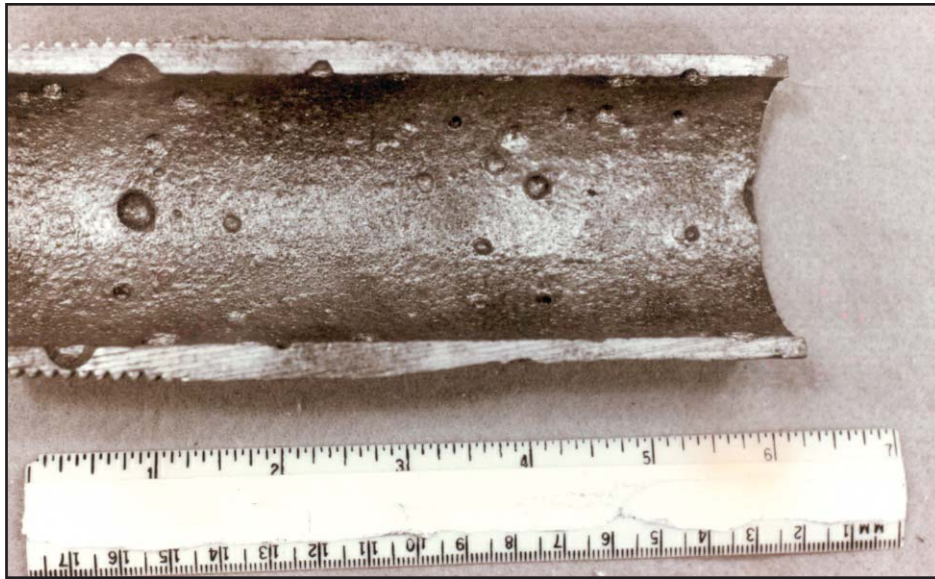
Figure I-9: CO_2 Pitting Corrosion

CO_2 dissolved in brine forms carbonic acid, and carbonic acid is extremely corrosive to steel, with horrendous corrosion rates. However, the carbonic acid corrosion by-product, iron carbonate (FeCO_3), usually forms protective films. FeCO_3 is relatively insoluble at downhole operating conditions. However, at breaks in the FeCO_3 film pits do develop. This pitting corrosion is extremely rapid and can cause failures. CO_2 pitting corrosion can be seen in Figure I-9.

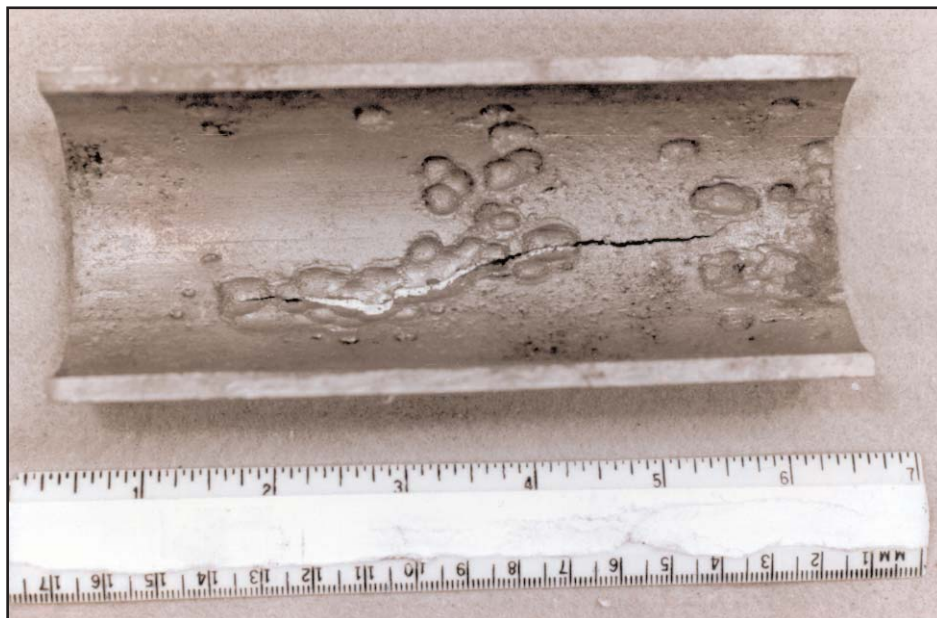
Figure I-12: Wormhole Attack

Another typical formation for CO₂ corrosion is called wormhole type of attack (Figure I-12).

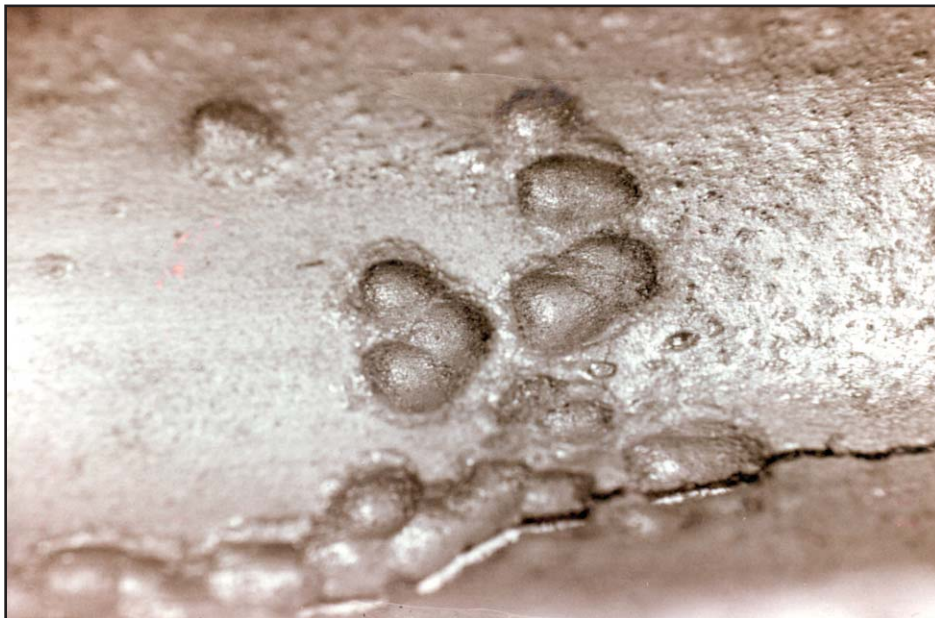
Figure I-16: Wormhole Effect — Cluster of Large Pits

At times, the wormhole can take the form of a cluster of large pits (Figure I-16).

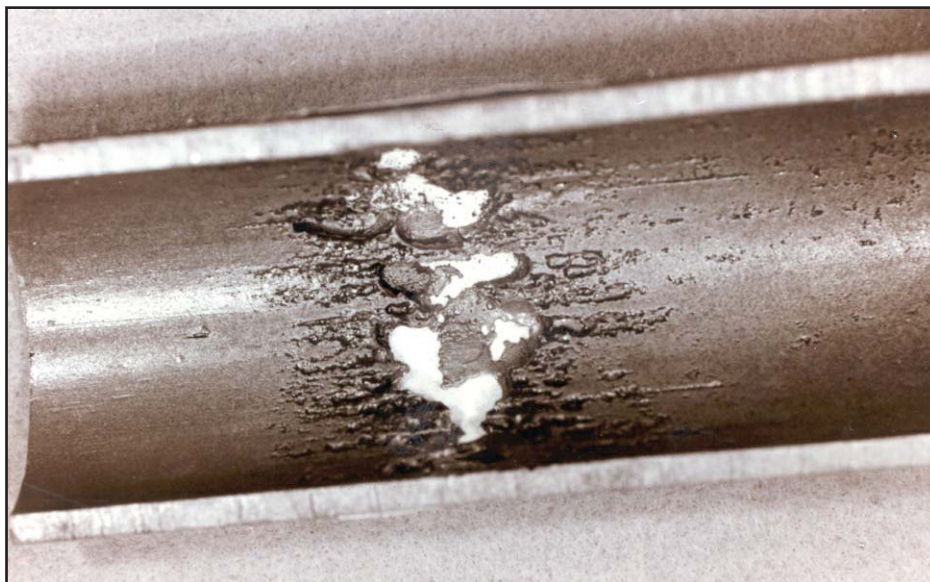
Figure I-18: Suspected Ringworm Corrosion

Ringworm corrosion is a metallurgical effect caused by the making of the upset. In fabricating the upset, a zone is created 4 to 6 inches from the upset shoulder, wherein carbon particles have been spheroidized. These spheroidal-shaped particles accelerate corrosion in mildly corrosive or even non-corrosive environments. This is a galvanic effect. If one observes numerous through-the-wall penetrations in tubing 4 to 6 inches from the upset shoulders such as in Figure I-18, ringworm corrosion is suspected.

The treatment for ringworm corrosion is to normalize the steel after making the upset. Normalizing redissolves the carbide particles eliminating the zone created by making the upset.

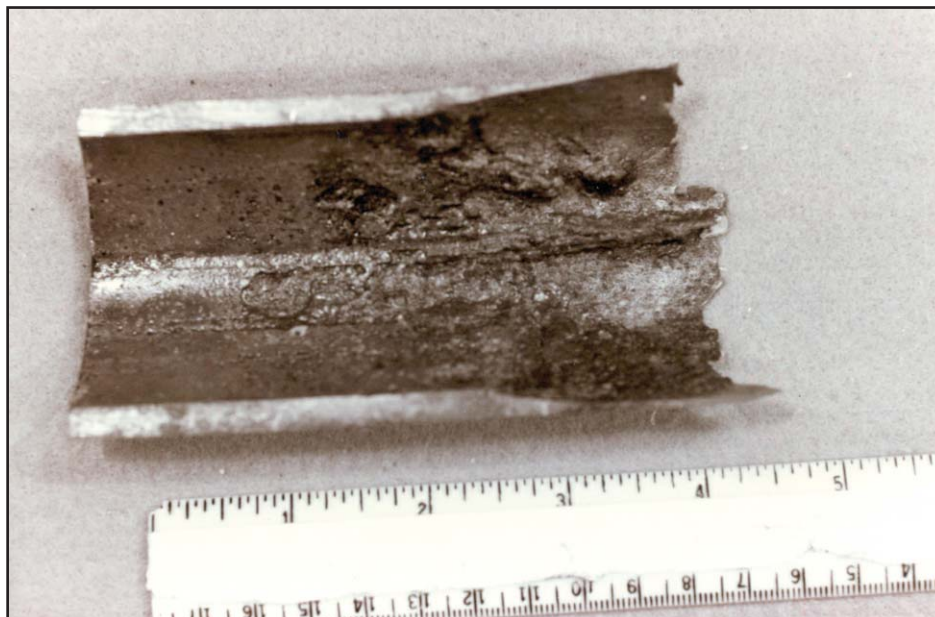
Figure I-20: Severe Thinning Caused by Ringworm Attack

Another example shows severe thinning at this point, with a smooth surface (Figure I-20).

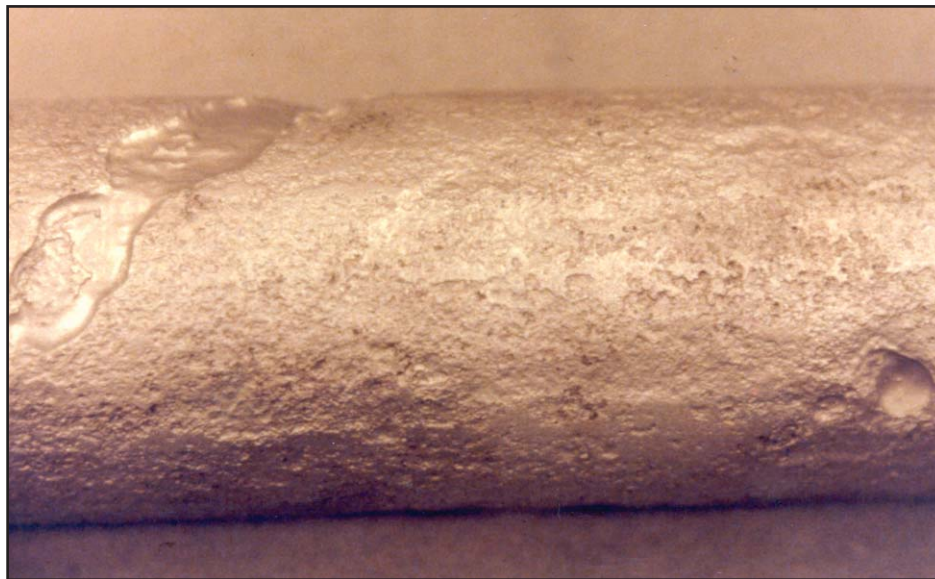
Figure I-27: Corrosion Resulting from Rolled-in Inclusions

An unusual form of metallurgical attack on the outside of tubing is shown in Figure I-26 and I-27, and is attributed to rolled-in inclusions.

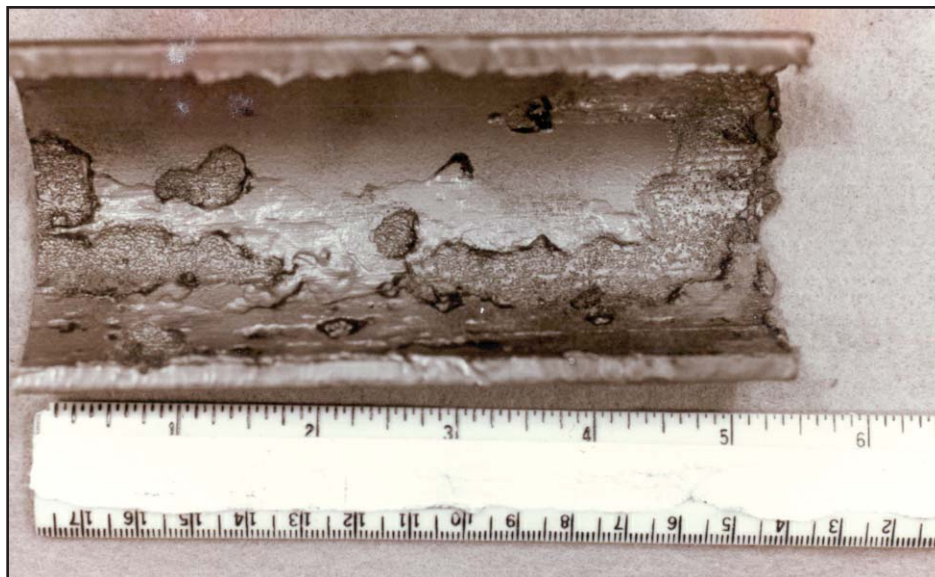
Figure I-28: Mesa Attack

Another form of CO₂ corrosion is called mesa attack. Mesa attack usually occurs where areas of metal that have a good protective coating exist and where other areas have no protective coating. In addition, mesa attack occurs in flowing environments (Figure I-28).

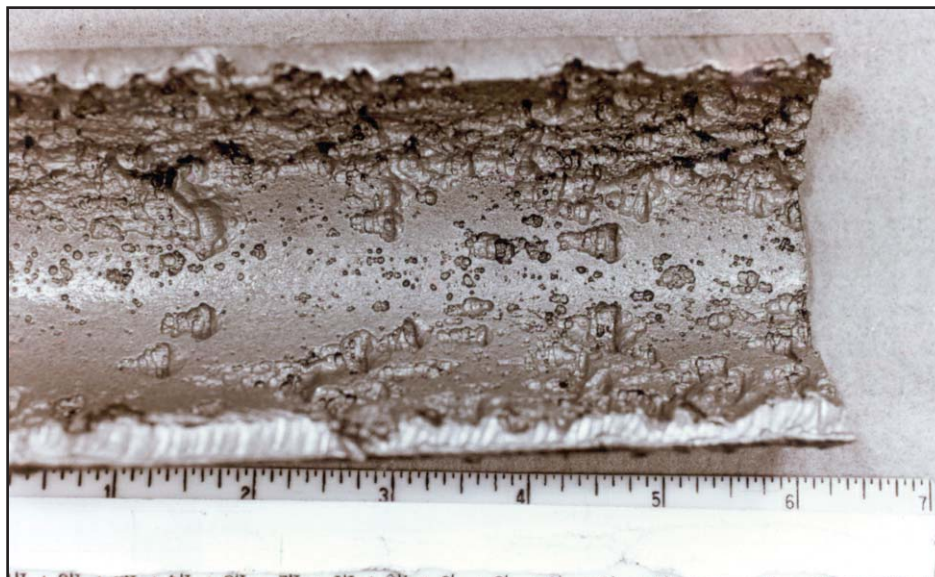
Figure I-31: Raindrop Attack

Another form of CO₂ corrosion occurs in gas condensate wells, which do not produce a large amount of water. In these wells, a zone where water droplets, or water of condensation, will drop out. This phenomenon is labeled raindrop attack (Figure I-31).

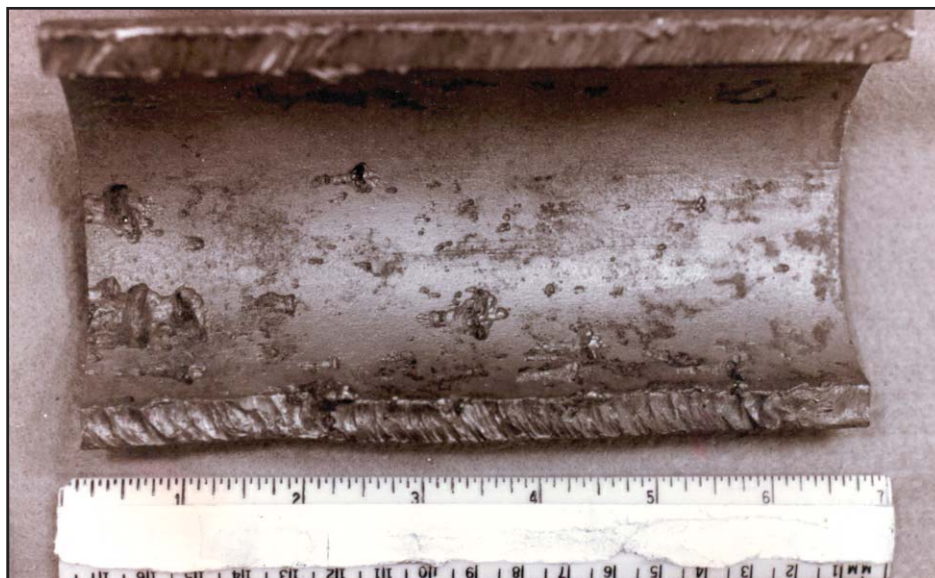
Figure I-32: Raindrop Attack — Deep Pits with Tails

In this area, very deep pits occur with tails. These deep pits on tubing are shown in Figure I-32. This tubing was the second and third joint below the Christmas tree.

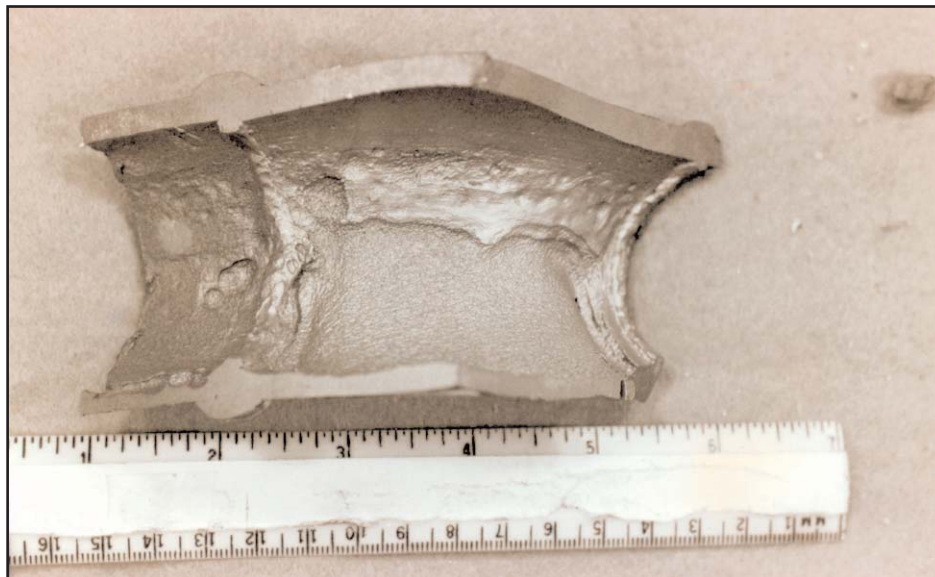
Figure I-39: Close-up Showing Severe Metal Loss

Figure I-39, a close-up view after cleaning, shows the severe metal loss. Figure I-40 shows the through-the-wall penetration.

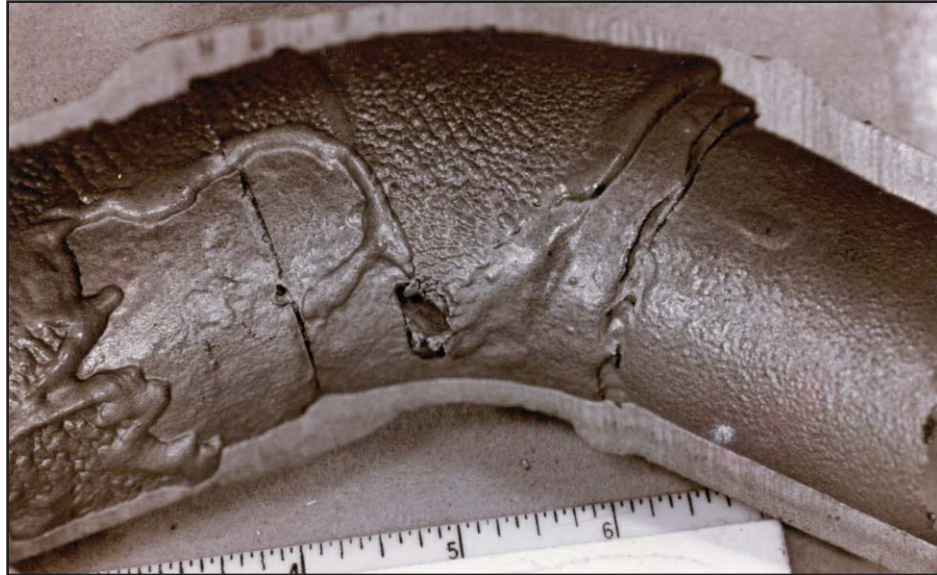
Figure I-41: Combination of Corrosion Mechanisms

In Figure I-41, this flowline has an unusual failure mode. It is a combination of flow-enhanced corrosion and heat-affected zone attack.

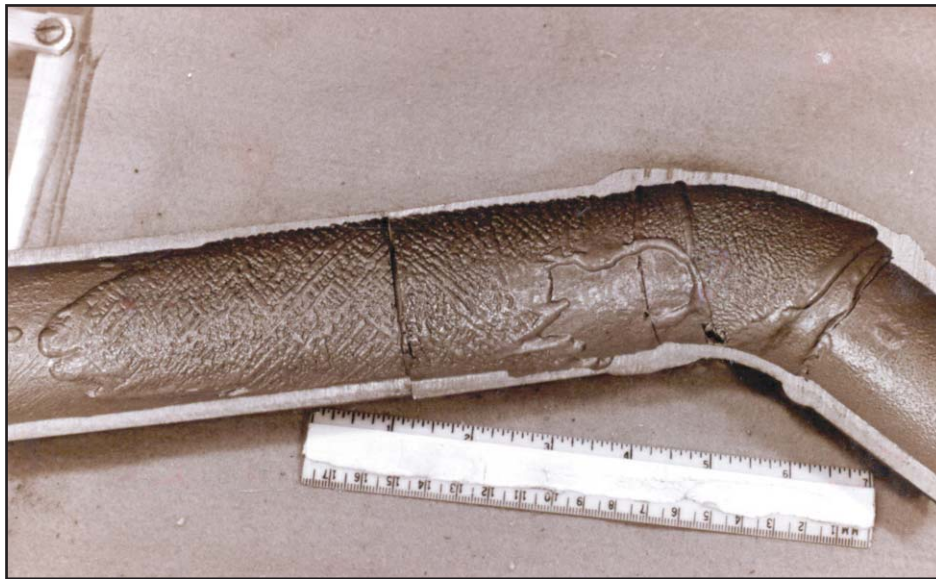
Figure I-42: Severe Metal Loss in Bend

After a 45° bend, severe metal loss was noted in the bend (Figure I-42). In addition, a clear demarcation can be found where the flow had ceased, and there was no further attack on the pipe.

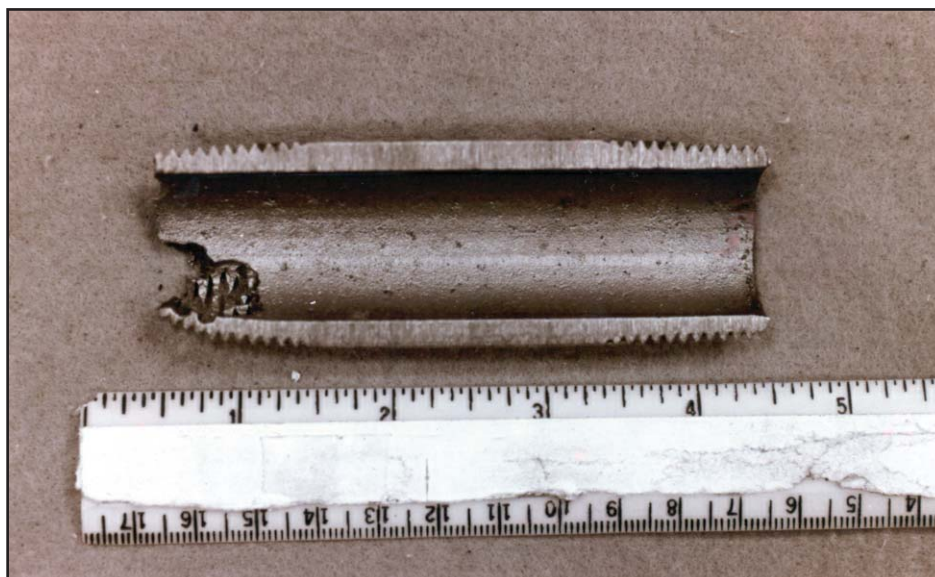
Figure I-44: Flow-Enhanced Corrosion at Nipple Joints

Another form of flow-enhanced corrosion is at nipple joints. Usually there is a gap when a threaded joint is made up, and at the gap, turbulence is generated and flow-enhanced corrosion can occur (Figure I-44 and Figure I-45).

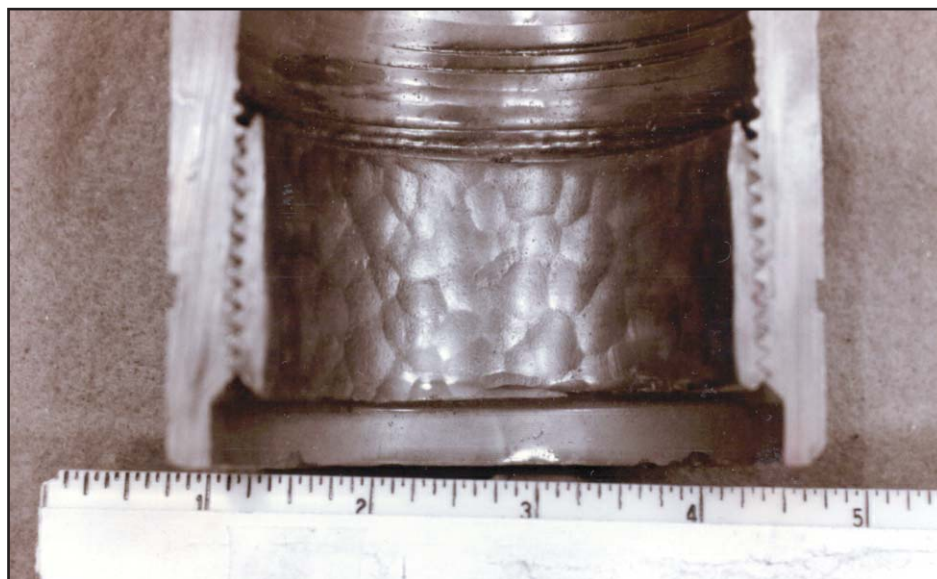
Figure I-46: Sand Erosion

Sand erosion can also occur (Figure I-46). This erosion is typified by a smooth surface with a sand dune pattern.

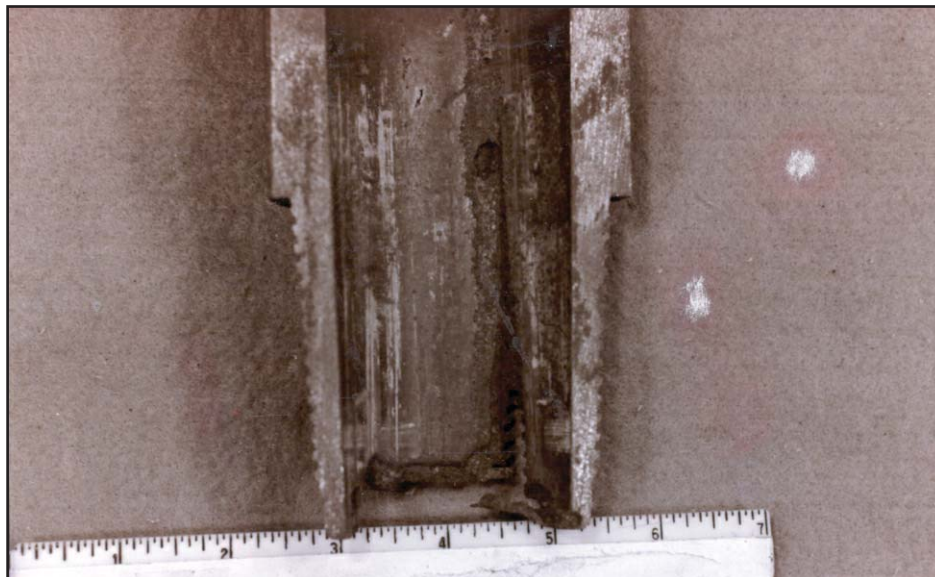
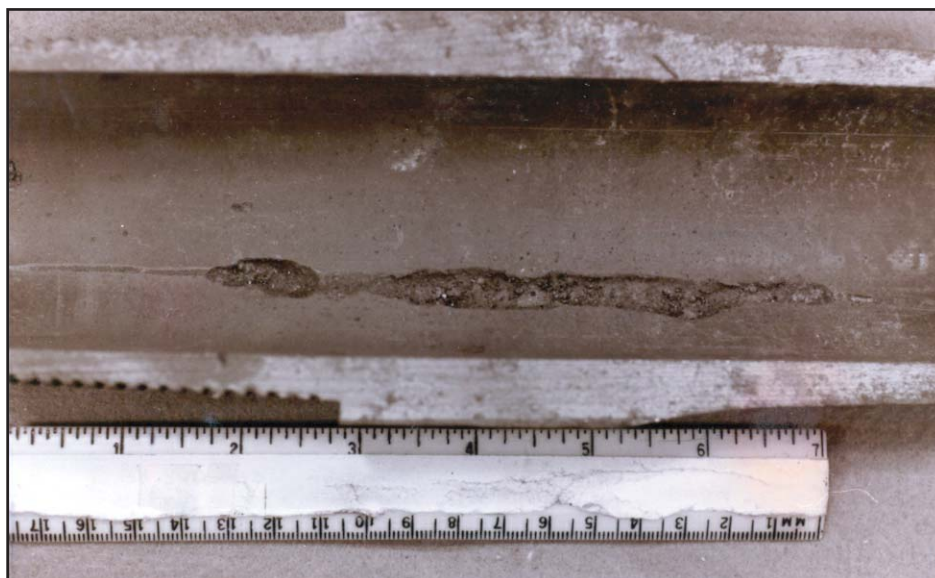
On coated tubing, wireline operations can sometimes cut the protective coating, resulting in corrosive attack where the breaks occur (Figure I-47 and Figure I-48). This attack is termed wireline attack.

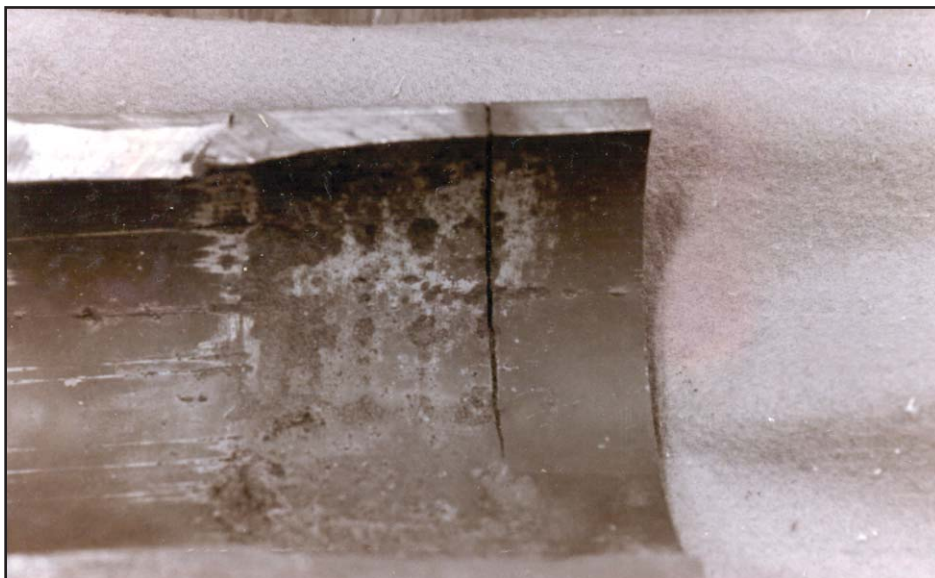
Figure I-52: Corrosion Fatigue in Drill Pipe

Corrosion fatigue is a combination of corrosion and cyclic stresses (Figure I-52).

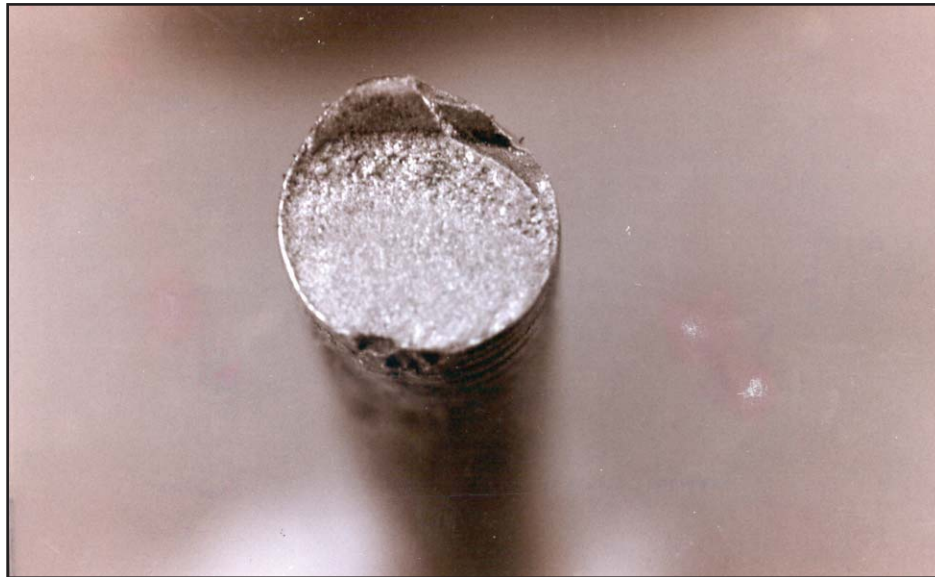
Figure I-53: Corrosion Fatigue in Sucker Rods

This failure has all the attributes of a corrosion fatigue failure, with an initiation point, a smooth half moon thumbnail, a crystalline area, and a lip break (Figure I-53).

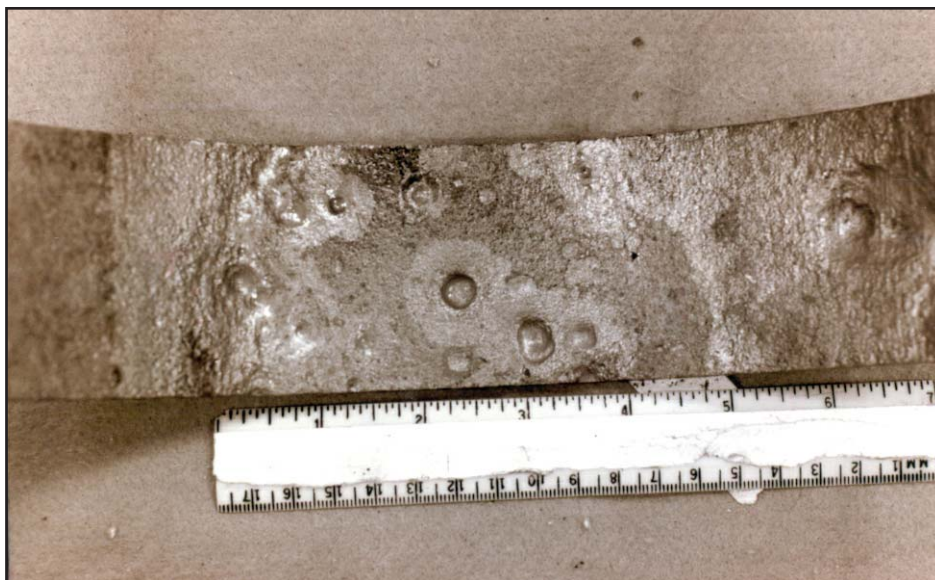
Figure II-1: Oxygen Corrosion

Oxygen is an extremely corrosive gas in produced brines, even more corrosive than CO_2 . Oxygen corrosion (Figure II-1) usually results in iron oxide corrosion by-products, usually hematite, goethite, and magnetite.

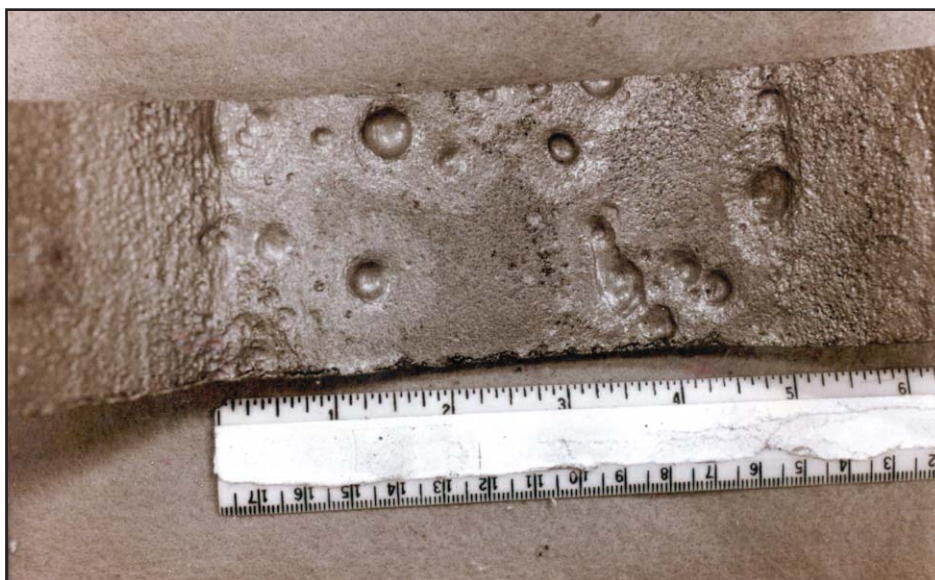
Figure II-2: Oxygen Corrosion in a Flowline

Typically, the corrosive by-products are a reddish brown rust (Figure II-2).

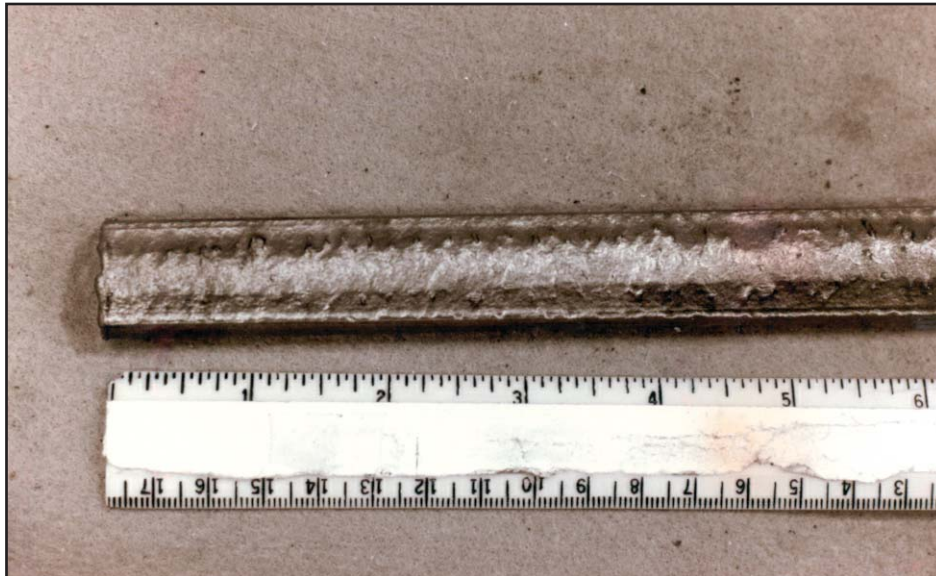
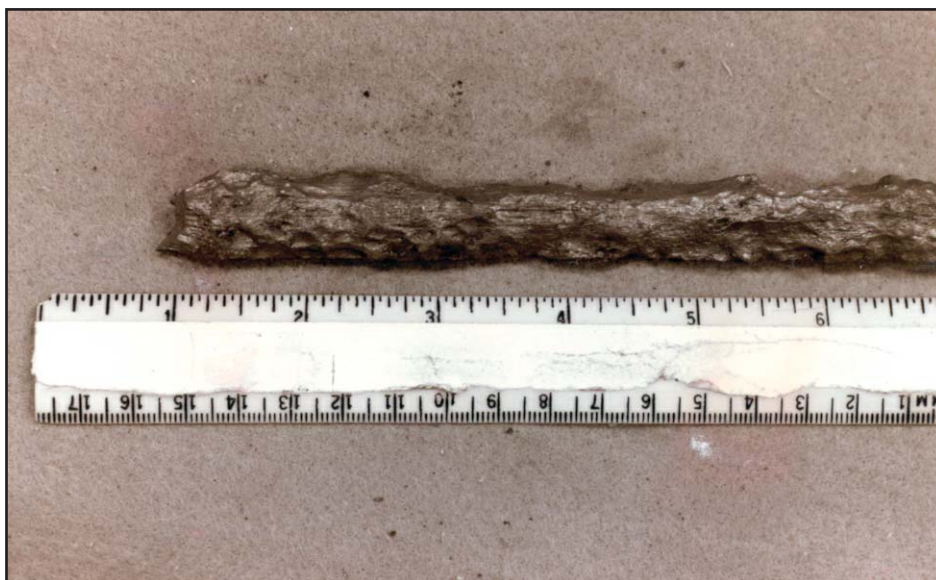
Oxygen corrosion on sucker rods are large areas of metal loss (Figure II-5 and Figure II-6).

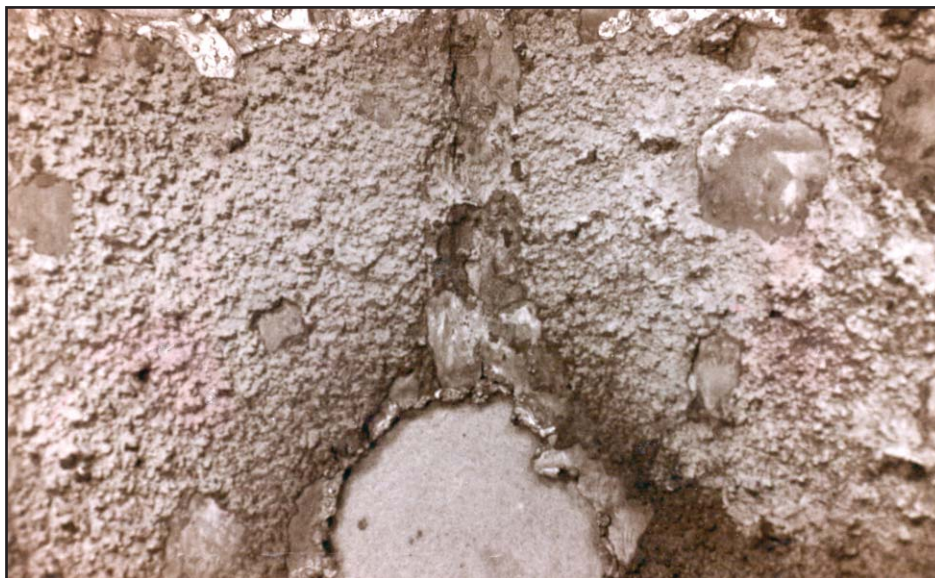
Figure II-7: Typical Rust-colored Deposits

Typical rust-colored deposits taken from a water line in a mining operation are shown in Figure II-7.

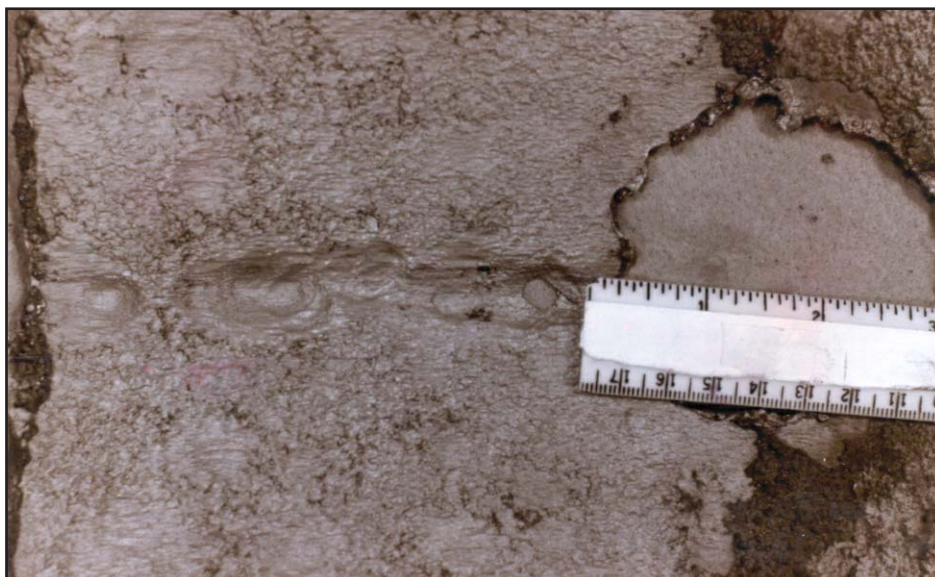
Figure II-8: Saucer-like Deposits and Pits

After cleaning, saucer-like deposits are seen (Figure II-8).

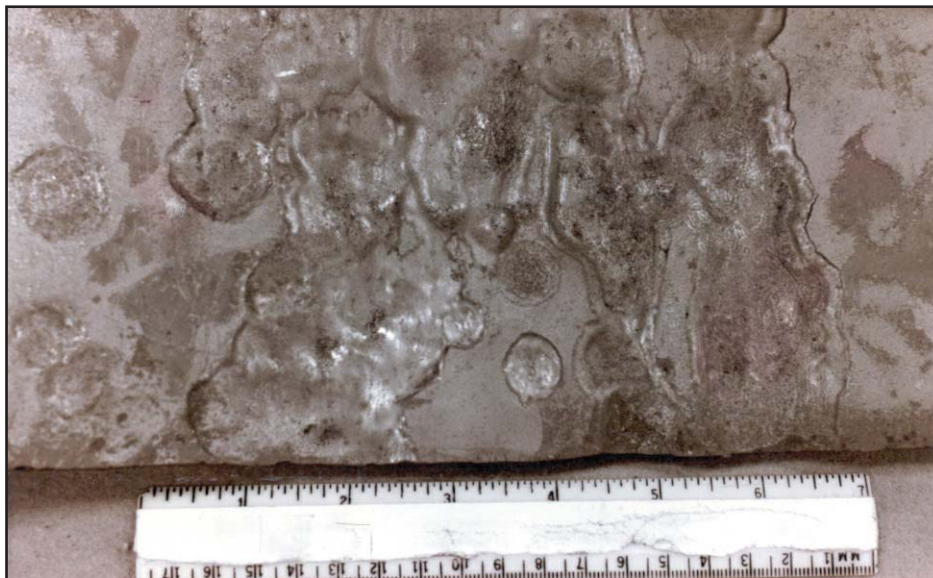
Figure II-9: Oxygen Corrosion in a 36" Pipeline

Another example of oxygen corrosion is in this 36" pipeline (Figure II-9).

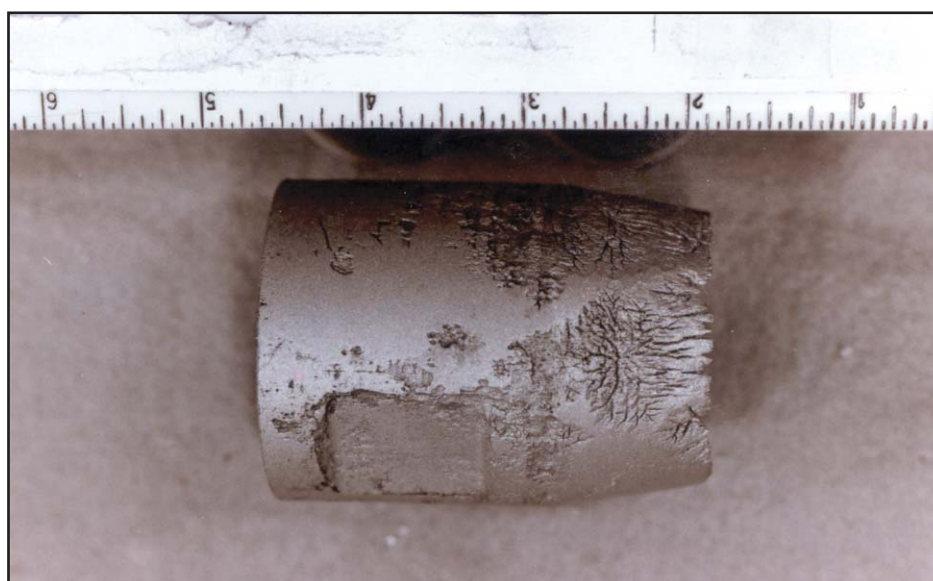
Figure III-7: Corrosion Fatigue in Sucker Rod Connectors

Alternating stresses can propagate notches, which are initiated by corrosion. An example of corrosion fatigue occurred in sucker rod connectors (Figure III-7).

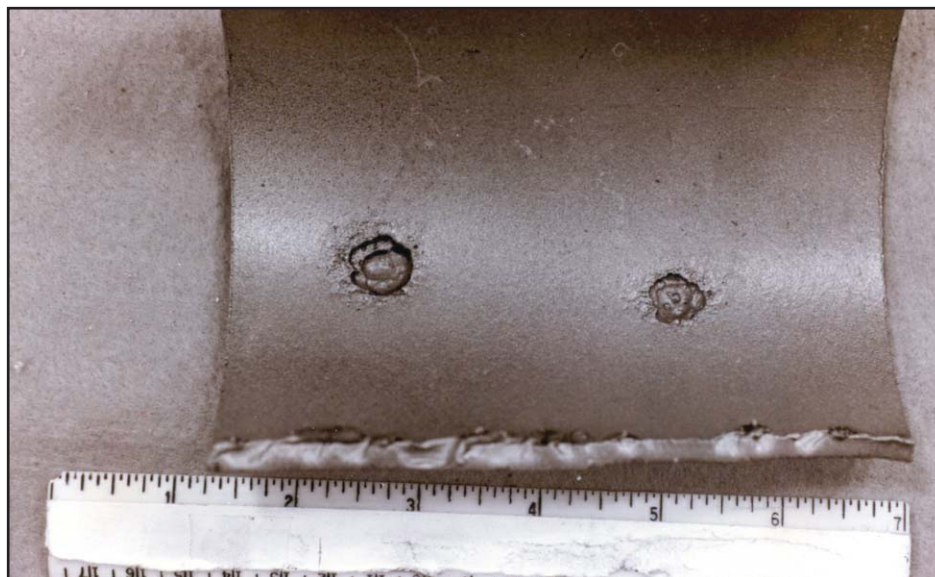
Figure IV-2: Bacterial Attack Characteristics

MIC occurs under bacterial growths and the exact mechanism is still open to discussion. In some cases, the bacteria produce acids, which cause the corrosion. In other cases with SRB, H_2S is produced, which can cause H_2S corrosion. With CO_2 , some typical CO_2 attacking can occur because of the breakdown of the film by the bacteria. Bacterial attack is usually characterized by rounded pits with etched sides, edges, and bottoms (Figure IV-2 and Figure IV-3).

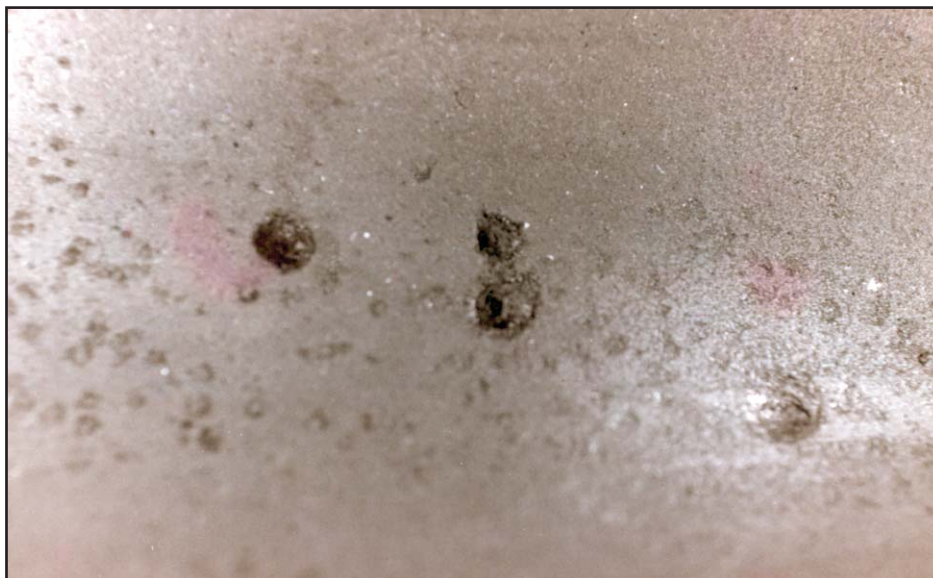
Figure IV-11: Detectable Black Growth

One of the failures had detectable black growths, which tested positive for SRB, and had corrosion pits beneath the growth (Figure IV-11).

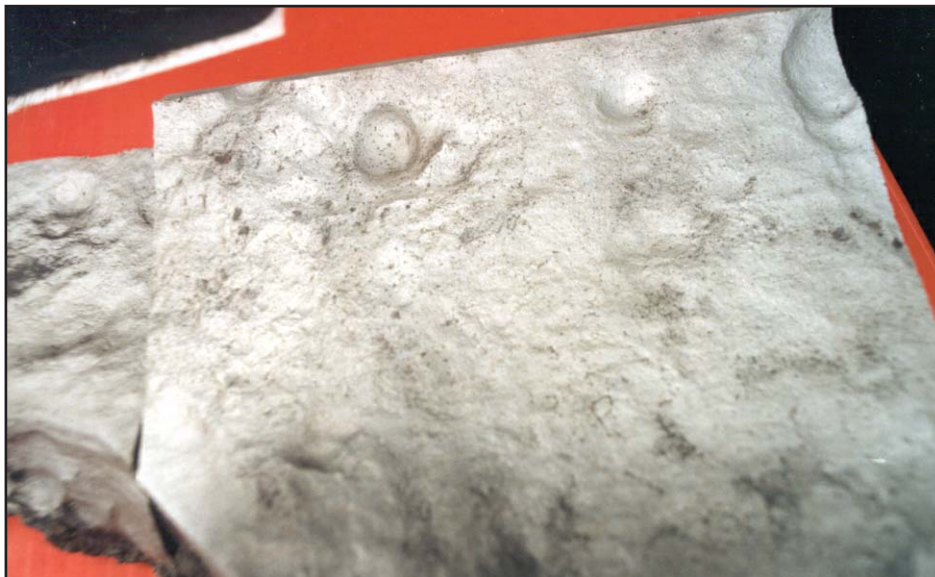
Figure V-2: Closer Inspection of the Pits

Closer inspection of the pits shows smooth depressions with gently sloping sidewalls and smooth bottoms (Figure V-2).

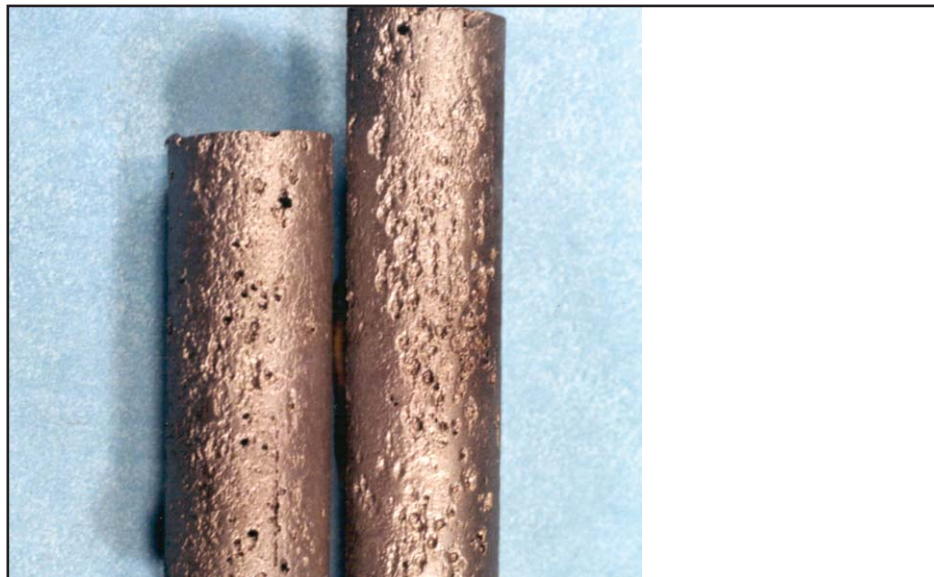
Figure V-5: Ammonium Chloride Corrosion on Carbon Steel Heat Exchanger Tubes

Figure V-5 shows an example of ammonium chloride underdeposit corrosion.

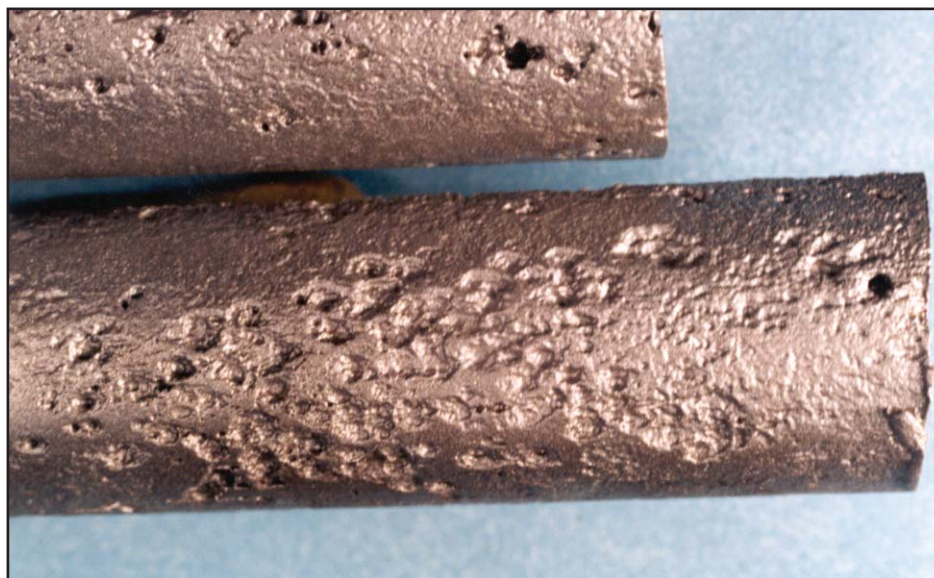
Figure V-6: Pits with Narrow Openings and Deep Cavernous Voids

The pits with narrow openings and deep cavernous voids are typical of hydrochloric acid pitting (Figure V-6).

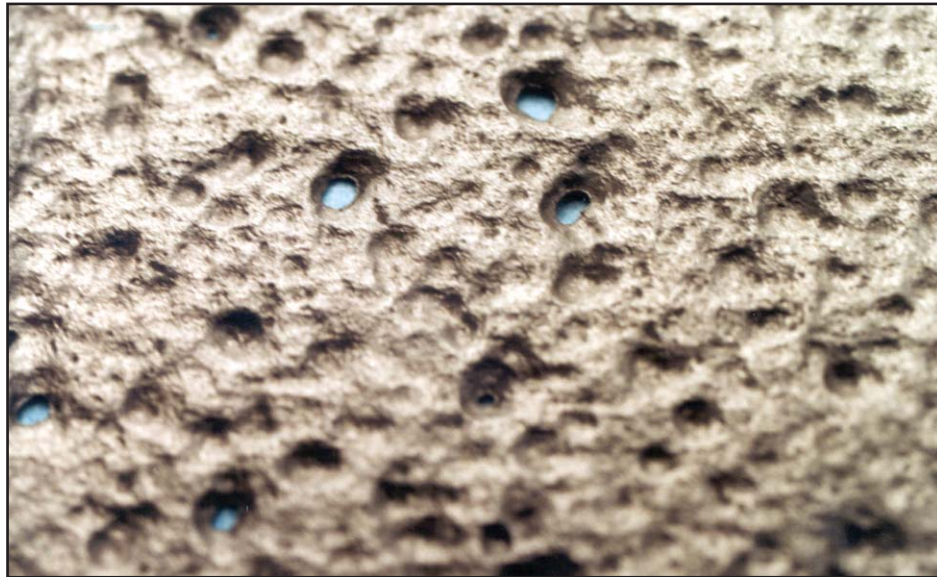
Figure VI-1: Naphthenic Acid attack on 14Cr Tray

Figure VI-1 shows an example of Naphthenic Acid attack on a 14Cr Tray.

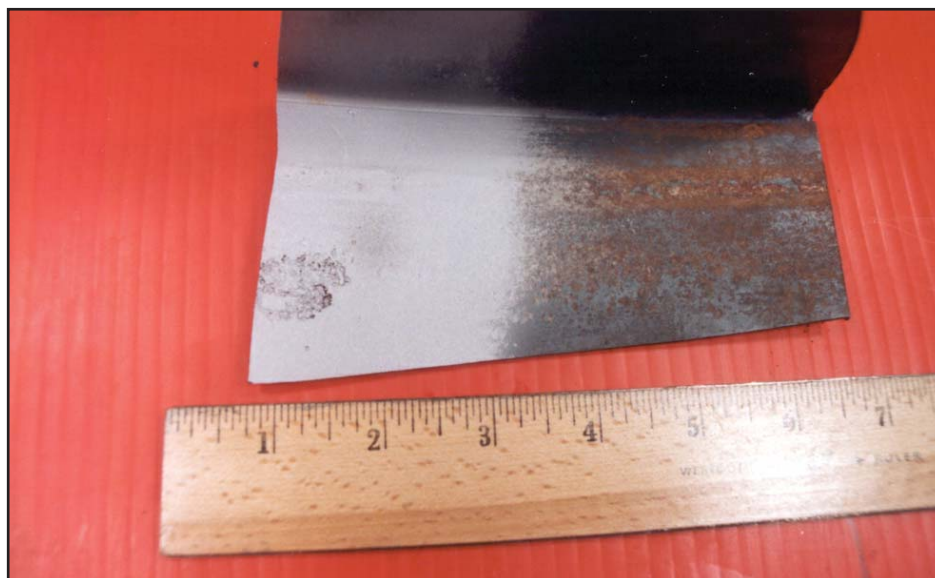
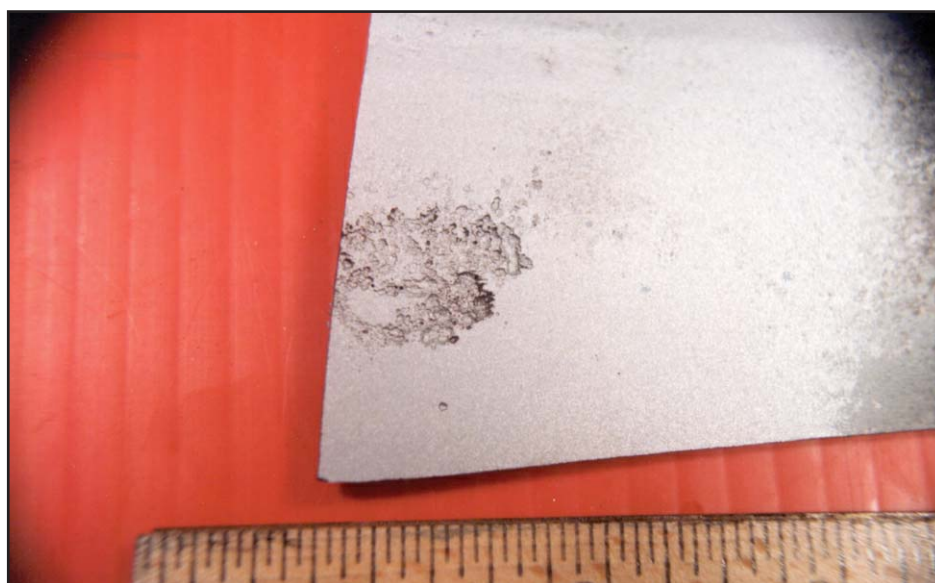
Figure VIII-15 and Figure VIII-16 shows an example of corrosion by pitting at the water layer in the bottom of diesel steel storage tanks. Possible mechanisms for pitting include microorganism influenced corrosion and/or galvanic corrosion due to sulfide inclusions in the steel.
