NALCO

Corrosion in the Petroleum Industry

TABLE OF CONTENTS

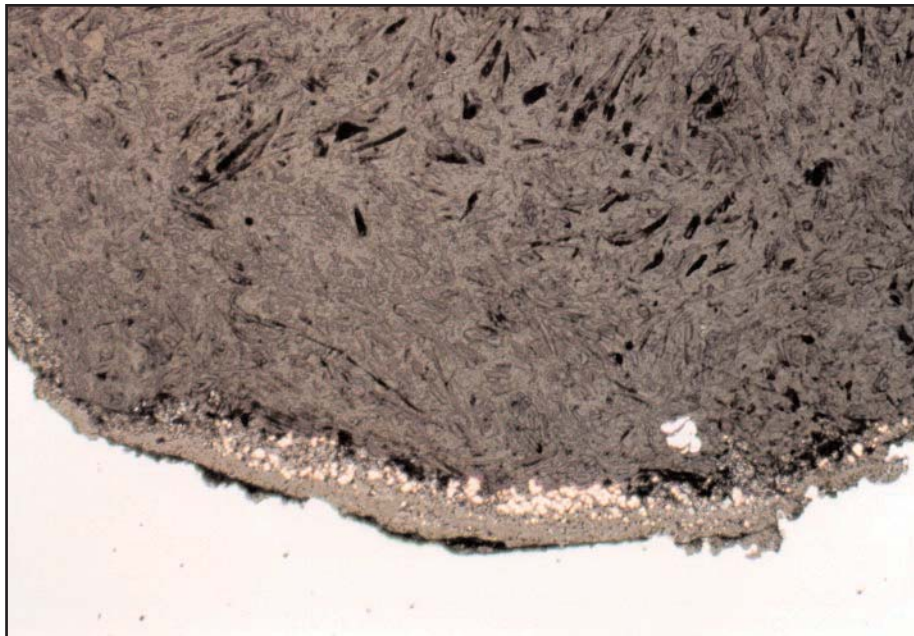
Figure IX-4: Corrosion Products in Wasted Area Containing Magnetite Needles and Metallic Copper Particles

Alkaline deposits, containing sodium, covered the surface in the corroded area (Figure IX-4). Metallographic analysis revealed the presence of magnetite needles and metallic copper on the corroded surface.

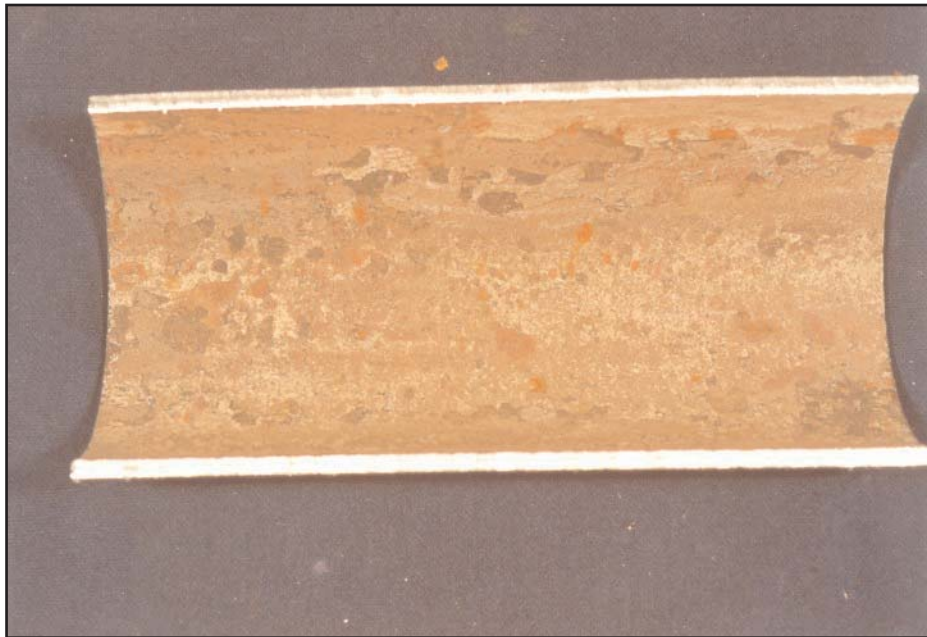
Figure IX-9: Heavy Deposit Layers Covering Internal Surface of Boiler Tube

Multiple leaks occurred in tubes located near the received section of tubing. Regions containing families of moderately deep fissures were present on the hot side internal surface beneath thick deposit layers (Figures IX-9 and Figure IX-10). The fissures propagated transgranularly through the microstructure and were filled with dense oxide containing a centerline crack (Figure IX-11). These features indicated the fissures were caused by corrosion fatigue cracking.

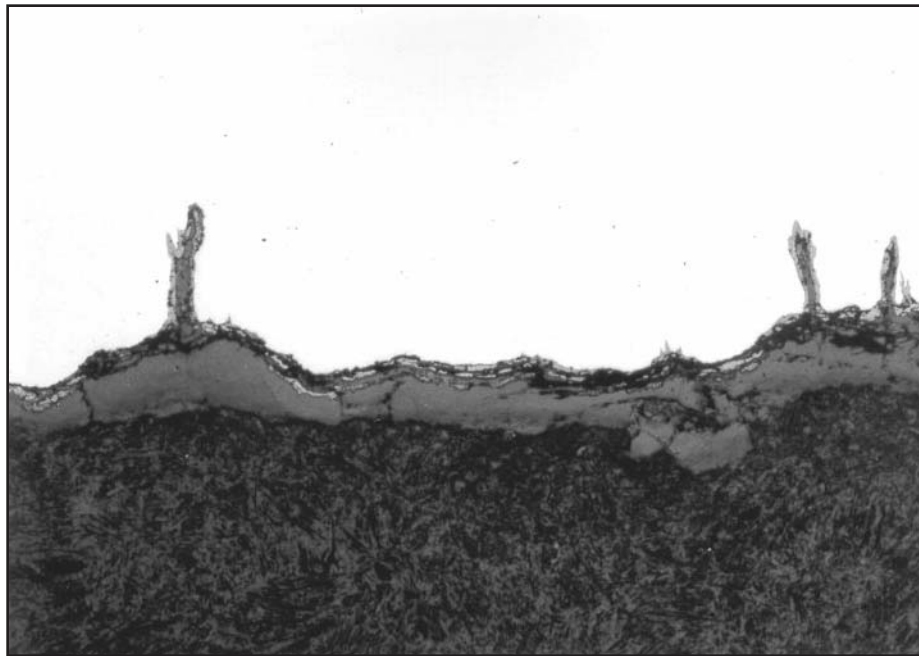
Figure IX-13: Numerous Fissures Initiating from Shallow Depressions Caused by Old Idle Time Oxygen Corrosion

Stresses may concentrate at locations of physical constraint and surface discontinuities, such as depressions and notches. The fissures were localized to shallow depressions caused by old oxygen corrosion that occurred during boiler idle time (Figure IX-13). These shallow depressions acted as stress concentrators, promoting nucleation sites for fissures.

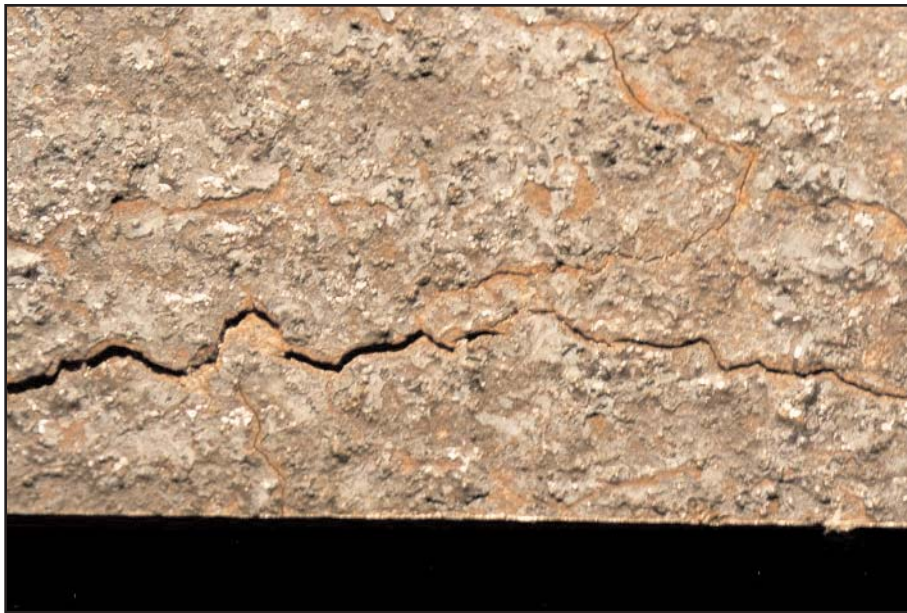
Figure IX-14: Cracks on Internal Surface Covered with Iron Oxide Corrosion Products

Numerous fissures and cracks formed in the dome of the degasifier section of a deaerator, requiring replacement of the entire dome (Figure IX-14). The system was shut down for four weeks before failure, during which time the deaerator was kept hot with steam feed. No failures occurred when the unit was restarted. However, after four days of operation several cracks penetrated through the dome. The internal surface was also covered with substantial amounts of iron oxide corrosion products that formed in place. These corrosion products overlaid shallow depressions (Figure IX-15).
