## RMS Titanic: A Metallurgical Problem

On 14 April 1912, at 11:40 p.m., Greenland Time, the Royal Mail Ship Titanic on its maiden voyage was proceeding westward at 21.5 knots (40 km/h) when the lookouts on the foremast sighted a massive iceberg estimated to have weighed between 150,000 to 300,000 tons at a distance of 500 m ahead. Immediately, the ship's engines were reversed and the ship was turned to port (left) in an attempt to avoid the iceberg. In about 40 seconds, the ship struck the iceberg below the waterline on its starboard (right) side near the bow. The iceberg raked the hull of the ship for 100 m, destroying the integrity of the six forward watertight compartments. Within 2 h 40 min the RMS Titanic sank.

Metallurgical examination and chemical analysis of the steel taken from the Titanic revealed important clues that allow an understanding of the severity of the damage inflicted on the hull. Although the steel was probably as good as was available at the time the ship was constructed, it was very inferior when compared with modern steel. The notch toughness showed a very low value (4 joules) for the steel at the water temperature ( $-2^{\circ}\text{C}$ ) in the North

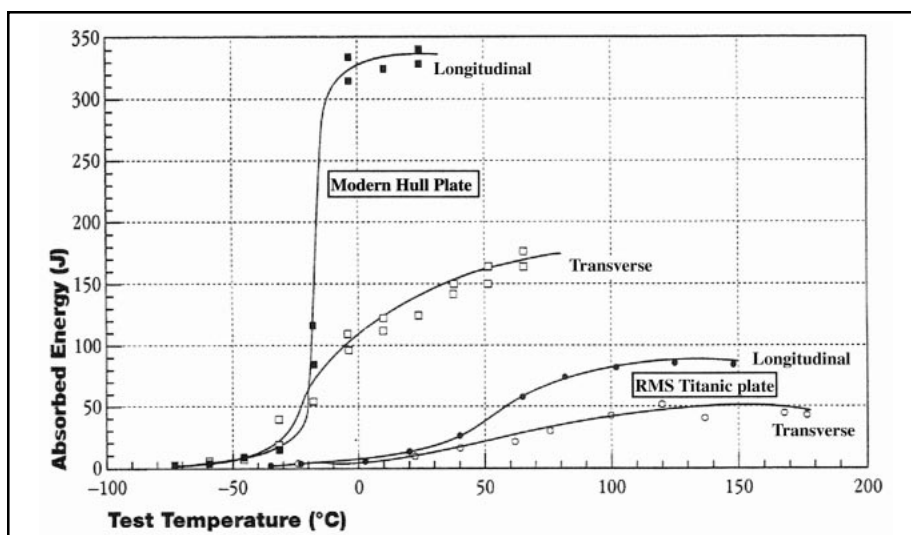
Fig. 1.<sup>[13]</sup> Not surprisingly the modern steel shows very superior results. As a point of reference, it should be noted that the sea water temperature at the time of the collision was  $-2\text{ }^{\circ}\text{C}$  ( $29\text{ }^{\circ}\text{F}$ ). The impact energy for the RMS Titanic steel at this temperature was 4 joules (3 ft-lbs.) in both the longitudinal and the transverse directions. The ductile-brittle transition temperature for the impact energy vs. temperature curve for specimens taken from the RMS Titanic and oriented in the longitudinal direction was  $30\text{ }^{\circ}\text{C}$ . Those specimens oriented in the transverse direction had a transition temperature of  $42\text{ }^{\circ}\text{C}$ .

For the modern steel, the impact energy at  $-2\text{ }^{\circ}\text{C}$  for the longitudinal direction is 325 joules (240 ft-lbs.) and in the transverse direction the impact energy is 100 joules (73 ft-lbs.). The ductile-brittle transition temperature for the modern steel is  $-42\text{ }^{\circ}\text{C}$  in both the longitudinal and transverse direction.

The low notch toughness of the RMS Titanic steel of 4 joules (3 ft-lbs.) at the temperature of the sea water ( $-2\text{ }^{\circ}\text{C}$ ) at the time of the colli-

sion with the iceberg means that the steel would have been prone to brittle fracture. Certainly brittle fracture of the steel hull plate contributed to the sinking of the ship. The low manganese:sulfur ratio of 7:1 for the 1996 RMS Titanic steel will allow the formation of iron sulfide or mixed iron-manganese sulfides in preference to the formation of manganese sulfides. Iron sulfides tend to be less plastic and more brittle than manganese sulfides. In order to have only manganese sulfide present, the Mn:S ratio must be at least 20:1. The modern steel used in this study has a Mn:S ratio of 39:1, hence yielding a high notch toughness and the low ductile-brittle transition temperature.

Fig. 1 Longitudinal and transverse toughness of the 1996 RMS Titanic plate compared with that of modern steel plate. Reproduced with permission of the Iron & Steelmaker.<sup>[13]</sup>

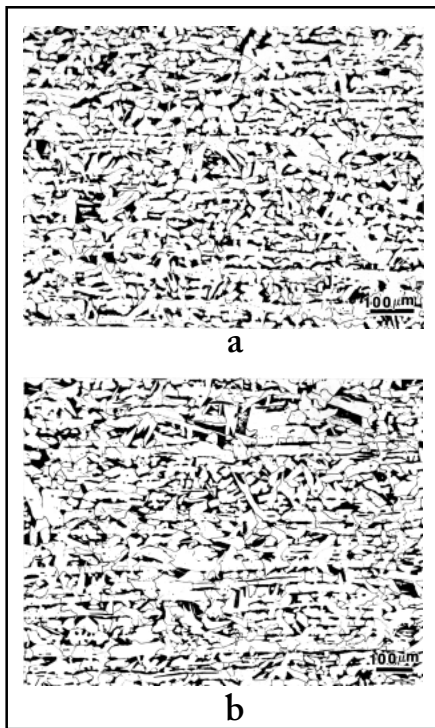
The RMS Titanic plate from the 1996 expedition was prepared metallographically to reveal the microstructure on the longitudinal and transverse directions, as shown in Fig. 2. The longitudinal section shows pearlite and acicular ferrite. Because the direction of rolling is parallel to the horizontal orientation of Fig. 2b, one observes banding of the pearlite colonies, and elongation of the sulfide particles and silicate particles. The microstructure is fairly typical of a 0.21% C steel. The percentage of pearlite is about 15% of the microstructure. The acicular ferrite, about 5%, is the result of air cooling of a steel having a large austenite grain size through the  $A_{c3}$  temperature. The average grain size is  $22.7\text{ }\mu\text{m}$  (ASTM 7.6). The transverse section shows very little or no banding.

Fig. 2 The general microstructure of the (a) longitudinal and (b) transverse planes of the RMS Titanic plate. (4% picral + 2% nital etch — 100 $\times$ )

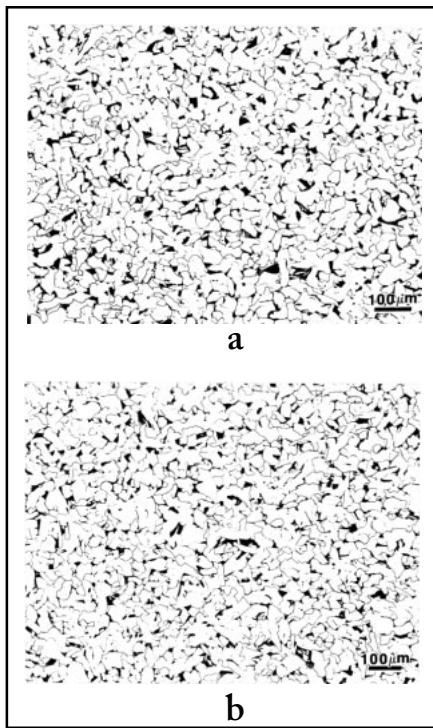
The microstructure of the modern steel plate is shown in Fig. 3, both longitudinal and transverse sections. There is no evidence of banding in either of the sections. For comparison, the same magnifications are used in Fig. 2 and 3. The microstructure consists of ferrite and a small amount of pearlite, 8.5%, which is expected because the carbon content is 0.09% in this steel. The grain size of the modern steel is  $20\text{ }\mu\text{m}$  (ASTM 7.9), somewhat smaller than the RMS Titanic steel.

Fig. 3 The general microstructure of the (a) longitudinal and (b) transverse planes of the modern steel plate. (4% picral + 2% nital etch — 100 $\times$ )

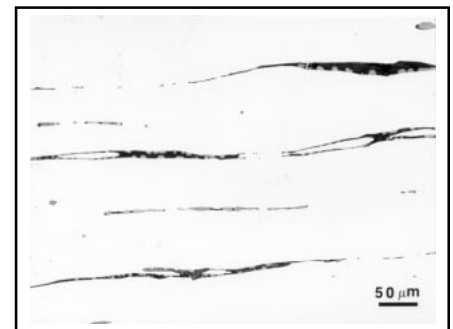
a well polished but unetched RMS Titanic steel specimen revealed the non-metallic inclusions. Figure 4 shows a typical worst field view (ASTM E 45) of inclusions at 500 $\times$ , for the transverse plane. The dark gray inclusions are silicates, whereas the light gray inclusions are sulfides. The elongated and rounded particles of a large silicate and several sulfides are shown in Fig. 5. The composition of the sulfide particles determines its plasticity. Manganese sulfide particles are more plastic than iron sulfides. The presence of iron in the manganese sulfide reduces the plasticity of the particles.

Because the RMS Titanic steel has a Mn:S ratio of 7:1, the MnS particles will have a varying amount of iron replacing manganese. The silicate particles (slag) are the result of their entrapment in the molten steel during

teeming into an ingot mold. By modern standards, the RMS Titanic steel is "dirty steel." It would not be acceptable by current standards. The RMS Titanic steel (1996) has 0.396 vol.% sulfides and 0.133 vol.% silicates, as compared with modern steel having 0.021 vol.% sulfides and 0.014 vol.% oxides and mixed oxides and sulfides. From these data, it is apparent that the modern steel is much cleaner than the RMS Titanic steel.

Fig. 4 Typical worst field view of inclusions at magnification of the RMS Titanic steel plate in the transverse plane. (Unetched — 500 $\times$ )

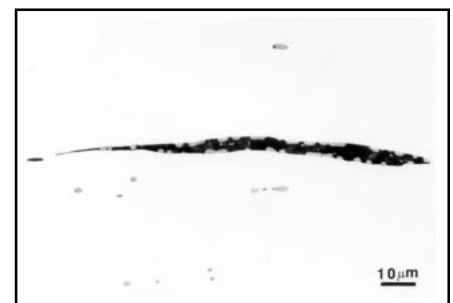
Fig. 5 View of a large silicate inclusion (dark gray) and smaller sulfides (light gray) of the RMS Titanic plate in the transverse plane. (Unetched — 100 $\times$ . Reproduced with permission of the Iron & Steelmaker.<sup>[13]</sup>)

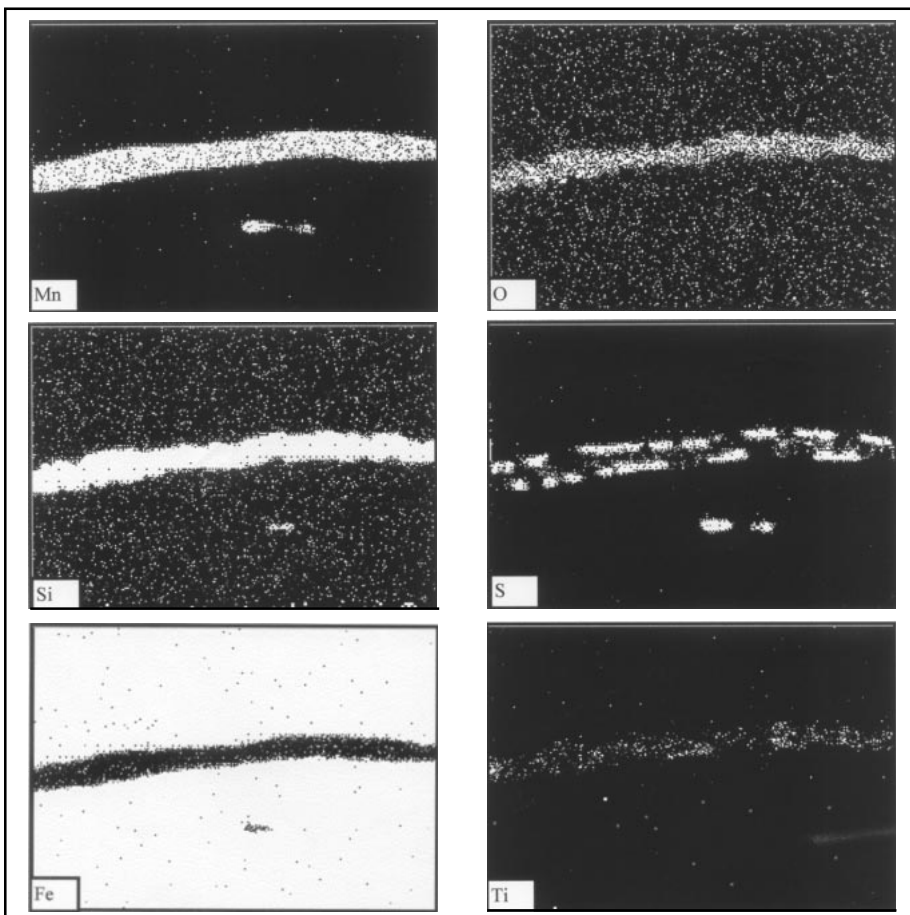
The characteristic X-rays emitted by the large silicate particle shown in Fig. 5 are mapped in order to identify the elements present. The resulting images are shown in Fig. 6. The dominant and most uniformly distributed element present is silicon, which is to be expected. Manganese is nearly uniformly distributed, while the oxygen and silicon have a similar density. This indicates that they co-exist as man-

ganese silicate present in copious amounts in the slag inclusion. The sulfur is confined to small regions on the slag inclusion, which appear as "droplets" on the slag particle shown in Fig. 5. The silicon and oxygen have parallel concentrations while the sulfur concentration is complementary to the silicon and oxygen concentration, i.e. where there is a high concentration of silicon and oxygen, there is little or no sulfur and vice versa. The small amount of titanium in the slag offers confirmation to the idea suggested above that titanium bearing low sulfur iron ore from Sweden was probably used to make the RMS Titanic steel in order to minimize the sulfur in the steel produced in an acid open hearth furnace.<sup>[8,9]</sup>

Fig. 6 X-ray maps showing the elements contained in the large silicate inclusion in Fig. 5. The maps are of the same field shown in the BEI of Fig. 7. Reproduced with permission of the Iron & Steelmaker.<sup>[13]</sup>

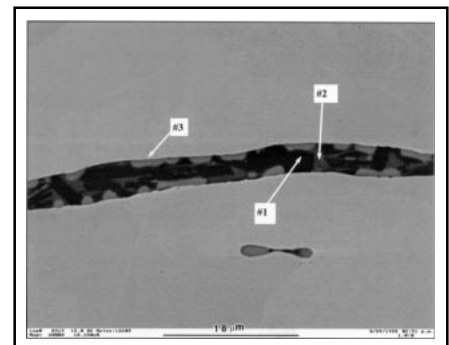
in Fig. 5. (Note that Fig. 5 and 7 are mirror images of the slag particle.) The arrows 1, 2, and 3 point to constituents analyzed by wavelength dispersive spectroscopy (WDS). The dark appearing matrix (arrow 1) is basically manganese silicate with a small amount of titanium and no iron. The titanium is dissolved in the manganese silicate. Arrow 2 points to a dark gray particle that appears to be a mixture of manganese silicate, MnS, FeS, and titanium. The presence of sulfide in the silicate slag suggests that the sulfide, at high temperatures, is soluble in the slag but it becomes immiscible at lower temperatures. The rounded particles, arrow 3, are essentially MnS containing a small concen-

tration of iron. This would be the product of the rejection of the sulfide from the silicate caused by declining temperatures.

Fig. 7 The back scattered image (BEI) of the large silicate particle in Fig. 5. The arrows, 1, 2, and 3, point to constituents analyzed by WDS. Reproduced with permission of the Iron & Steelmaker.<sup>[13]</sup>

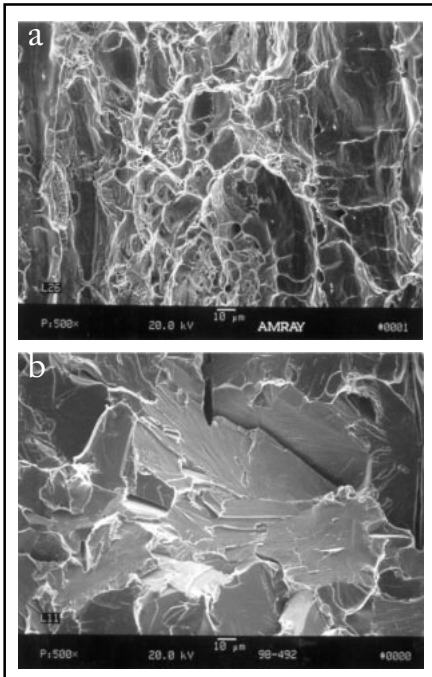
SEM photomicrographs were taken of the fracture surfaces of several broken Charpy specimens made from the plate from the RMS Titanic recovered in 1996. Those in Fig. 8a are from longitudinal Charpy specimens fractured at temperatures on the upper and lower shelves, respectively. Those in Fig. 8b are similar specimens in the transverse direction. The specimen broken in the upper shelf temperature range shows ductile fracture with inclusions in the voids created during fracture. The Charpy speci-

mens broken in the temperature range of the lower shelf show cleavage fracture typical of low temperature failure of steel.

**Fig. 8a** SEM micrographs showing fracture surfaces of longitudinal Charpy specimens from the RMS Titanic plate tested at (a) 120 °C and (b) -32 °C. Reproduced with permission of the Iron & Steelmaker.<sup>[13]</sup>

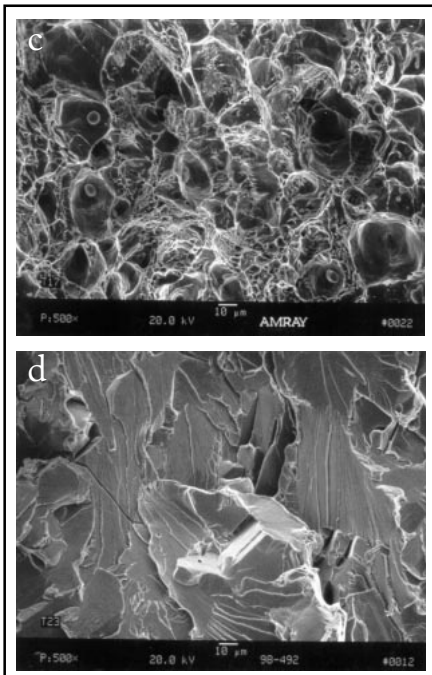
**Fig. 8b** SEM micrograph showing fracture surfaces of transverse Charpy specimens from the RMS Titanic plate tested at (c) 148 °C and (d) -34 °C. Reproduced with permission of the Iron & Steelmaker.<sup>[13]</sup>

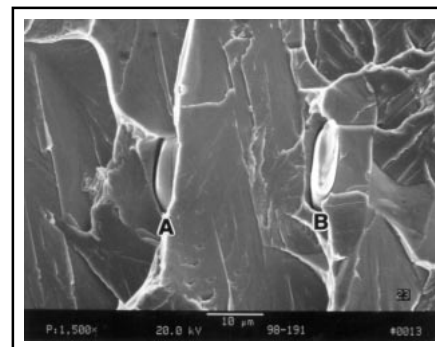
Figure 9 is the fracture surface of a transverse Charpy specimen. The inclusion labeled B protrudes from the surface. The EDS spectrum for particle A is substantially MnS with a smaller amount of FeS while particle B is a nearly equal mixture of Fe and Mn sulfide. This means that the A particle is more plastic than particle B. This could account for the protrusion of particle B in that being less plastic, it could have fractured as the specimen fractured.

**Fig. 9** The SEM micrograph shows sulfide inclusions A and B in the fracture surface of the transverse Charpy specimen from the RMS Titanic plate tested at -34 °C. Reproduced with permission of the Iron & Steelmaker.<sup>[13]</sup>
