# **ENVIRONMENTAL AND INDUSTRIAL CORROSION**

## **PRACTICAL AND THEORETICAL ASPECTS**

Edited by  
**Benjamin Valdez Salas**  
**Michael Schorr**

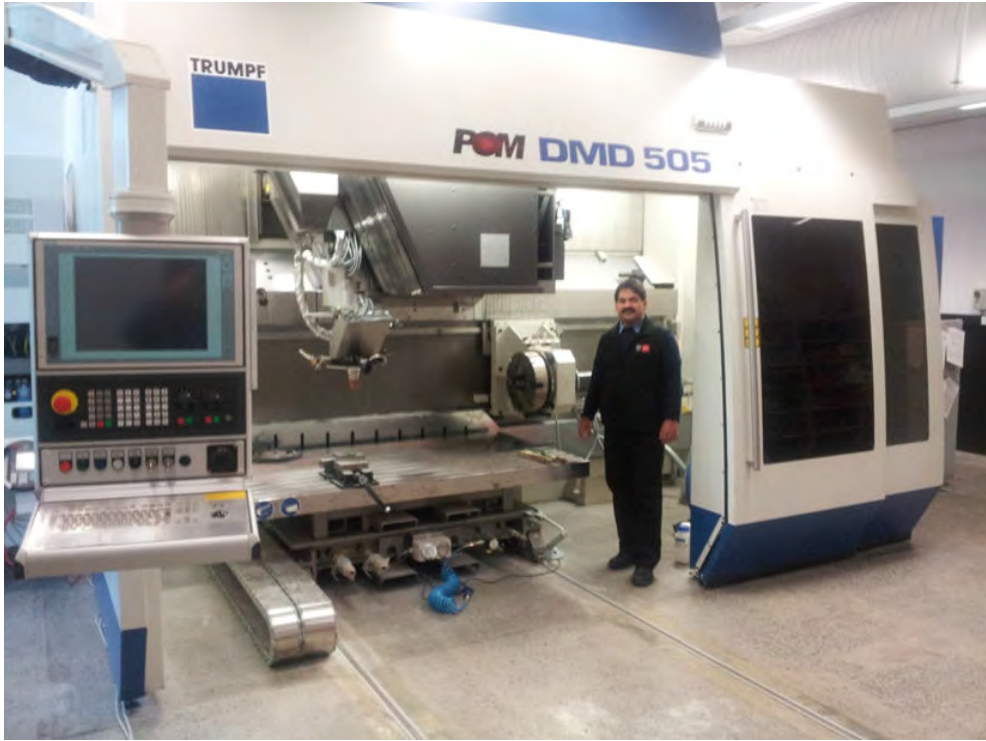
**Figure 1.** POM DMD (direct metal deposition machine) featuring 6-axis rotating, CAD-CNC control using a 5kW CO<sub>2</sub> Trumpf laser.

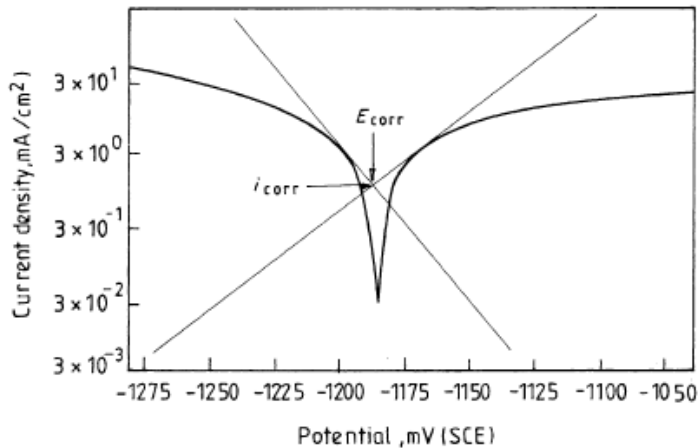
**Figure 3.** Variation of current density with potential indicating the pitting potential and current, taken from [3].

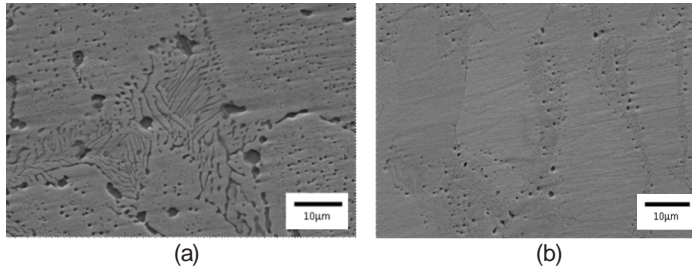
**Figure 4.** Nickel-aluminium bronze microstructure before and after laser heat treatment processing; a – Cast microstructure showing precipitates and  $\kappa_{III}$  lamella; b – laser heat treated microstructure showing that the  $\kappa_{IV}$  and  $\kappa_{III}$  lamella was dissolved.

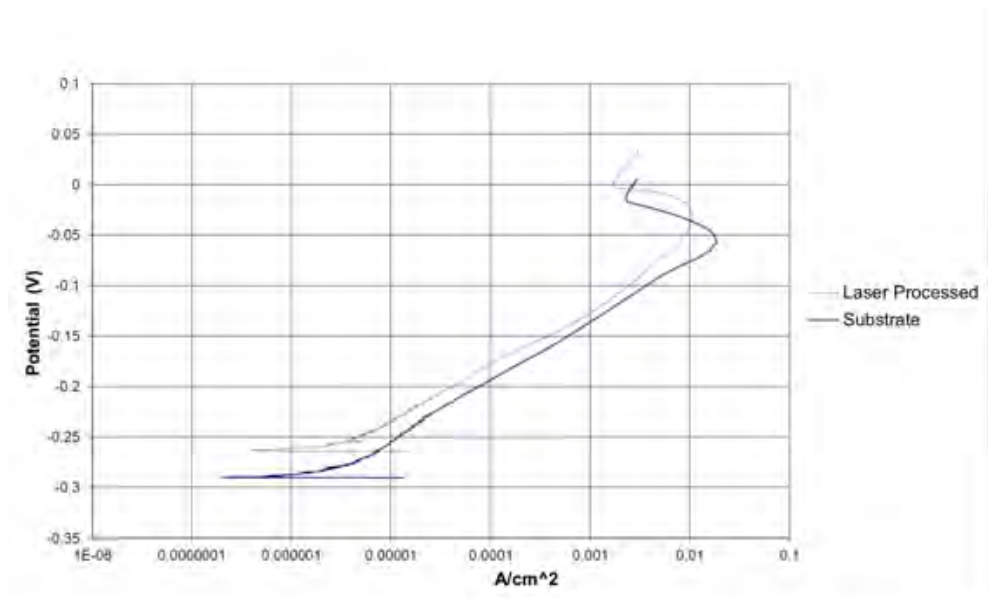
**Figure 5.** Linear polarisation curves for as cast substrate and laser processed nickel-aluminium bronze.

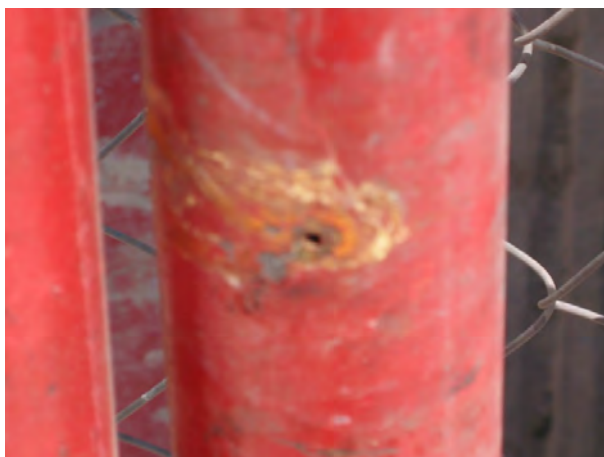
**Figure 2.** External pitting caused by biocorrosion on the internal surface of a carbon steel pipe in a fire extinguisher system.

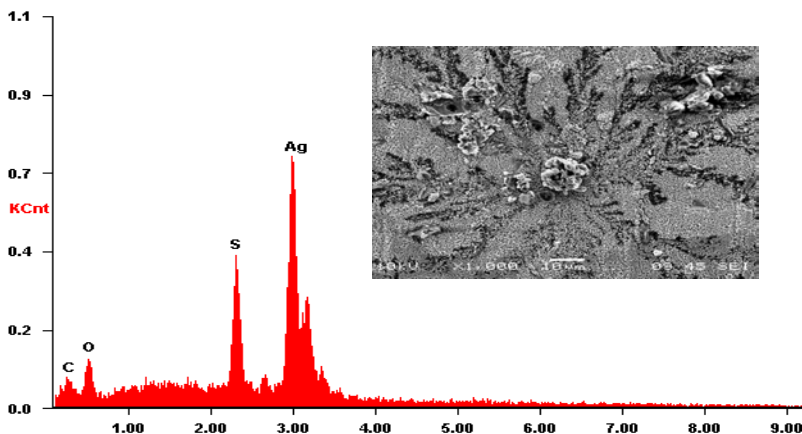
**Figure 4.** Scanning Electron Microscopy and EDS analysis of silver corrosion products at indoor conditions of an electronics plant contaminated with  $H_2S$ .

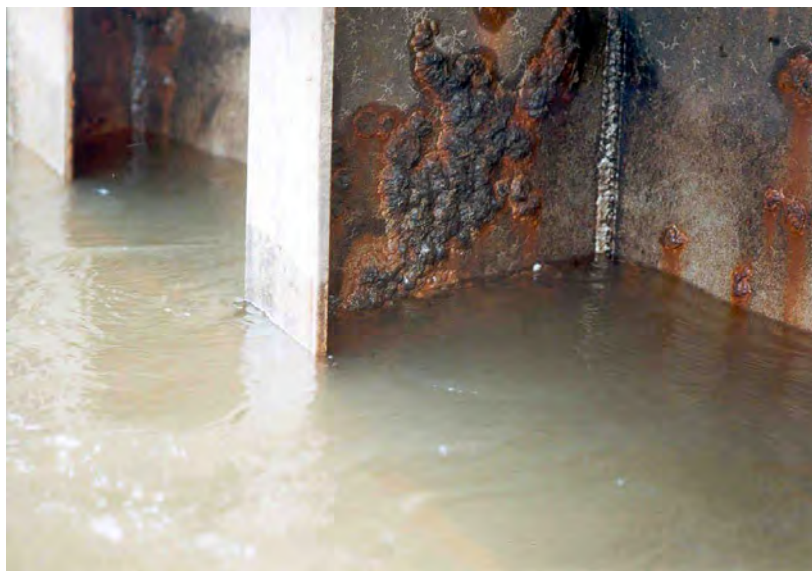
**Figure 5.** Corrosion on the gates dam on the Colorado River, Baja California, Mexico

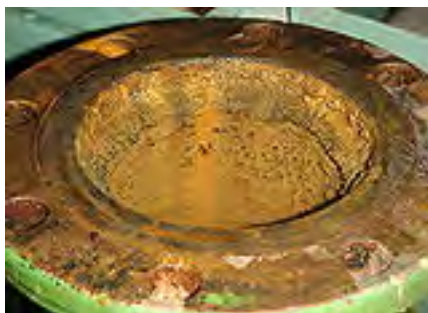
**Figure 6.** Corrosion in potable water pipes.

Corrosion can occur anywhere on the pipes that carry drinking water, mainly at sites of contact between two dissimilar metals, thus forming a corrosion cell. In general, the metals will corrode to a greater or lesser degree in water, depending on the nature of the metal, on the ionic composition of water and its pH. Waters high in dissolved salts (water hardness), favor the formation of scale, more or less adherent, in different parts of the equipment (Figure 6). These deposits may be hard or brittle, sometimes acting as cement, creating a physical barrier between the metal and water, thereby inhibiting corrosion. Calcium carbonate ( $\text{CaCO}_3$ ) is the most common scale; its origin is associated with the presence of carbon dioxide gas ( $\text{CO}_2$ ) in water. Sometimes these deposits are filled with pasty or gelatinous hydrated iron oxides or colonies of bacteria (Valdez, B. et al., 1999, 2010).

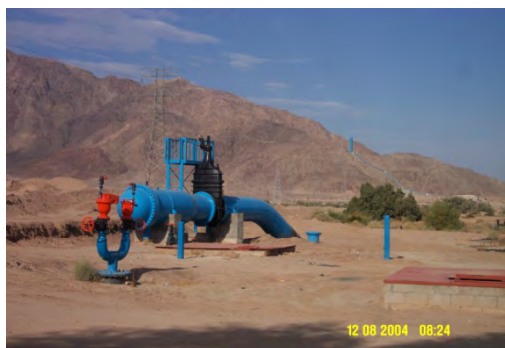
**Figure 7.** Valve system of a desert water aqueduct.

Metal structures are buried depending on their functionality and security. Most often they traverse large tracts of land, being exposed to soils with different degrees of aggressiveness exposed to air under atmospheric conditions (Figure 7).

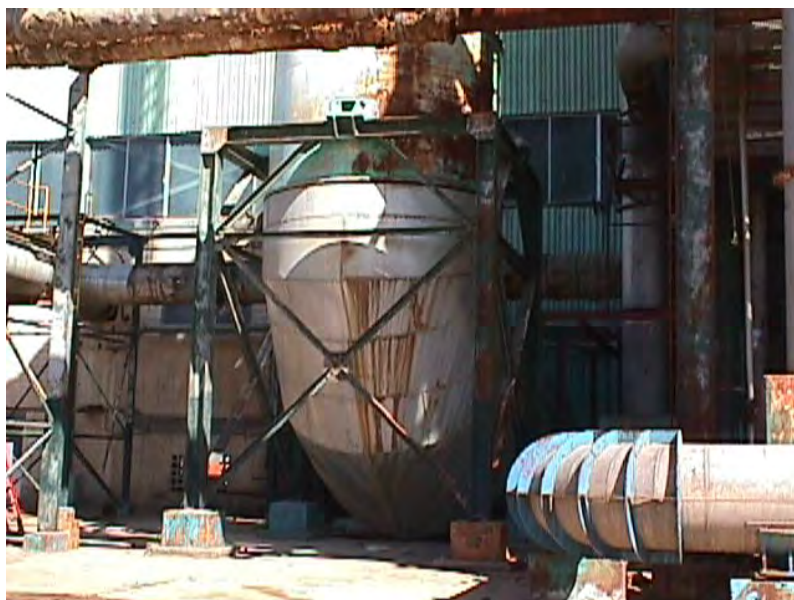
**Figure 9.** Corrosion of a carbon steel pipe under insulation.

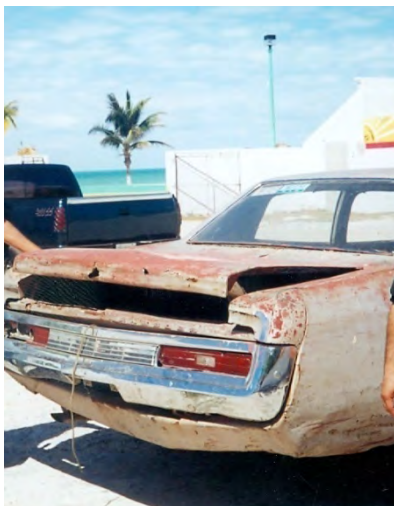
**Figure 10.** Corrosion on a bodywork exposed to the Gulf of Mexico tropical coast.

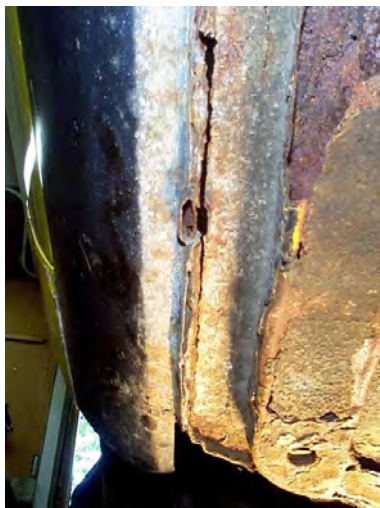
**Figure 11.** Corrosion on a car door and bottom of the bodywork

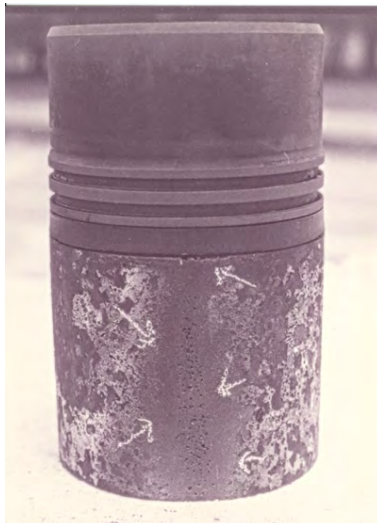
**Figure 12.** Corrosion in a carbon steel jacket on the water face in a diesel combustion engine truck.

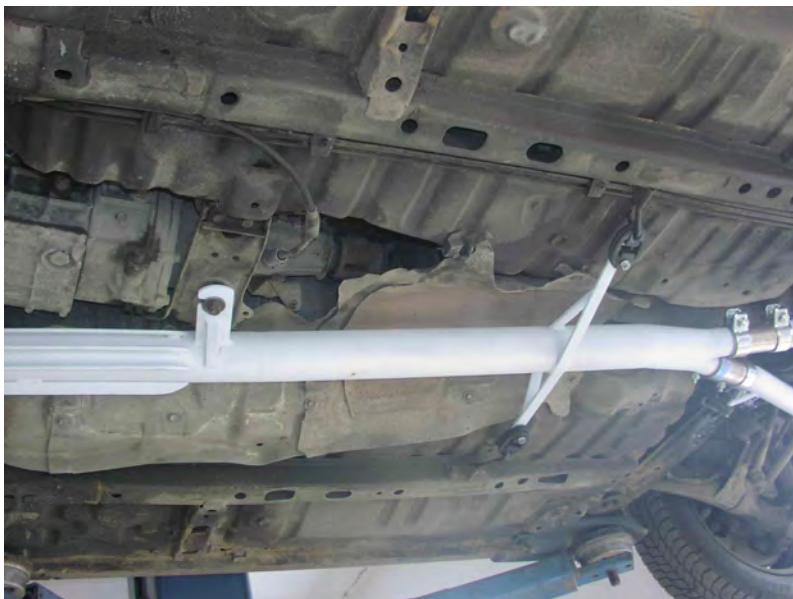
**Figure 13.** Corrosion on carbon steel exhaust pipes coated with aluminum.

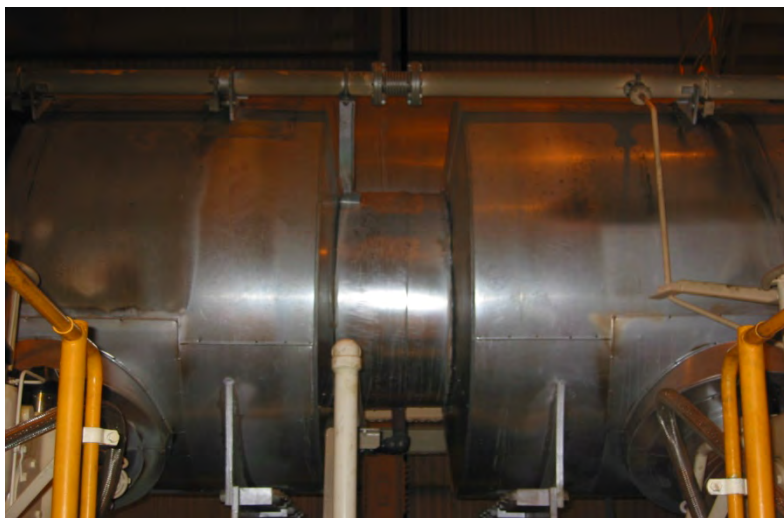
**Figure 14.** Stress corrosion cracking, in a combustion gases pipe of a thermoelectric station.

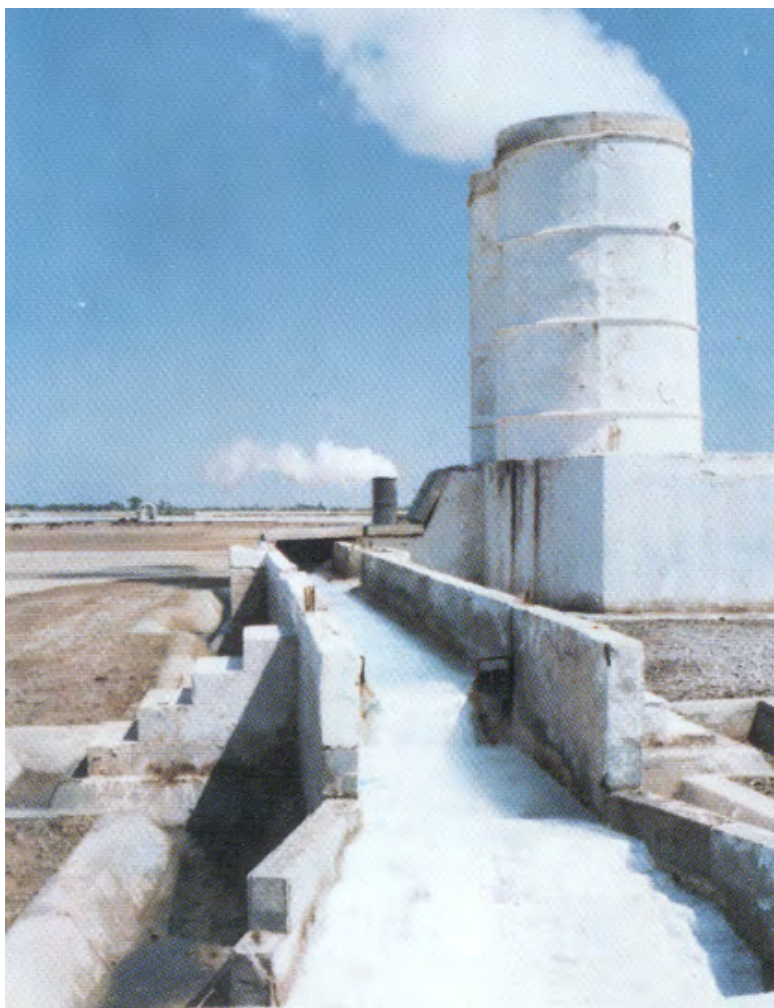
**Figure 15.** Corrosion in concrete structures used to separate steam from water and to operate steam silencers.

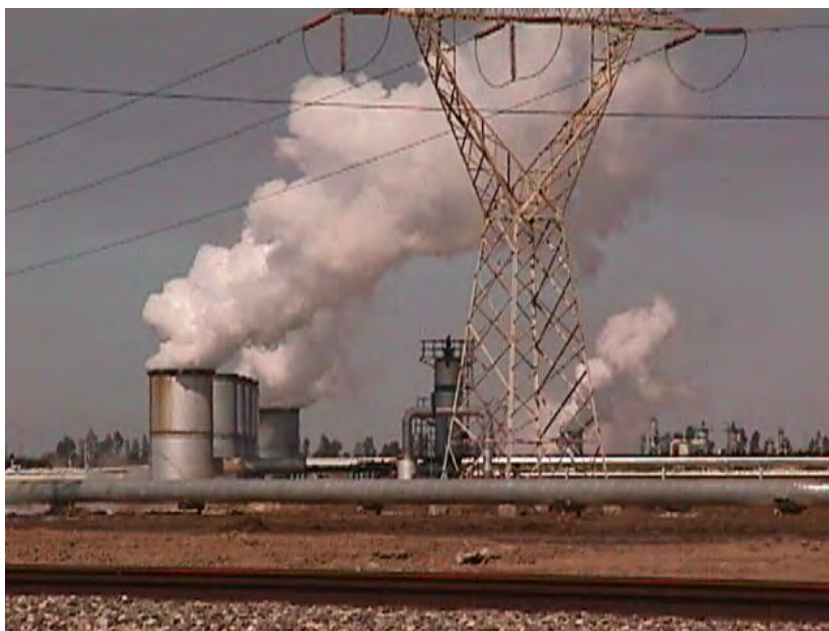
**Figure 16.** A humid corrosive environment in a geothermal field caused by steam and gases emission.

The combination of an aerated moist environment with the presence of hydrogen sulfide gas (H<sub>2</sub>S) dissolved in water provides a very aggressive medium (Figure 16), which promotes the corrosion of metals and alloys, such as CS and SS. The presence of dust, from the geo-

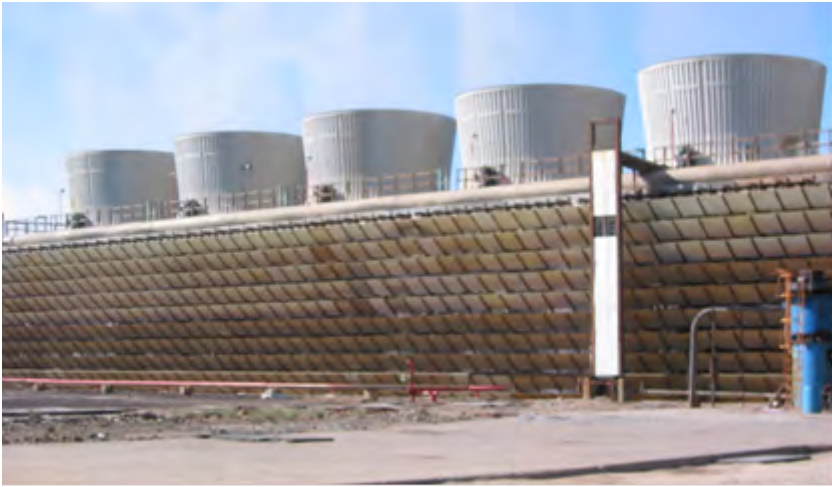
**Figure 17.** Corrosion in a cooling tower of a geothermal power plant.

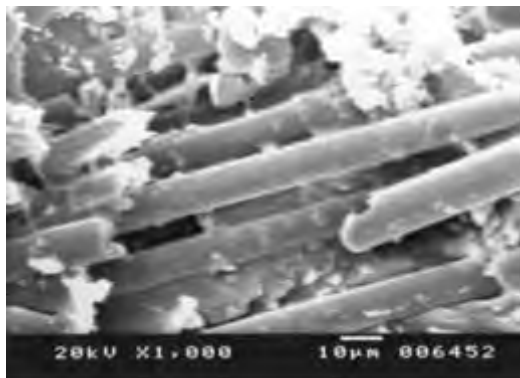
**Figure 18.** Biodeterioration of polyester polymeric matrix in a fiberglass screen exposed at geothermal temperatures.

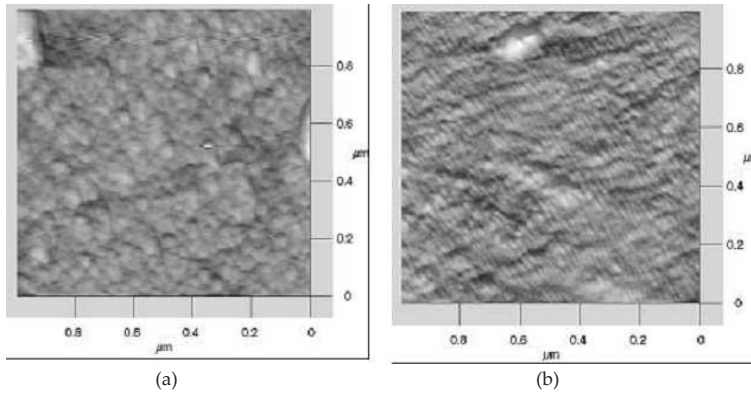
**Figure 3.** AFM Micrographs of a) TiC monolayers and of b) Multilayers, where the grain-size difference is observed.

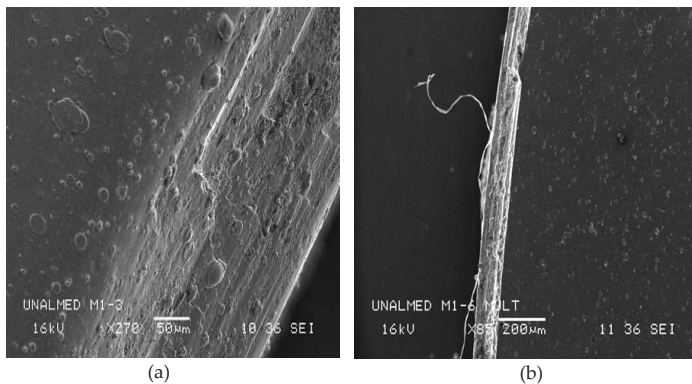
**Figure 4.** SEM Micrographs after wear test: a) TiC monolayer, b) multilayer.

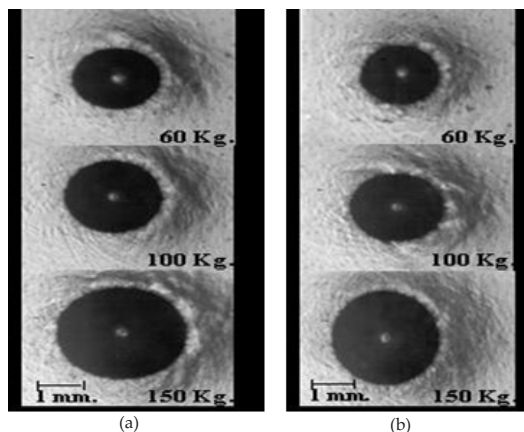
**Figure 5.** Images of Rockwell C indentation traces a) upon TiC monolayers, and b) on multilayers, (charges are indicated).

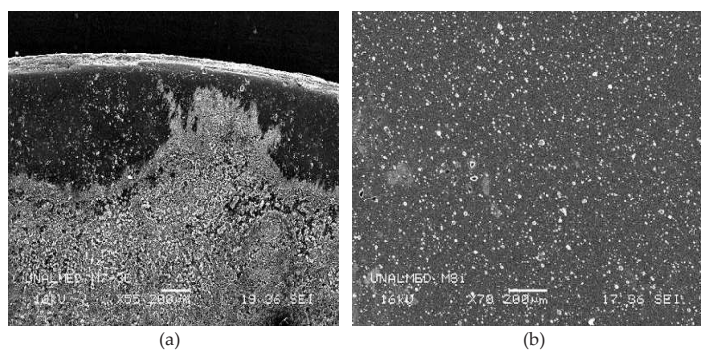
**Figure 6.** SEM Micrographs after corrosion test in a saline atmosphere a) TiC film b) multilayer.

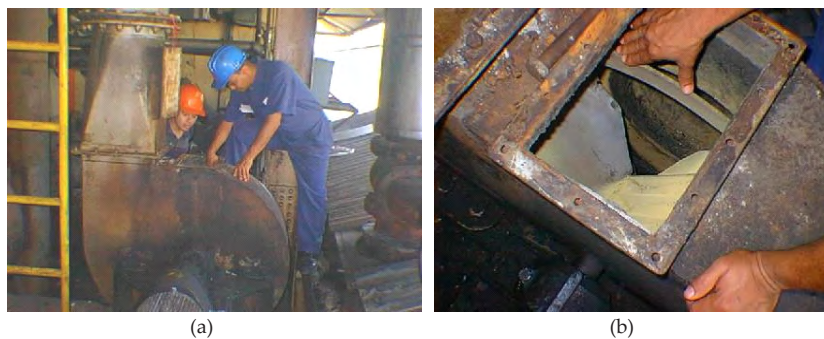
**Figure 7.** Photos of the attack-sites of samples: a) Ventilator extractor where samples were placed, b) Ventilator damp where samples were anchored.

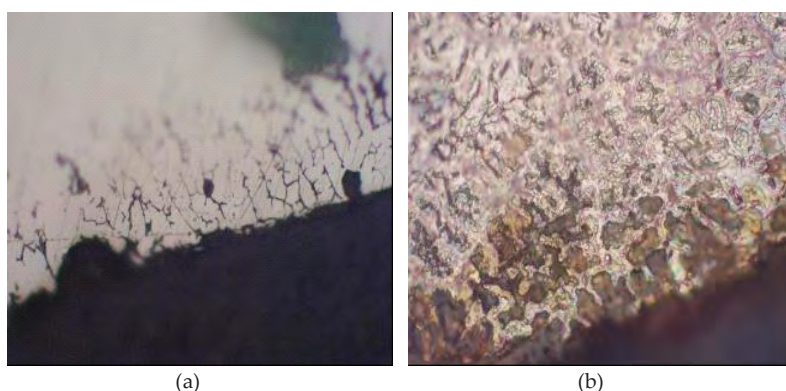
**Figure 8.** Optical Microscopy Images of samples with GMAW welding process; removed after 1.5 months: a) Non-attacked sample – X50 welding welt, b) attacked sample, X500 fused zone.

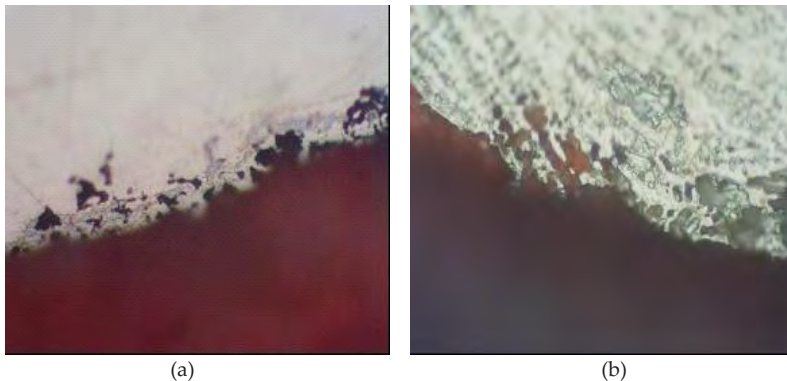
**Figure 10.** Optical Microscopy Images of samples with GTAW welding process; removed after 1.5 months: a) Non-attacked sample – X500 welding welt, b) Zone defused and attacked with acid.

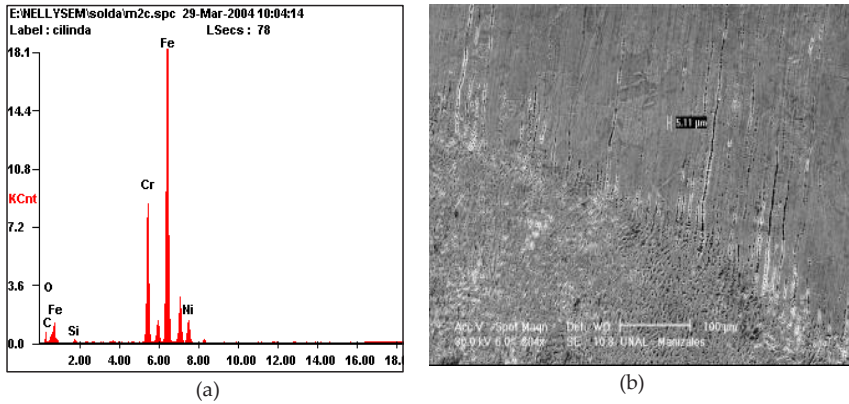
**Figure 11.** a) EDX Spectrum, b) SEM image of segregated zone of samples with GTAW processes; removed after 1.5 months.

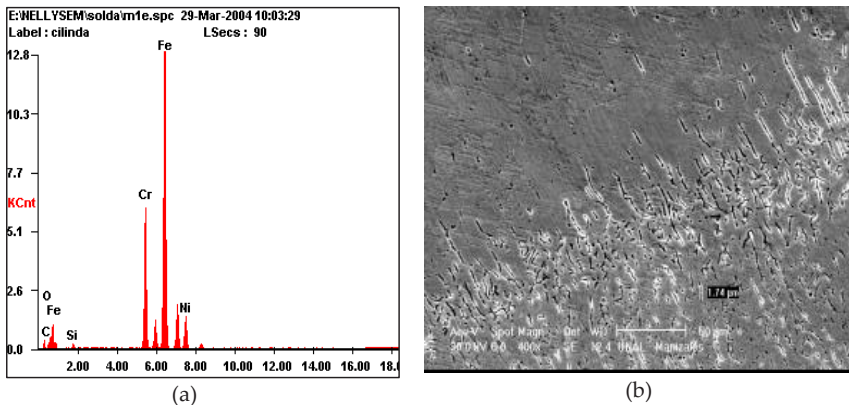
**Figure 12.** a) EDX Spectrum, b) SEM image of segregated zone of samples with GMAW processes; removed after 1.5 months.

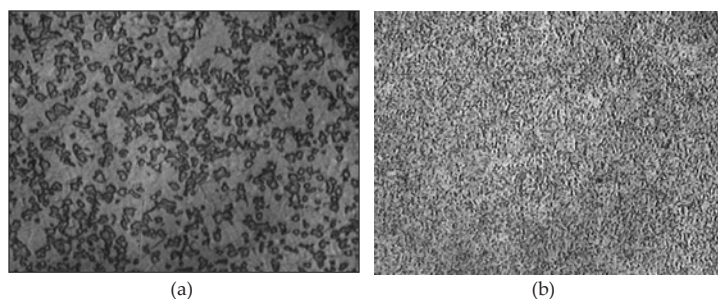
**Figure 14.** AISI 420 steel micrographs a) without heat treatment HT and b) after heat treatment HT.

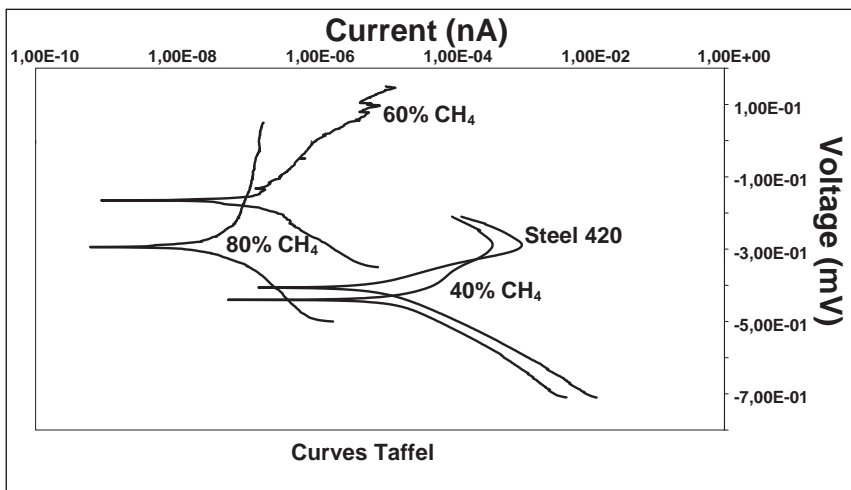
**Figure 15.** Polarization Curves of the different steel substrates without and with bilayers.

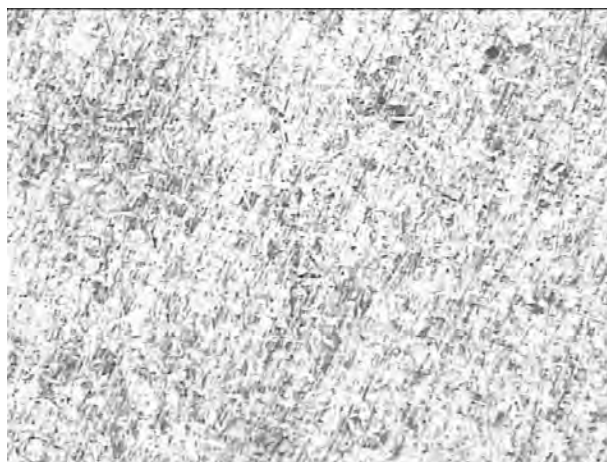
**Figure 16.** AISI 420 steel micrograph attacked by electrochemically corrosion.

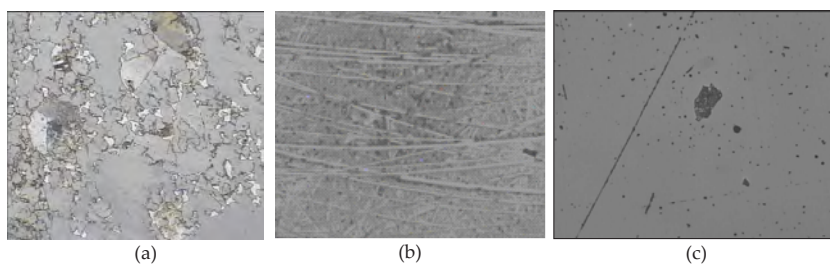
**Figure 17.** Attacked electrochemical corrosion surface bilayer micrographs a) 40% CH<sub>4</sub>, b) 60% CH<sub>4</sub> and c) 80% CH<sub>4</sub>.

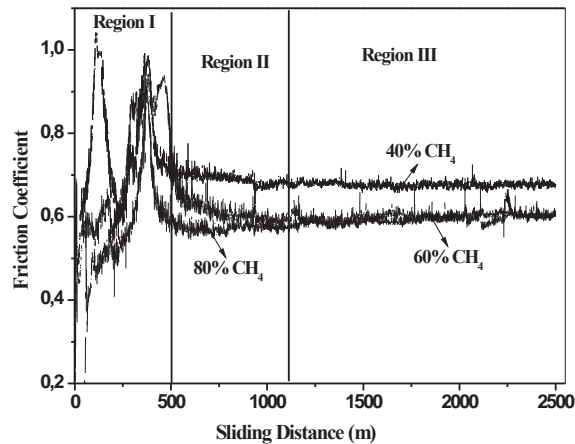
**Figure 18.** Friction coefficient of hard coatings W/WC grown with different CH<sub>4</sub> on to steel AISI 420 as a function of sliding distance.

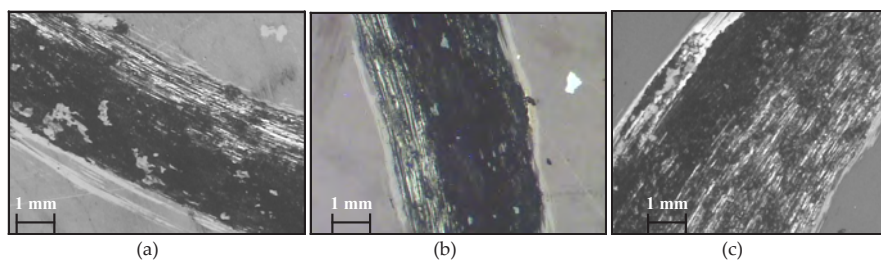
**Figure 20.** Trace micrographs on AISI 420 coated steel with W/WC. a) 40% CH<sub>4</sub>, b) 60% CH<sub>4</sub> and c) 80% CH<sub>4</sub> bilayers

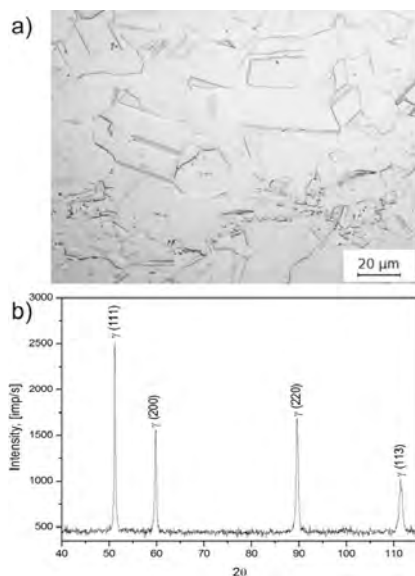
**Figure 2.** Austenitic microstructure with annealing twins of X5CrNi18-8 steel in a delivery state (a) and X-ray diffraction pattern (b).

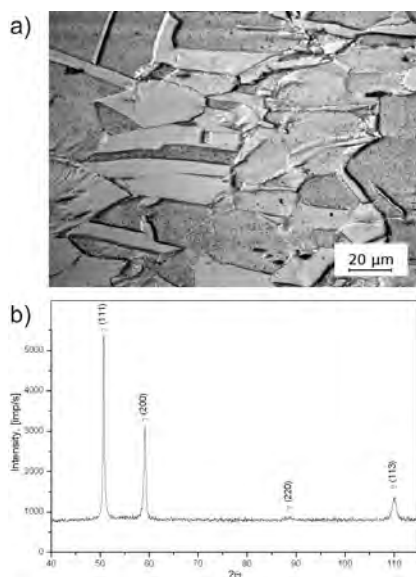
**Figure 3.** Austenitic microstructure with annealing twins of X6MnSiAl26-3-3 steel after the thermo-mechanical rolling and immersion in 1N H<sub>2</sub>SO<sub>4</sub> (a) and X-ray diffraction pattern (b).

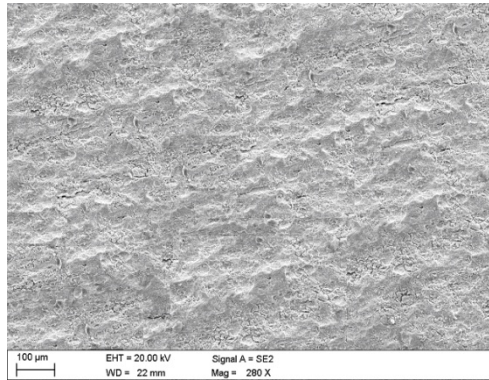
**Figure 5.** Micropores and corrosion pits on the X5CrNi18-8 steel surface in a delivery state after immersion tests in 3.5N H<sub>2</sub>SO<sub>4</sub> solution.

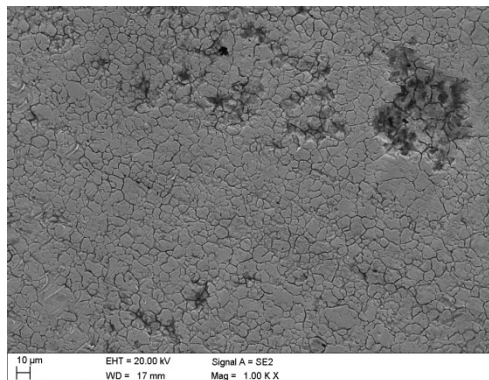
**Figure 6.** Corrosion pits on the X5CrNi18-8 steel surface in a delivery state after immersion tests in 3.5 wt% NaCl solution.

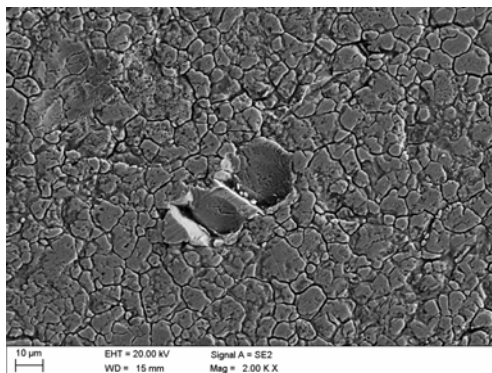
**Figure 7.** Corrosion pits and the cracked surface layer of the X5CrNi18-8 steel in a delivery state after immersion tests in 3.5 wt% NaCl solution.

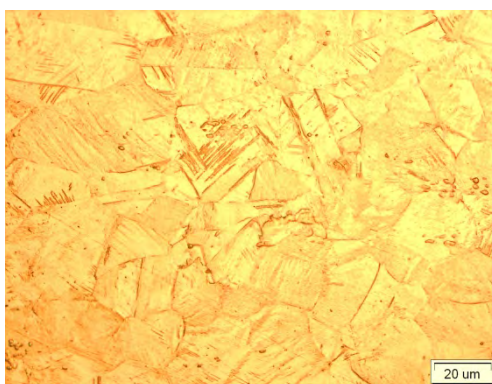
**Figure 8.** Elongated austenitic grains containing deformation twins and  $\alpha'$  martensite in the X5CrNi18-8 steel deformed to the reduction of 30%.

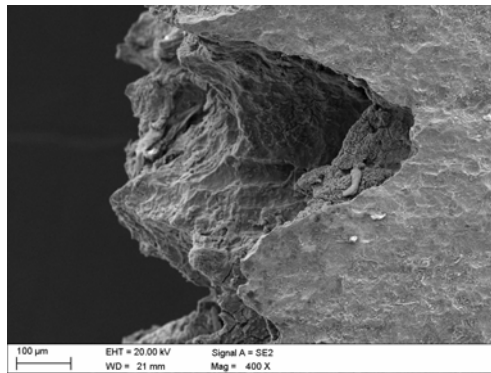
**Figure 10.** Corrosion pits on the surface of X5CrNi18-8 steel 40% deformed and immersed in 3.5N H<sub>2</sub>SO<sub>4</sub>.

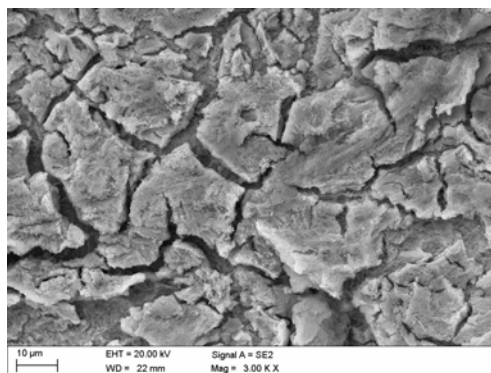
**Figure 11.** Cracked passive layer on the surface of X5CrNi18-8 steel 40% deformed and immersed in 3.5N H<sub>2</sub>SO<sub>4</sub>.

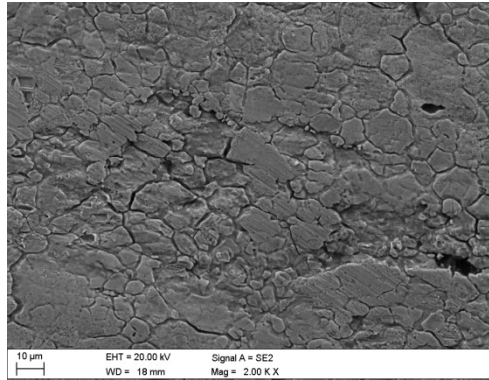
**Figure 14.** Corrosion pits on the surface of the X5CrNi18-8 steel 30% deformed and immersed in 3.5 wt% NaCl.

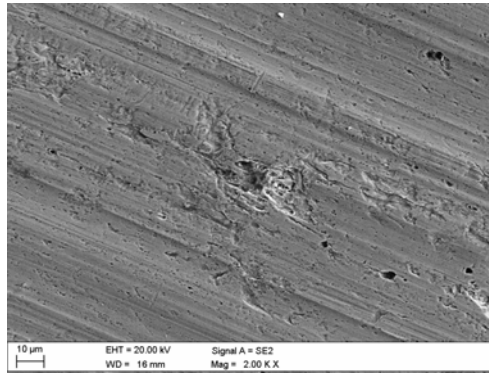
**Figure 15.** Corrosion pits on the surface of the X5CrNi18-8 steel 70% deformed and immersed in 3.5 wt% NaCl.

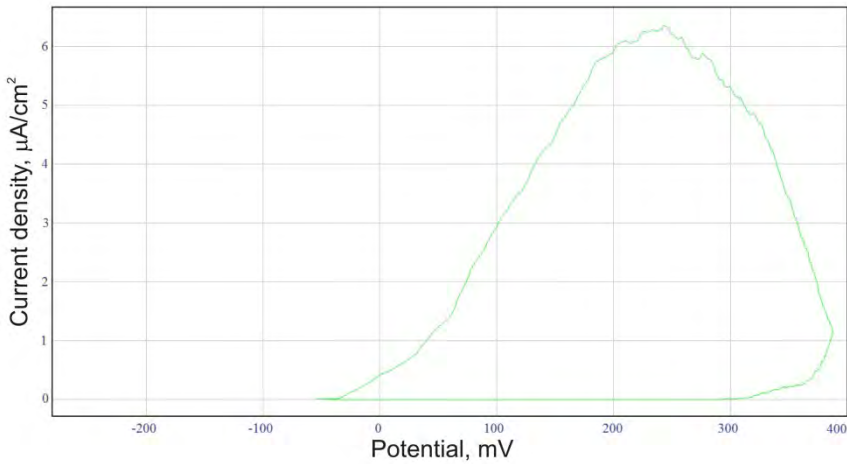
Figure 16. Anodic polarization curve registered for the X5CrNi18-8 steel in a delivery state in 3.5 wt% NaCl.

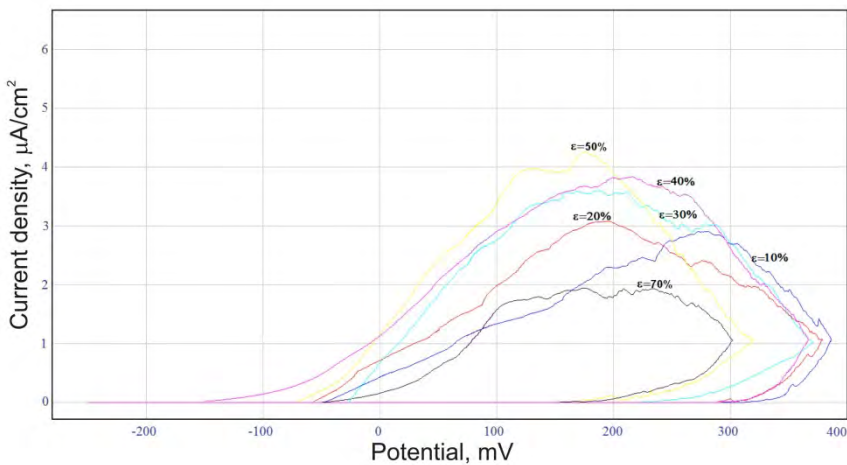
Figure 17. Anodic polarization curves registered for the cold-deformed samples of X5CrNi18-8 steel in 3.5 wt% NaCl.

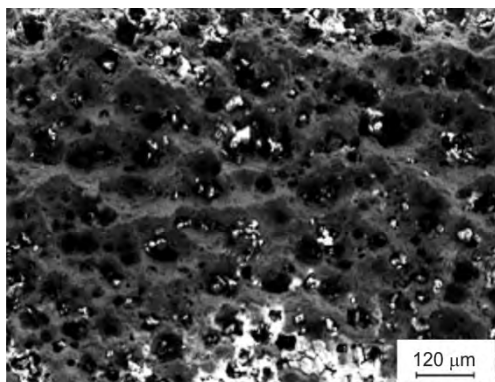
**Figure 27.** Numerous craters formed due to corrosion pitting and probable hydrogen impact in the X6MnSiAl26-3-3 steel after bending and immersion in 1N H<sub>2</sub>SO<sub>4</sub>.

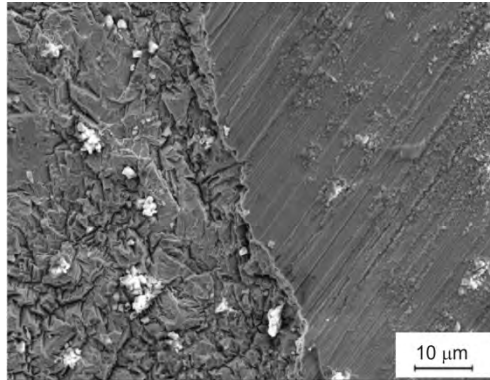
**Figure 28.** The boundary between undipped and dipped parts of the sample showing a scaled and cracked layer of corrosion products in the X6MnSiAl26-3-3 steel after bending and immersion in 3.5 wt% NaCl.

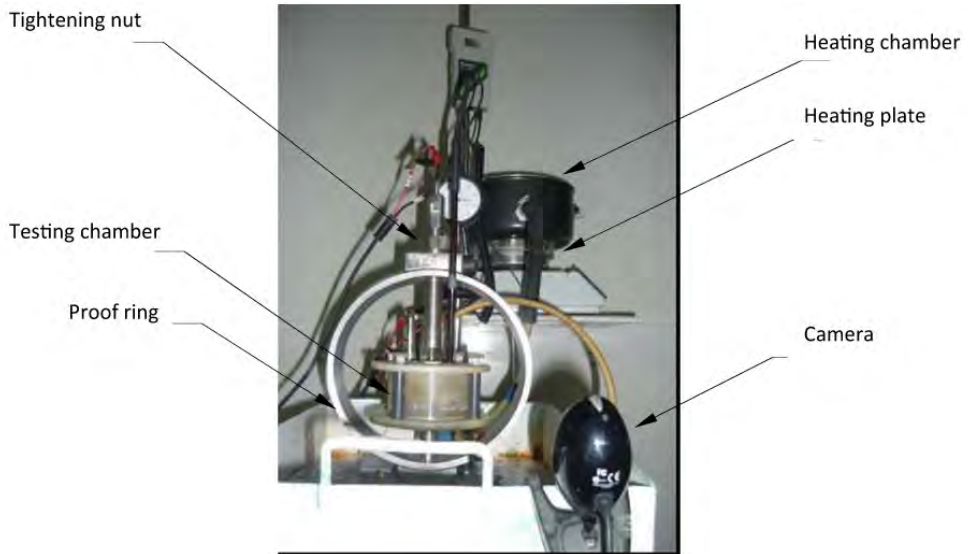
**Figure 1.** SCC test rig designed following the guidelines of ASTM and NACE Type A testing method [4, 5]. a) proof ring, b) SCC testing chamber, c) tightening screw and nut system, d) hot brine container, e) heating plate, f) monitoring camera [2].

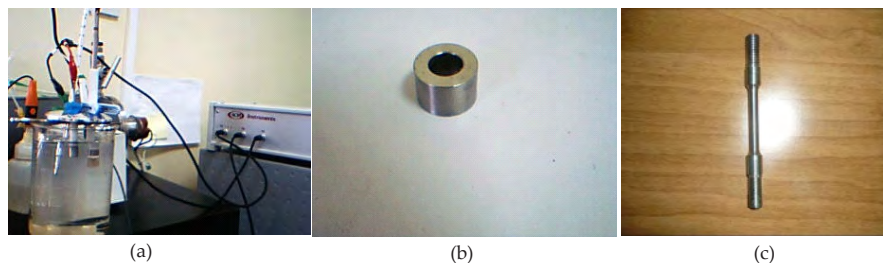
**Figure 3.** Setup of electrochemical testing (a), an electrochemical test sample (b), and an SCC test sample (c)[2, 6].

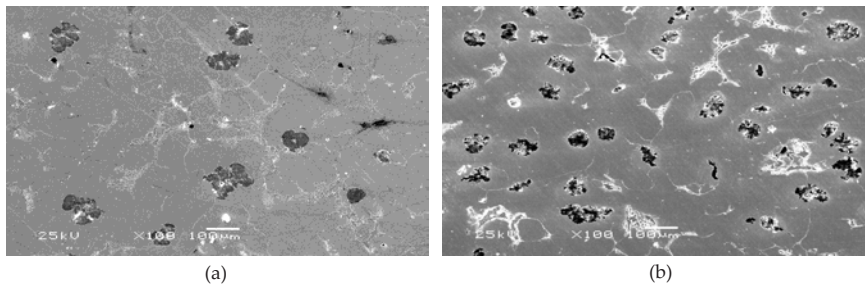
**Figure 4.** SEM micrographs showing the difference between the microstructures of the D-type (a) and the G-type (b) of the Ni-Resist austenitic cast irons [6].

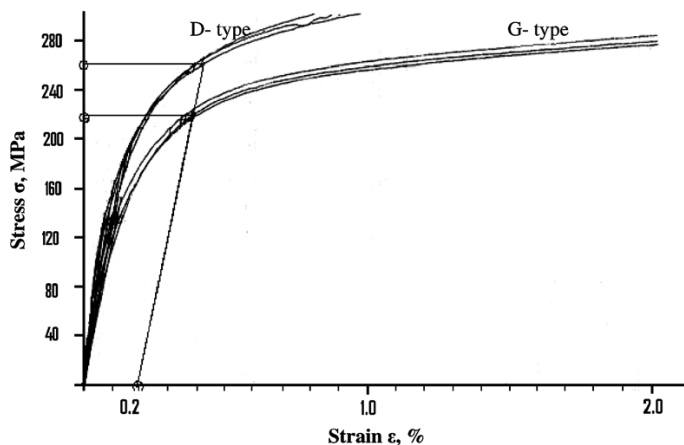
**Figure 5.** Stress-strain plots for the two types of nickel-resist cast irons [6].

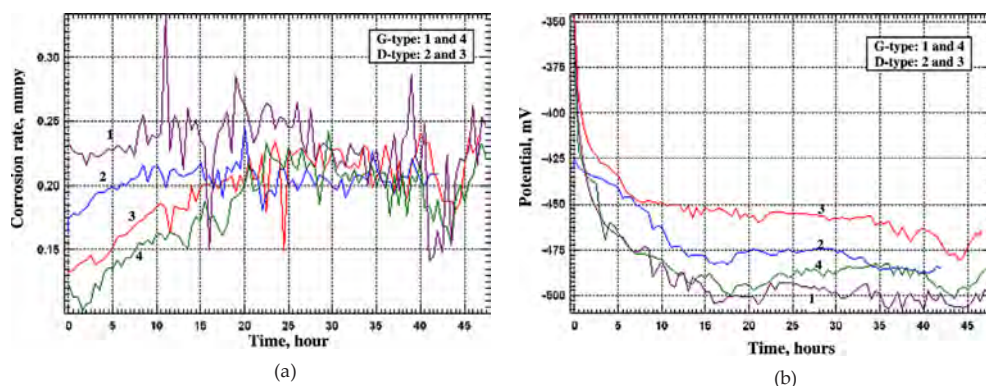
**Figure 6.** Corrosion rates (a) and potentials (b) of four specimens (two from each D and G materials). Potentials are measured versus Ag/AgCl reference electrode [6]

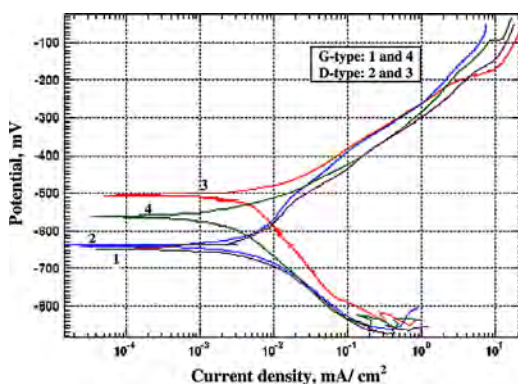
**Figure 7.** Tafel plots of four specimens (two from each D and G-type materials). All potentials are measured versus Ag/AgCl reference electrode [6].

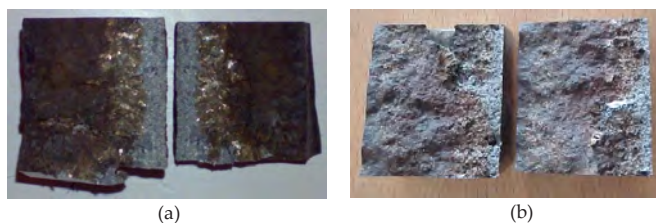
**Figure 8.** Two photographs showing (a) G material as fractured prior to cleaning and (b) D material after chemical cleaning [7].

The two specimens, sampled from failed pump casings, for examination of the crack surfaces were opened till fracture using special holders prepared for this purpose. Figure 8 shows two photographs for the fracture surfaces of the two materials. They show corroded and mechanically fractured areas. Figure 9 shows photographs for the service induced SCC of the two materials. All cracks pass through the matrix without preference to phases. Figure 10 shows SEM micrographs of fracture surfaces of the same specimens shown in figure 8. They indicate two distinctive fracture surfaces. The first is the mechanical fracture surface caused by loading using the MTS tensile testing machine and the second is the SCC fracture surfaces developed during pump service. The second surfaces are similar to those reported in literature [16].

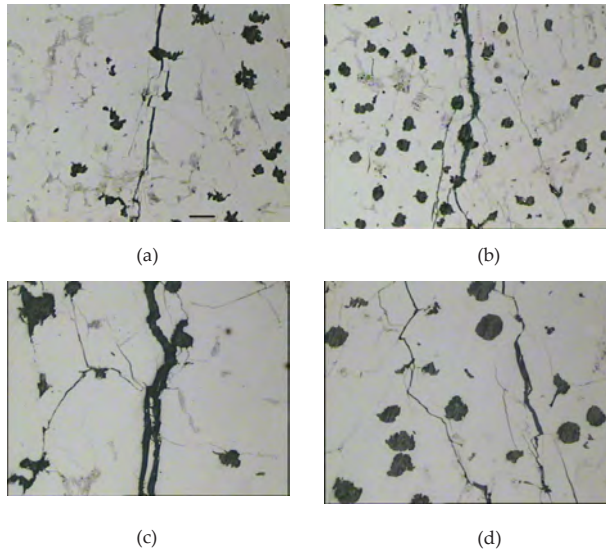
**Figure 9.** Service induced SCC cracks of D material at (a) 100X and (c) 200X and those of G material (b) 100X and (d) 200X. Cracks propagate through matrix without preference to phases [7].

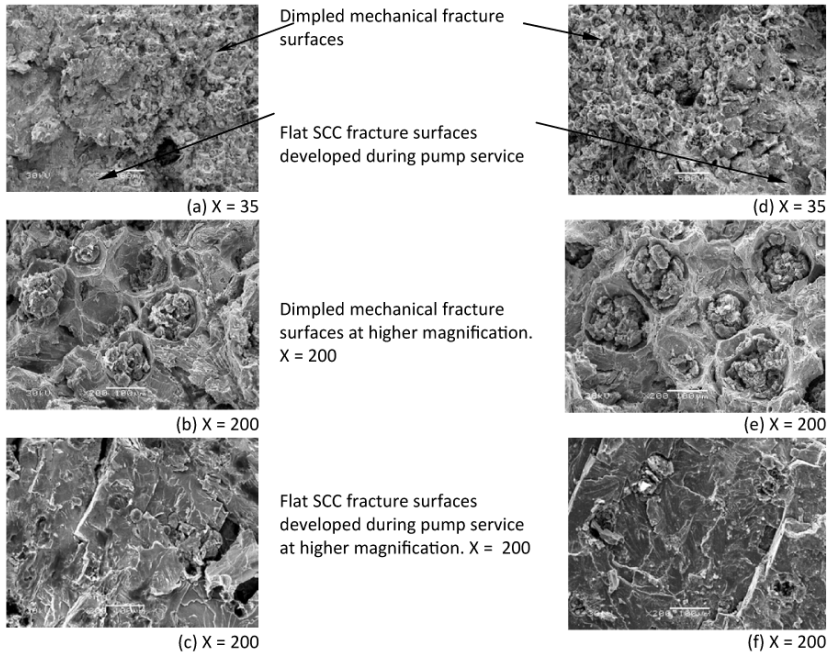
**Figure 10.** SEM micrographs of fracture sections of D material (a, b, and c) and G materials (d, e, and f). SCC fracture surfaces were produced during pump service, whereas, mechanical fracture surfaces were produced due to specimen forced fracture using MTS testing machine [7].

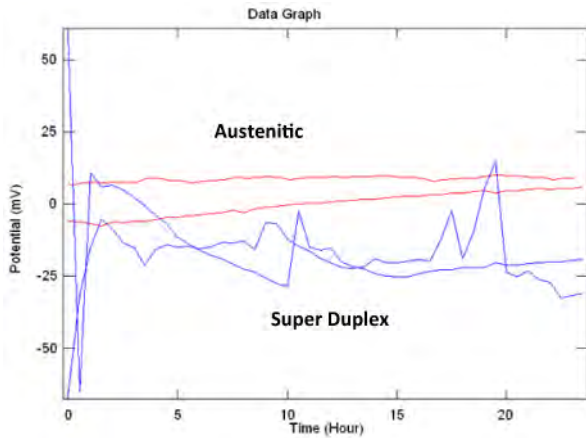
**Figure 15.** Open circuit potential against time for the as received austenitic and super duplex stainless steels. All potentials are measured against austenitic stainless steel reference electrode [2].

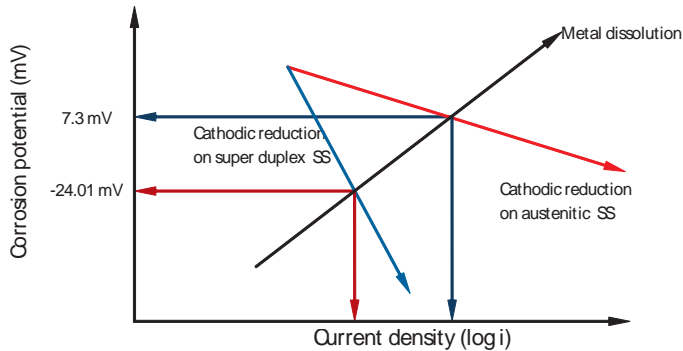
**Figure 16.** Schematic for (E- log i) diagram illustrating higher corrosion tendency for austenitic stainless steel versus relatively lower corrosion tendency on super duplex stainless steel [2].

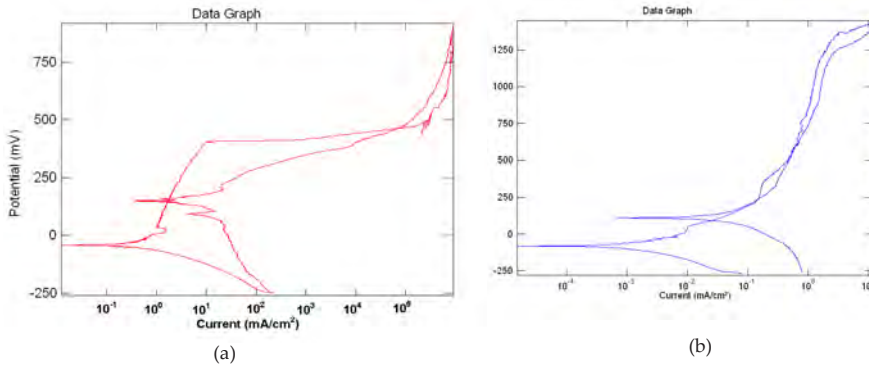
**Figure 17.** Cyclic sweep potential plots against current density for the as received (a) austenitic and (b) super duplex stainless steels. All measured potentials are measured versus austenitic stainless steel reference electrode[2].

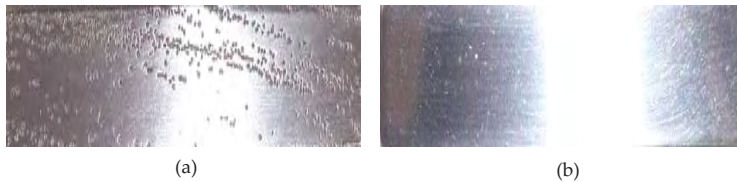
**Figure 18.** Pitting on austenitic sample (a) as compared by no pitting on super duplex sample (b) after one run of cyclic sweep testing [2].

Fig. 16 shows that when a relatively higher cathodic potential is measured on super duplex stainless steel a correspondent lower current density is expected. On the other hand, higher anodic potential corresponds to higher current densities on the surface of the austenitic stainless steel. The lower corrosion tendency of the super duplex stainless steel is clearly attributed to the relatively higher chromium levels which help form a more stable and a stronger passivity on its surface under these specific test conditions. The enhanced passivity of the super duplex was also confirmed visually by having no signs of pitting and by electrochemical cyclic sweeps.

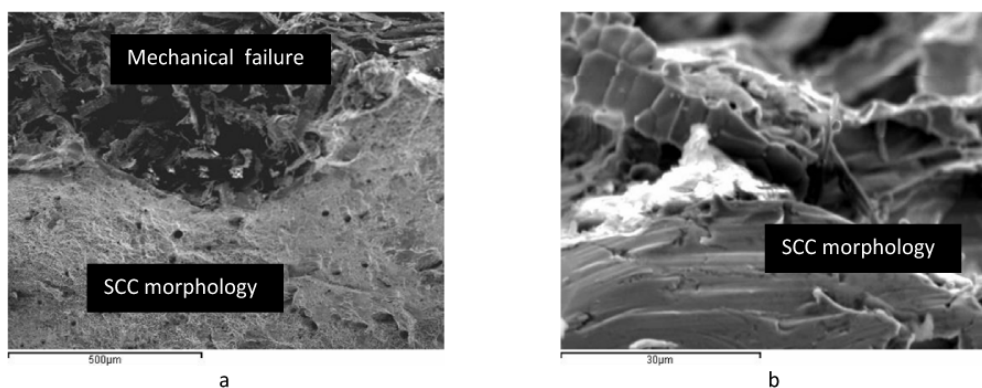
**Figure 19.** Fracture section of failed austenitic stainless steel sample due to SCC at X 200 (a) and X 3500(b) [2].

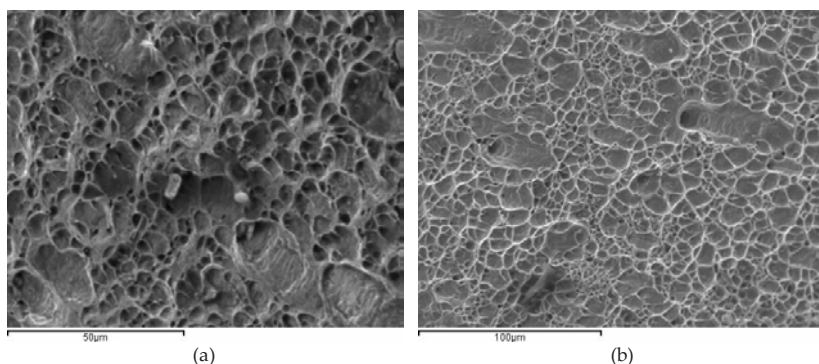
**Figure 20.** Fracture sections of super duplex stainless steel samples before SCC testing, X 2000 (a) and after 335 hours of SCC testing, X 1000 (b). Both samples were forced to mechanical failure using the MTS testing machine [2].

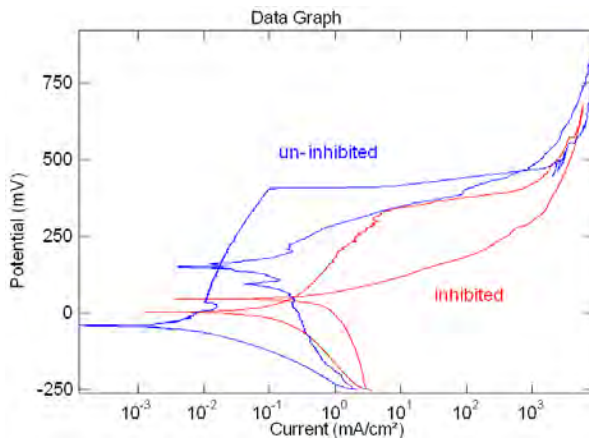
**Figure 21.** Cyclic sweep test plots for austenitic stainless steel in hot brine without inhibition and with inhibition. All measured potentials are measured versus austenitic stainless steel reference electrode [29].

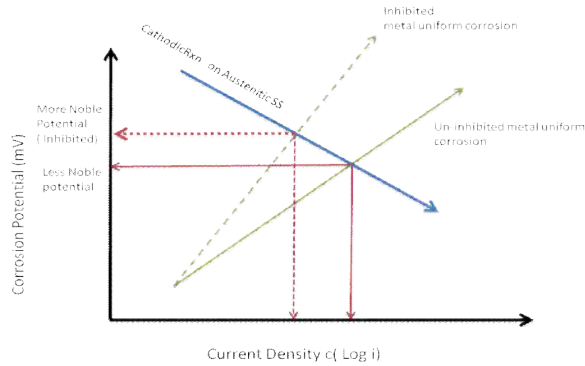
**Figure 22.** Evans Diagram illustrating results from cyclic sweeps due to environment chemical inhibition [29].

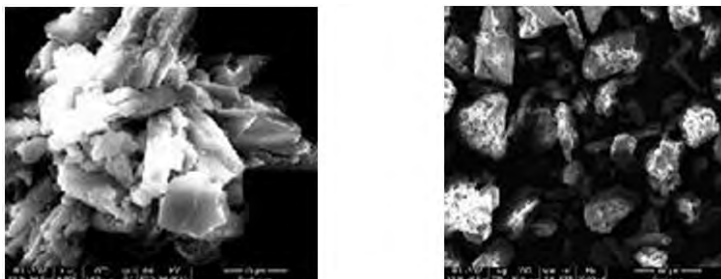
**Figure 1.** SEM micrographs of phosphogypsum films, 30  $\mu\text{m}$
