# **ENVIRONMENTAL AND INDUSTRIAL CORROSION**

## **PRACTICAL AND THEORETICAL ASPECTS**

Edited by  
**Benjamin Valdez Salas**  
**Michael Schorr**

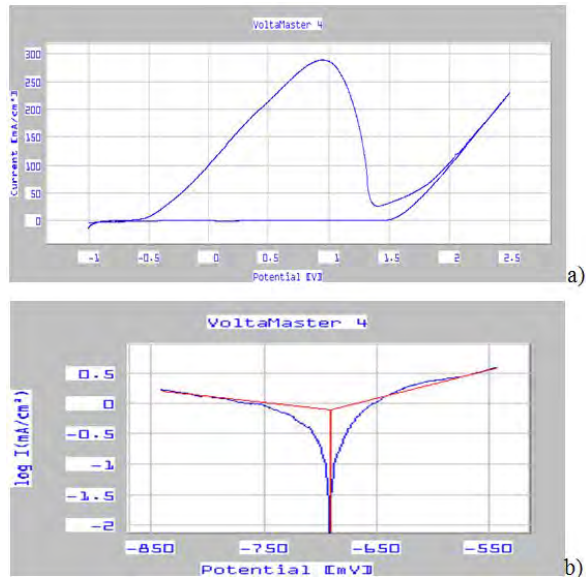
**Figure 2.** Uncoated carbon-steel electrode; 20% Na<sub>2</sub>SO<sub>4</sub> support electrolyte; polarisation speed – 100 mV/s; 25°C temperature. a – cyclic voltammogram; b – Tafel test

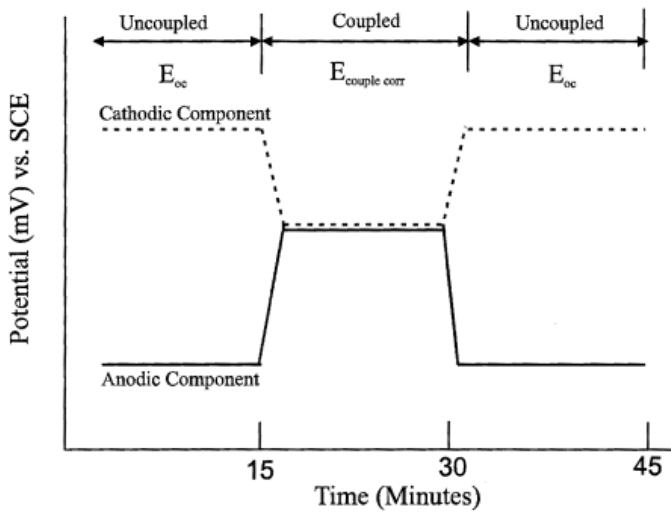
Figure 1. Schematic of data acquired during continuous potential measurement [8].

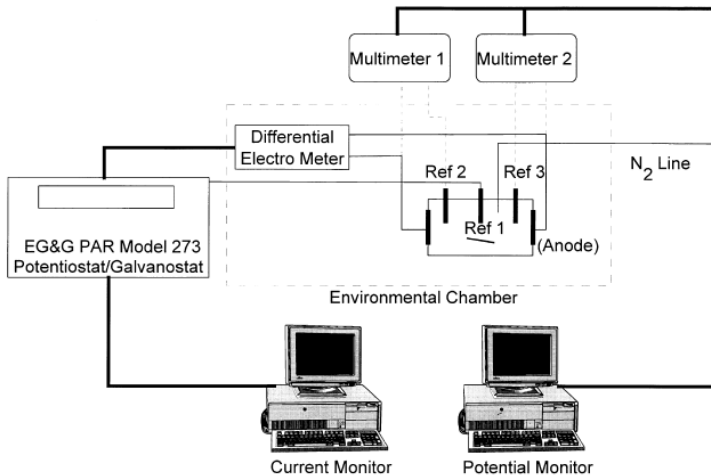
Figure 2. Schematic diagram for the galvanic cell set-up [8].
