METAL FAILURES

MECHANISMS, ANALYSIS, PREVENTION

Second Edition

Arthur J. McEvily

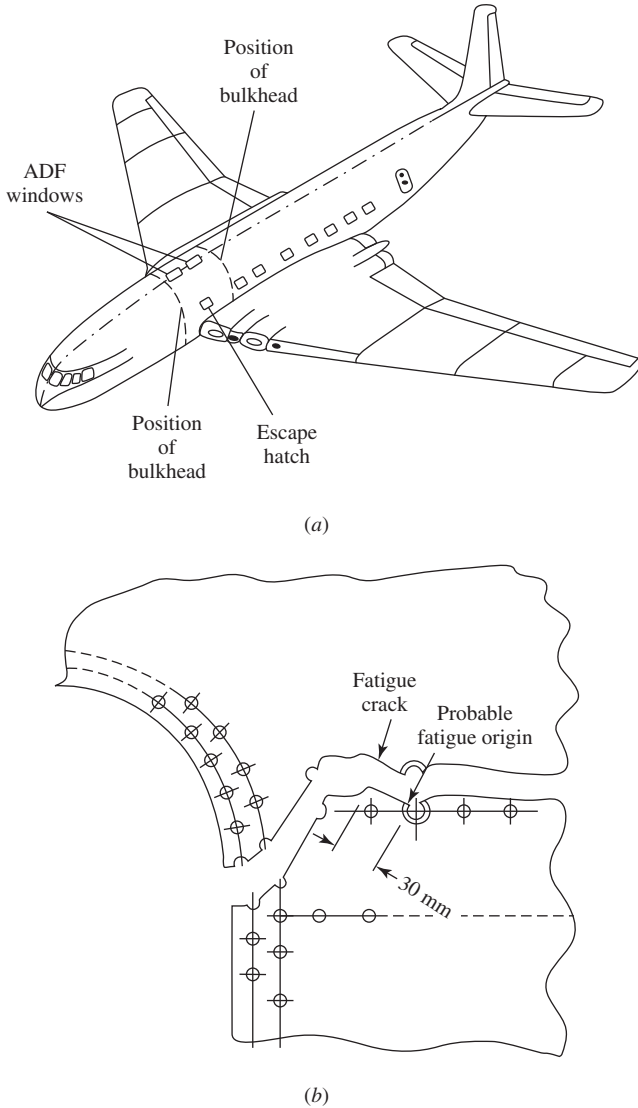
Fig. 1-4. (a) The Comet aircraft. (b) The location of fatigue cracking near an aft corner of the automatic direction finder (ADF) window. (After Jones, 3, with permission of Elsevier Science.)

The results of these crashes were significant. First of all, the Comet fleet was grounded and orders for new aircraft were canceled. Secondly, the crashes drew attention to the importance of fatigue crack growth in aircraft structures. Thirdly, it was realized that pressurized fuselages had to be designed so as to avoid catastrophic depressurization in the presence of damage such as fatigue cracking or penetration of debris should an engine explode. As a result of these crashes, significant steps to

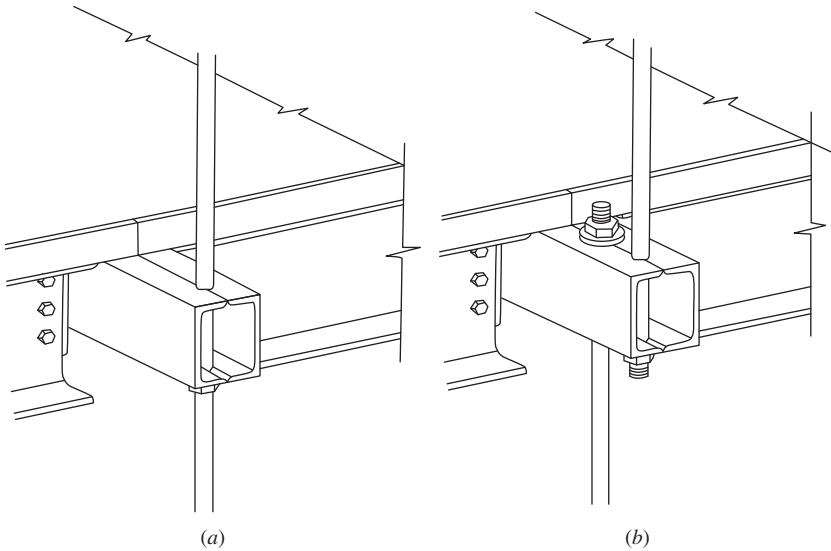
Fig. 1-5. A comparison of the Kansas City Hyatt walkway connectors. (a) As originally designed. (b) As built. (From National Bureau of Standards, 8.)

A.5. Kansas City Hyatt Regency Walkways Collapse (8) (Construction Problem) On July 20, 1981, two suspended walkways within the atrium area of the Hyatt Regency Hotel in Kansas City, Missouri, collapsed, leaving 113 people dead and 186 people injured. In terms of loss of life and injuries, this was the most devastating structural collapse ever to take place in the United States. The second-floor walkway was suspended from the fourth-floor walkway, which was directly above it. In turn, the fourth-floor walkway was suspended from the atrium roof framing by three pairs of hanger rods. In the collapse, the second- and fourth-floor walkways fell to the atrium floor, with the fourth-floor walkway coming to rest on top of the lower walkway. Most of those killed or injured were either on the first-floor level of the atrium or on the second-floor walkway.

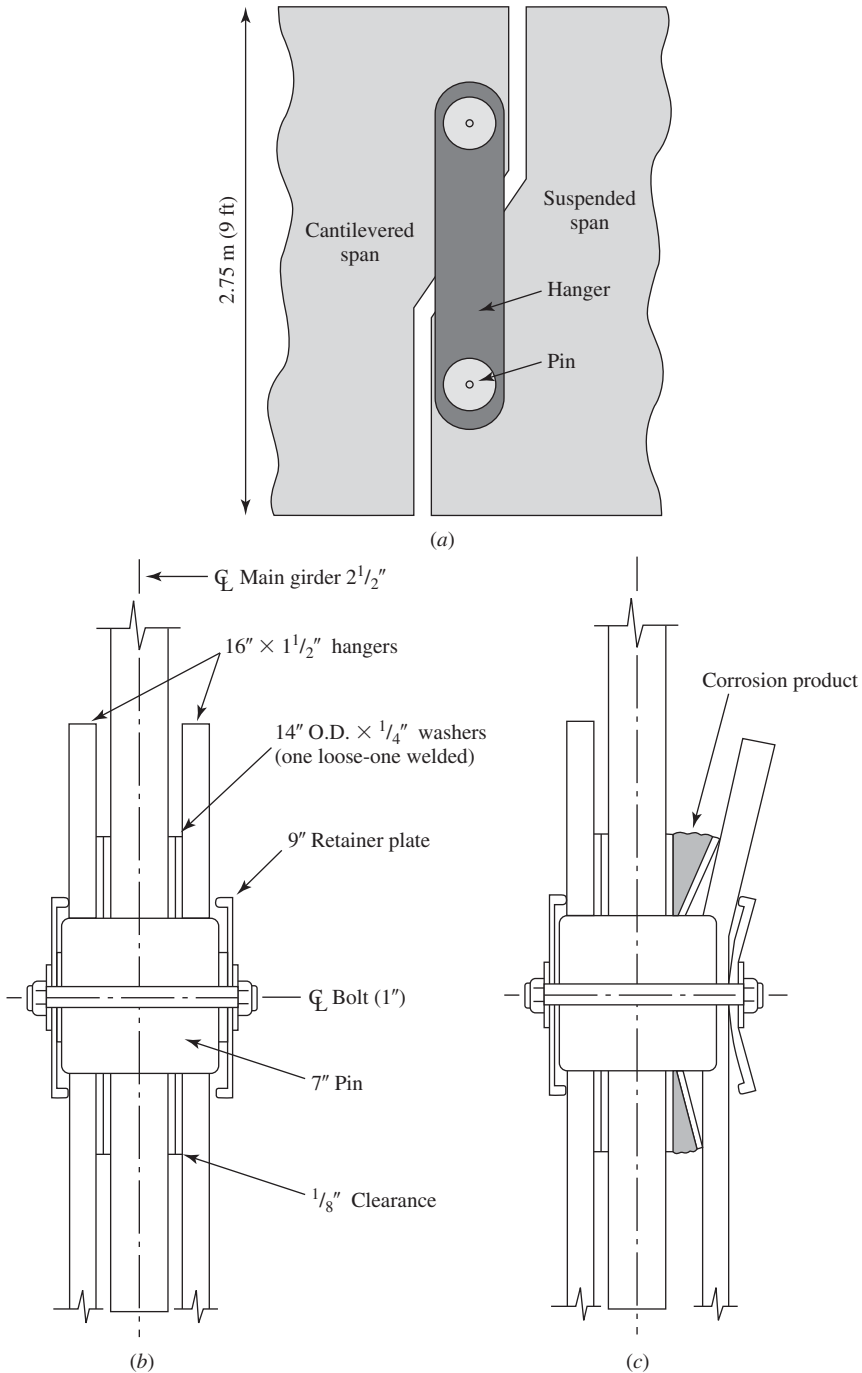
Fig. 1-6. The Mianus River bridge hangers. (a) Method of supporting the failed suspended span. (b) Pin-hanger assembly as built. (c) Pin-hanger assembly after 24 years of service. (Figs. 1.7b and 1.7c after Demers and Fisher, 9.)

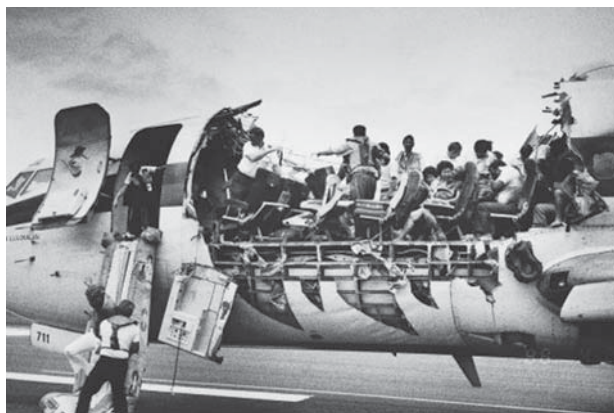
Fig. 1-7. General view showing the damage sustained by the Aloha Airlines Flight 737. (From NTSB, 10.)

B.3. Aloha Airlines Boeing 737-200 (10) (Inspection Problem) In 1988, a Boeing 737-200 operated by Aloha Airlines, while en route from Hilo to Honolulu, Hawaii, experienced an explosive decompression and structural failure as the plane leveled off at 7,315 m (24,000 ft). Approximately 8.2 m (18 ft) of the cabin skin and structure aft of the cabin entrance door and above the passenger floor had separated from the airplane, Fig. 1-7. There were 89 passengers and 6 crew members on board. One flight attendant was swept overboard, and seven passengers and one flight attendant received serious injuries. An emergency landing was made on the island of Maui. As a result of the accident, the airplane was damaged beyond repair and was dismantled and sold for scrap.

Failure was found to have initiated along a fuselage skin longitudinal lap joint that had been “cold bonded.” The cold bonding process utilized an epoxy-impregnated woven “scrim” cloth to join the longitudinal edges of the single-thickness 0.91 mm (0.036 in.) skin panels together. In addition, the joint contained three rows of

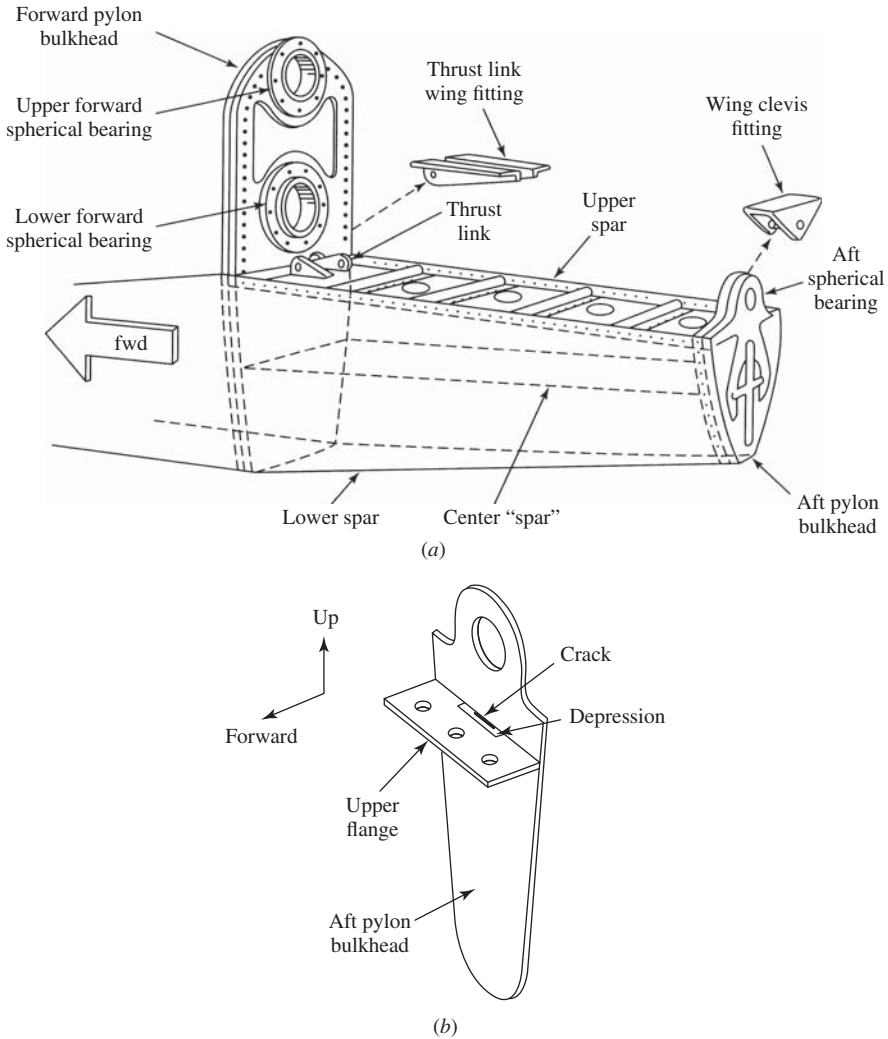
Fig. 1-9. (a) The pylon assembly of a DC-10. (b) Attachment of an upper spar to a flange on the forward side of the aft bulkhead. (Fig. 1-10a from NTSB, 11.)

In postaccident inspections of the DC-10 fleet, four American Airlines planes and two Continental Airlines planes were found to have cracked upper flanges on the pylon aft bulkheads, with the longest of these cracks being 152 mm (6 in.). In addition, it was discovered that two Continental Airlines DC-10s, one in December

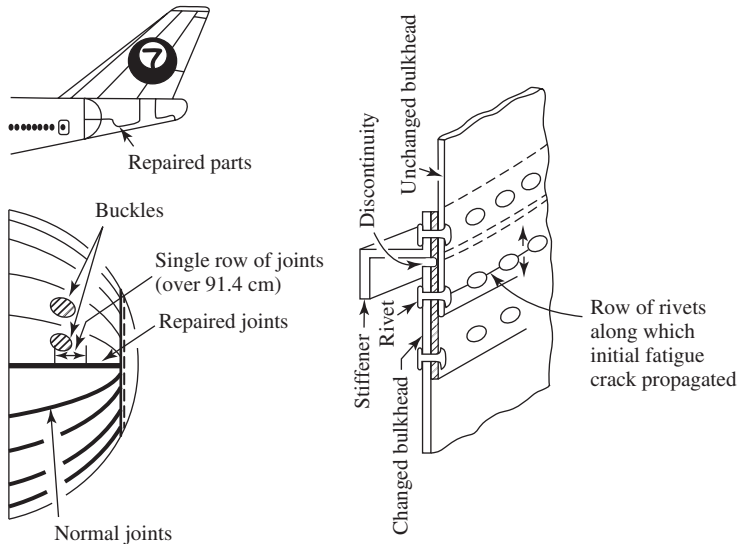
Fig. 1-10. The rear bulkhead of the JAL 747SR. (After Kobayashi, 12. *J. Japan Soc. Safety Eng.*)

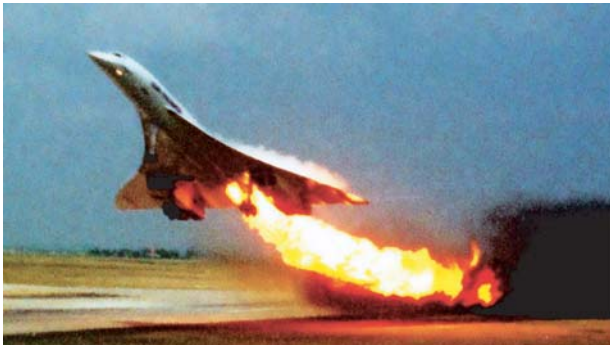
Fig. 1-11. Concorde on takeoff just prior to crash.

B.7. Air France Concorde Crash, July 25, 2000 (Design Problem) The crash of an Air France Flight 4590, a supersonic transport Concorde (SST), moments after takeoff from the Charles de Gaulle Airport near Paris, resulted in the deaths of 109 people aboard the jet and 5 people on the ground. The evidence gathered in this case, together with a past history of similar events that fortunately had not been catastrophic, indicated that the bursting of a tire on the left side of the plane while the plane was accelerating during its takeoff run was critical. A 406 mm (16 in.) piece of metal that fell to the runway from the engine of a plane that had taken off shortly before the Concorde may have caused the tire to burst. The metal strip matched a gash found in one of the Concorde's left tires, and it is probable that this piece caused the cut. There have been 57 cases of burst tires on Concorde, and in 7 instances these bursts have led to the rupture of fuel tanks, the severing of hydraulic lines, and the damaging of engines. French investigators believe that in the Paris crash, after the tire burst, a 3.6 kg (8 lb) piece of rubber penetrated the fuel tank, thereby releasing a plume of fuel that ignited (Fig. 1-11), since the plume was in close proximity to the two left side engines. Both British and French aviation authorities grounded the Concorde, and before they returned to service, fuel-tank liners were added to minimize potential damage related to tire bursts. However, in 2003 the Concorde was permanently grounded because of the Paris crash as well as other economic considerations.

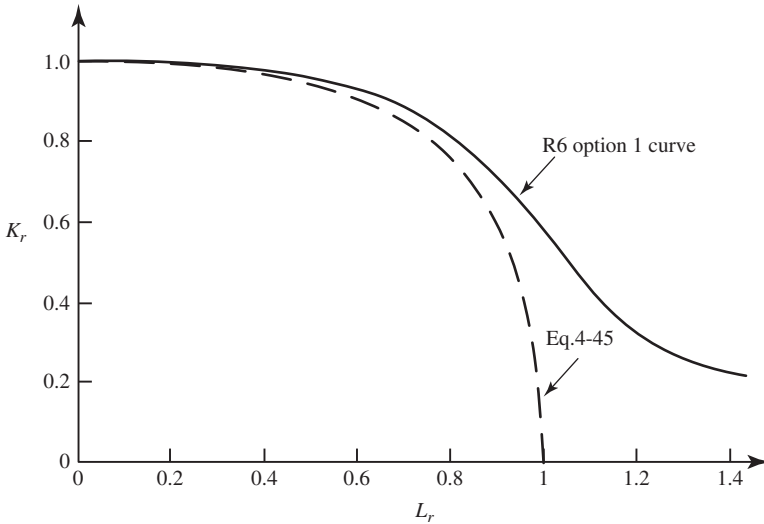
Fig. 4-21. R6 option 1 failure assessment curve.

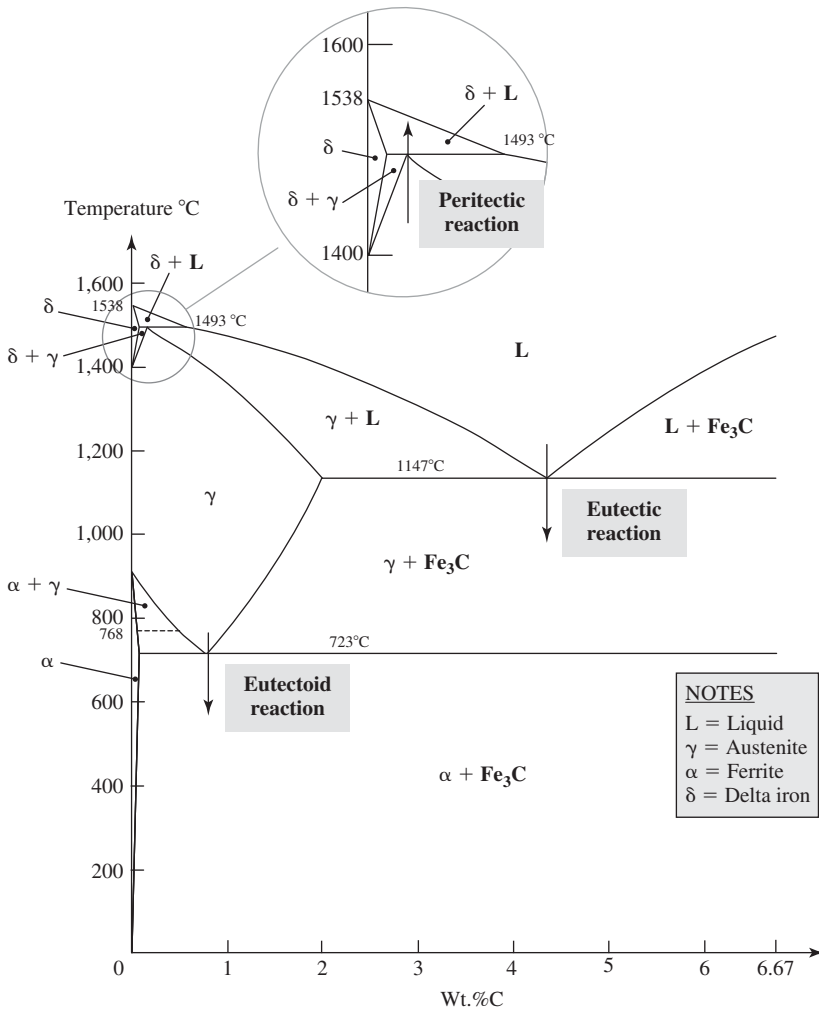
Fig. 5-3. The iron-carbon equilibrium diagram. (After *Smithells Metals Reference Book*, 1.)

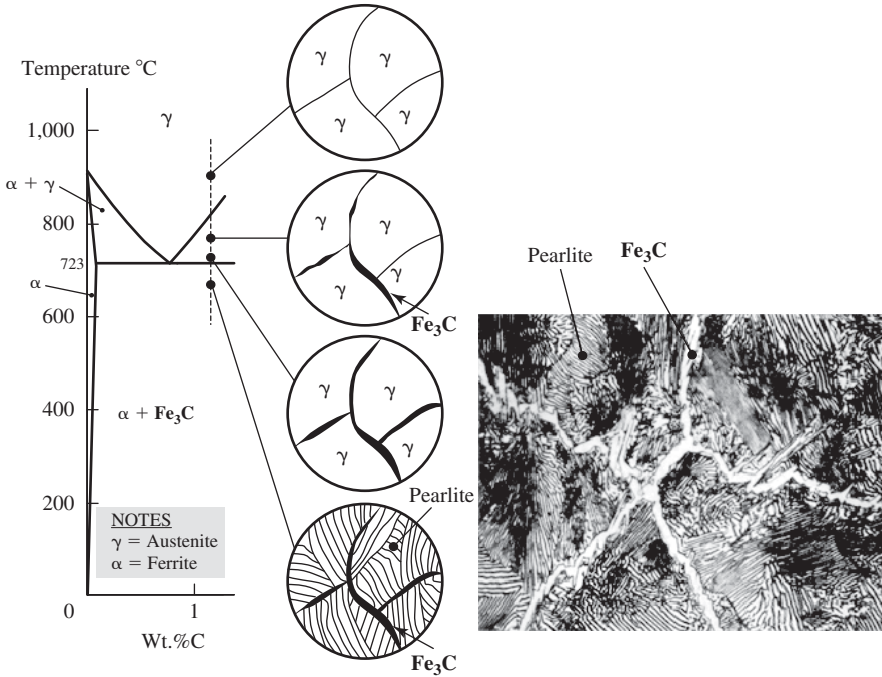
Fig. 5-7. Microstructures formed in a hypereutectoid steel ($>0.8\%$ C) upon slow cooling from the austenitic region. (Author created diagram; photo sourced from William F. Smith, Javad Hashemi, *Foundations of materials science and engineering*, 4th edition, McGraw-Hill International Edition, 2006, page 372.)

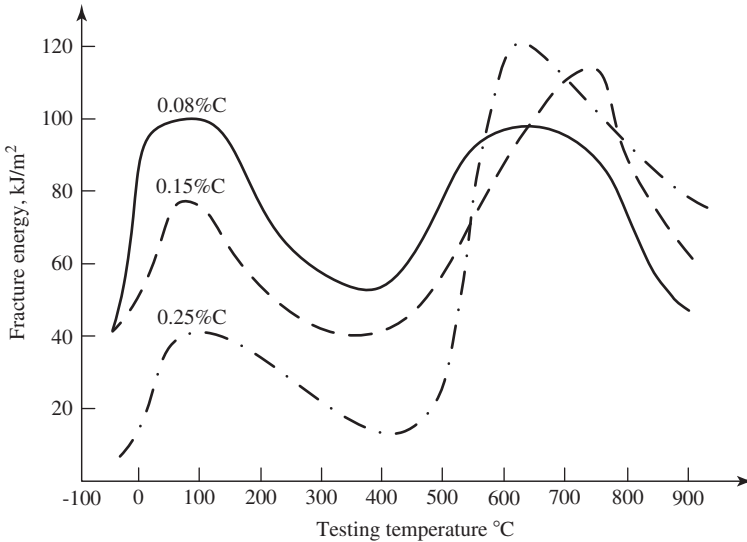
Fig. 5-11. Impact energy curves for low-carbon steels in which blue brittleness occurs at around 300°C (562°F). (After Rheinhold, 11.)

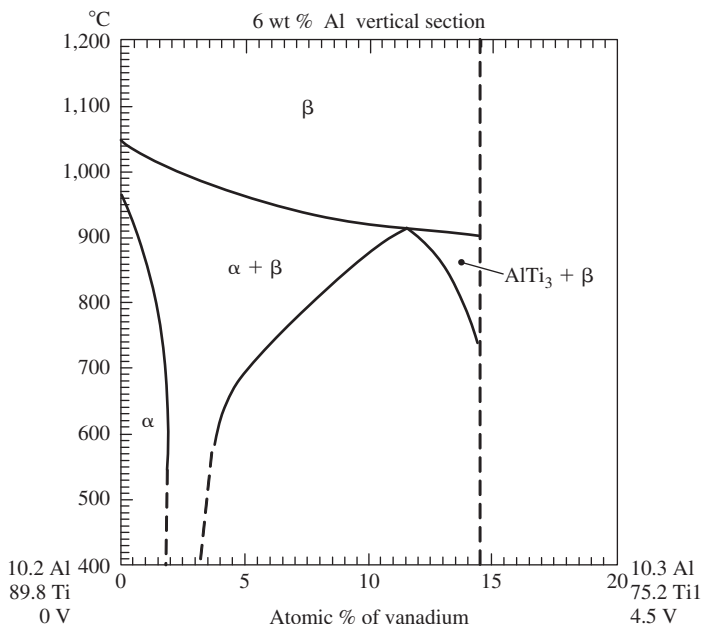
Fig. 5-13. (Ti-6Al)-V phase diagram. (After *Handbook of Ternary Alloy Phase Diagrams*, 6.)

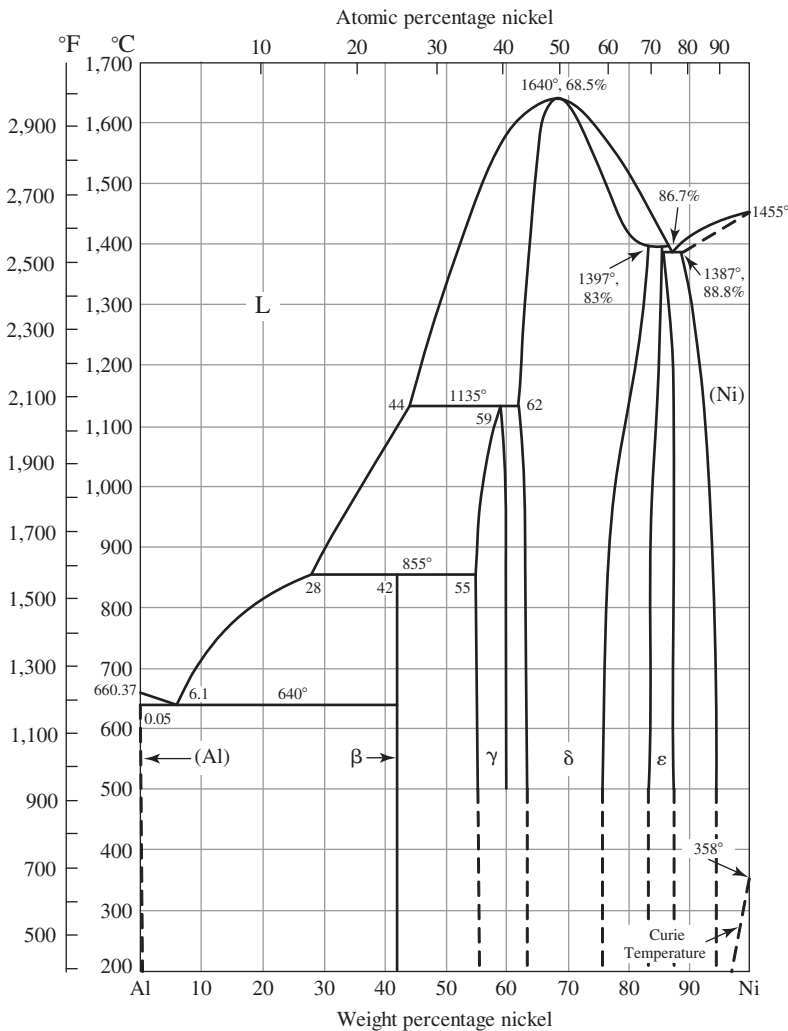
Fig. 5-15. Al-Ni phase diagram. (After ASM Metals Handbook, 7.)

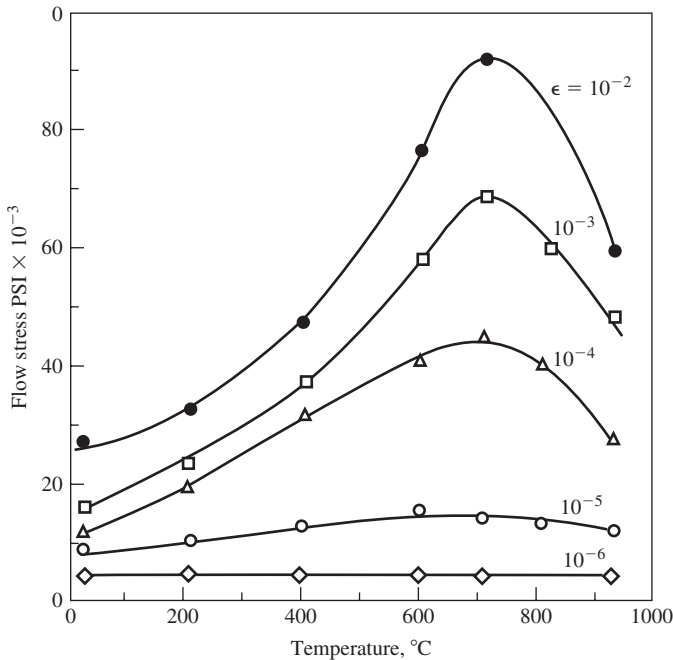
Fig. 5-18. The microstrain yield stress as a function of temperature for Ni_3Al . (After Thornton et al. (9).)

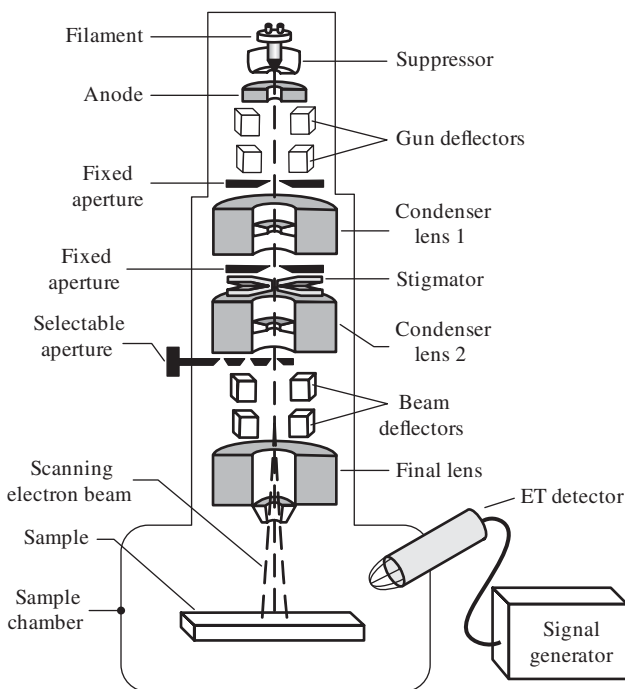
Fig. 6-2. Basic elements of an SEM.

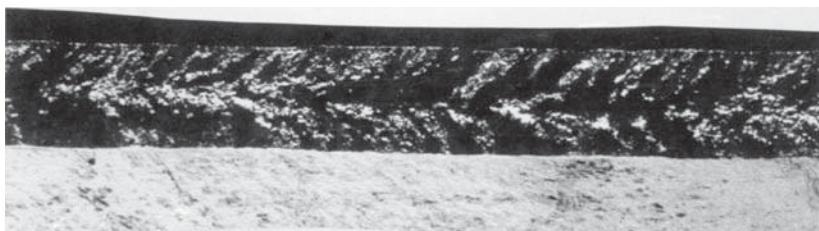
Fig. 7-2. An example of chevron markings on the fracture surface of a 25 mm thick steel plate involved in the collapse of an Allegheny County, Pennsylvania, oil tank in 1988. The origin of the fracture is to the left. (Courtesy of Dr. I. Le May.)

On a macroscopic level, the brittle fracture of a steel plate is characterized by so-called chevron markings. These markings are useful in failure analysis, as the tips of the chevrons point toward the origin of the fracture. An example is shown in Fig. 7-2. These chevron markings are macroscopic tear lines that run perpendicular to the curved crack front and diverge as the crack extends. Crack front curvature is due to a slower rate of crack propagation in the plane-stress surface region than in the plane-strain interior region.

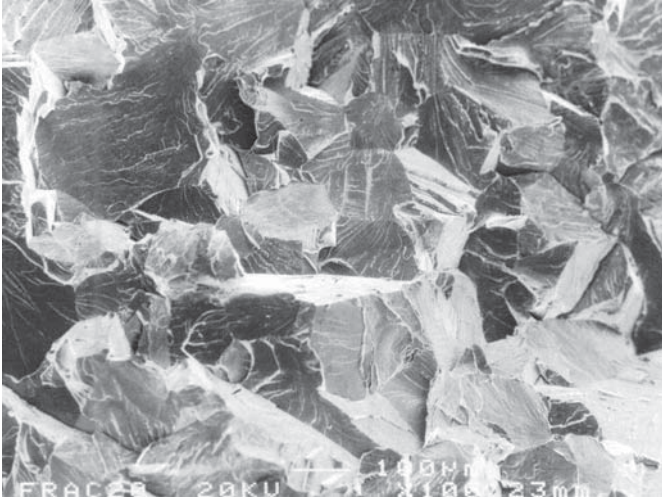
Fig. 7-3. Intergranular fracture in steel. (Courtesy of Dr. J. Gonzalez.)

Intergranular fractures are also brittle. Such fractures occur because of a weakness of the grain boundaries, which is often due to the segregation of impurity elements to the grain boundaries during processing and heat treatment. The term *rock candy* is used to characterize the appearance of intergranular fractures, Fig. 7-3. At low magnification, regions of intergranular fracture will appear to be bright because of the planar rock-candy topography, but the crystallographic planarity associated with cleavage fracture is absent.

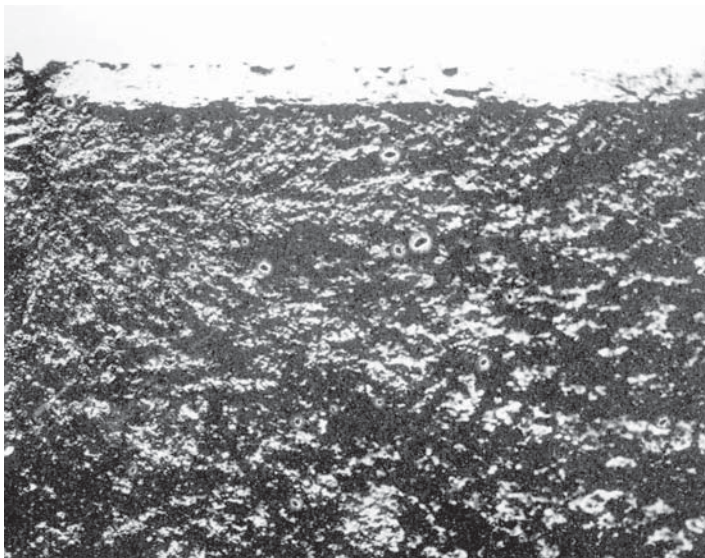
Fig. 7-4. Two flaws, upper left, 3 mm and 1.5 mm in radius, that existed prior to fracture of the critical eyebar of the Point Pleasant Bridge. (From NTSB, 3.)

two adjacent small semicircular flaws of the order of a few millimeters in radius, Fig. 7-4, in one of the eyebars that were linked together to make up the suspension system. These eyebars were 9.1 m (30 ft) or so in length, arranged in pairs so that four bars met at a pin connector, Fig. 7-5. However, the structure was not redundant, for if one member failed, the resulting load on its companion member would be sufficient to bring about its failure as well. One of the flaws was 3.2 mm (1/8 in.) in radius and the other was 1.6 mm (1/16 in.) in radius. These flaws had initiated at corrosion pits and had developed due to a combination of corrosion fatigue and

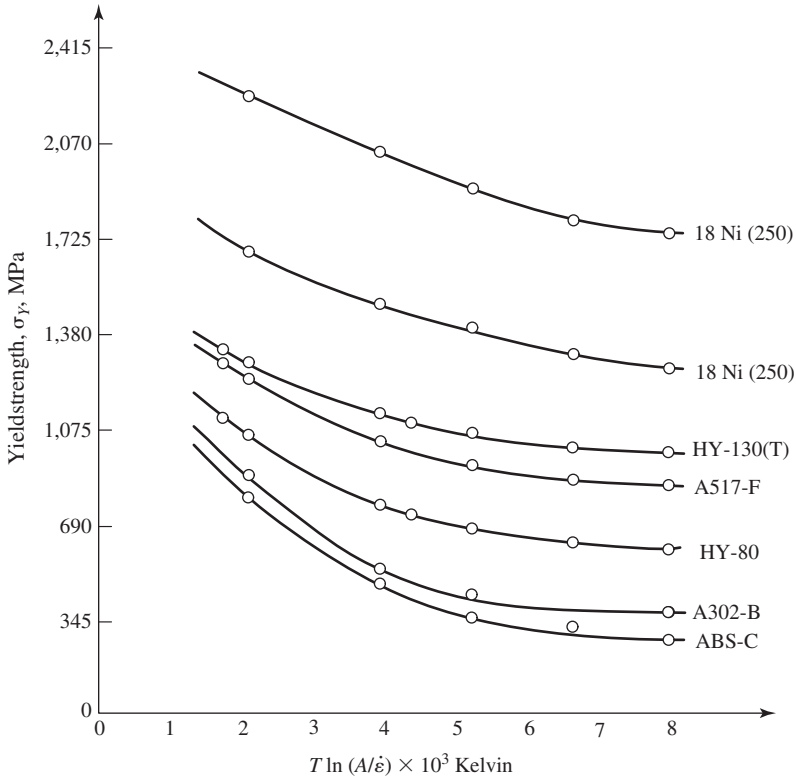
Fig. 7-8. Yield strength of several steels as a function of the parameter $T \ln A/\dot{\epsilon}$ with $A = 10^8/\text{sec}$ and the temperature T in degrees Kelvin. (After Rolfe and Barsom, 1. Based on Bennett and Sinclair, 13.)

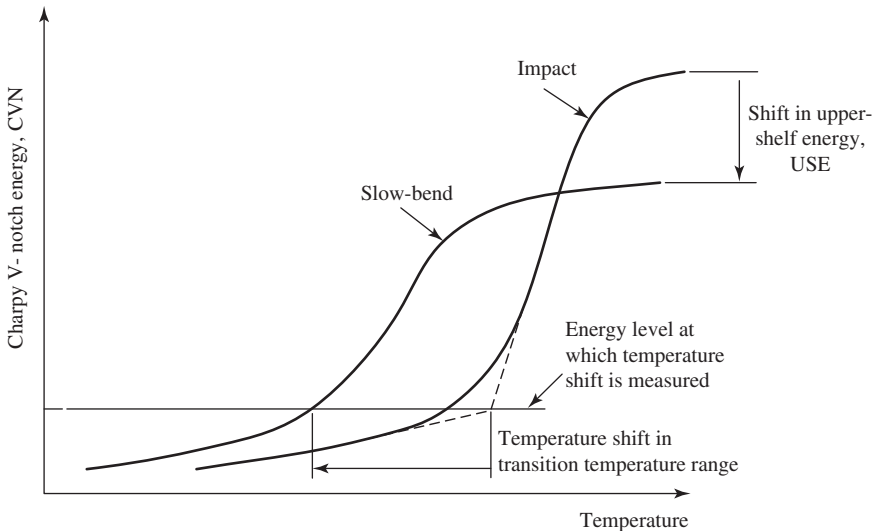
Fig. 7-11. A schematic representation of the upward shift in temperature of the Charpy V-notch transition temperature and the upper-shelf energy level due to an increase in strain rate. (After Barsom and Rolfe, 1.)

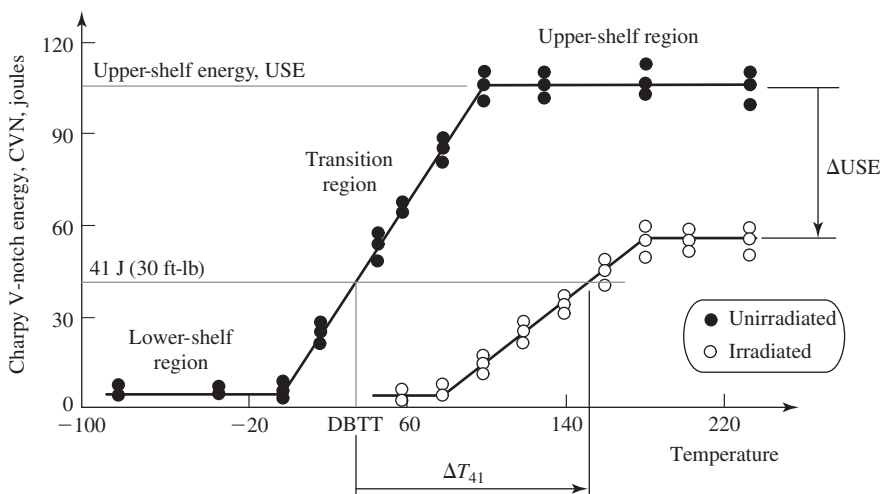
Fig. 7-12. A schematic indication of the effect of neutron irradiation on Charpy impact behavior. (After Manahan et al., 4.)

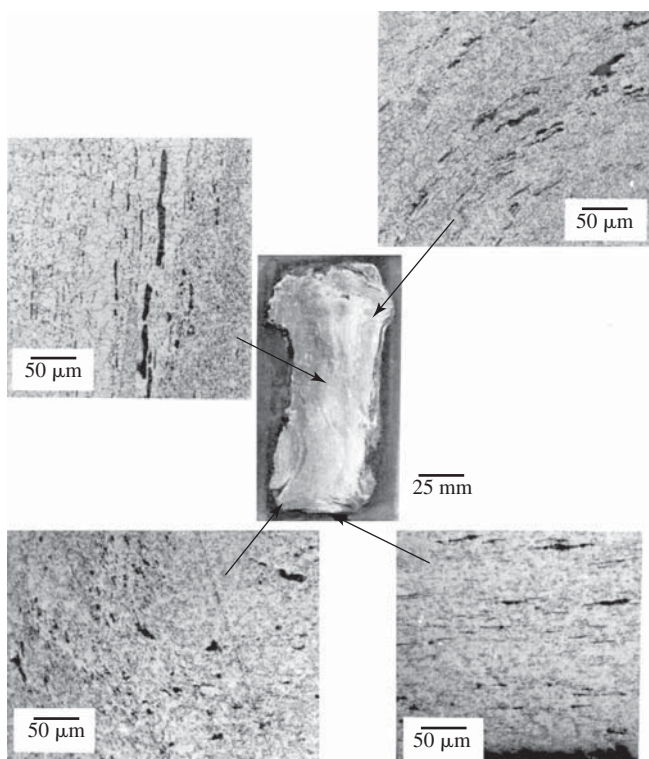
Fig. 7-16. The orientation of silicate slag at various locations within a cross section of a *Titanic* hull rivet. At the bottom right near the fracture surface created when the inner rivet head popped off, the stringers are oriented perpendicular to the tensile axis due to deformation when the inner head was formed. (From Foecke, 6.)

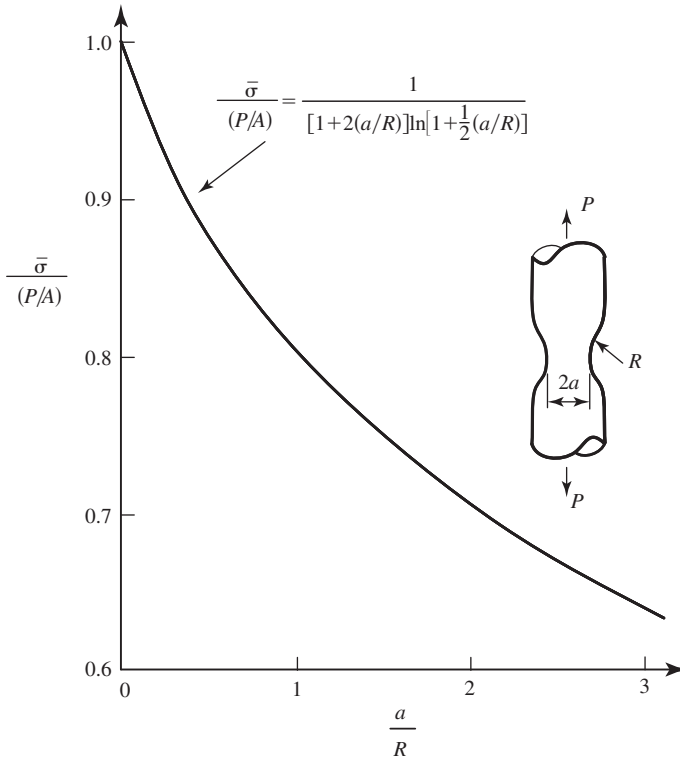
Fig. 7-19. The ratio of the effective stress $\bar{\sigma}$ to the nominal stress in a necked tensile specimen, where $2a$ is the diameter of the bar at the neck and R is the radius of the neck. (After Bridgman, 8, and McClintock and Argon, 9.)

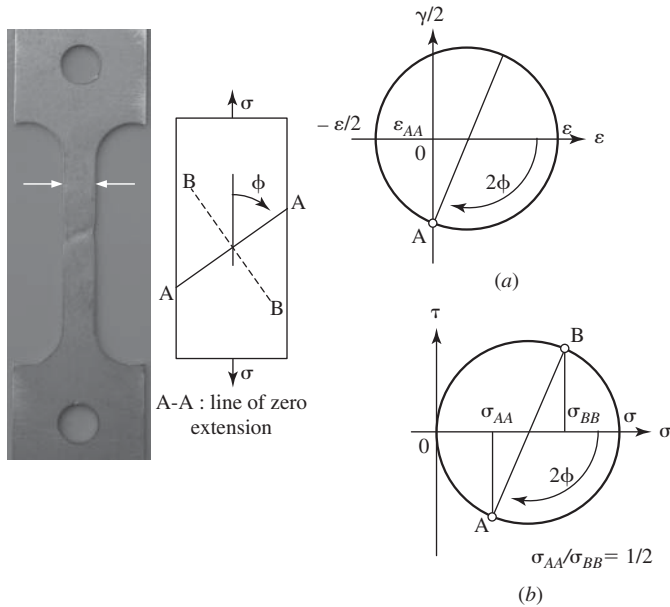
Fig. 7-20. Conditions for localized necking in a sheet. (a) Mohr circle for strain. (b) Mohr circle for stress.

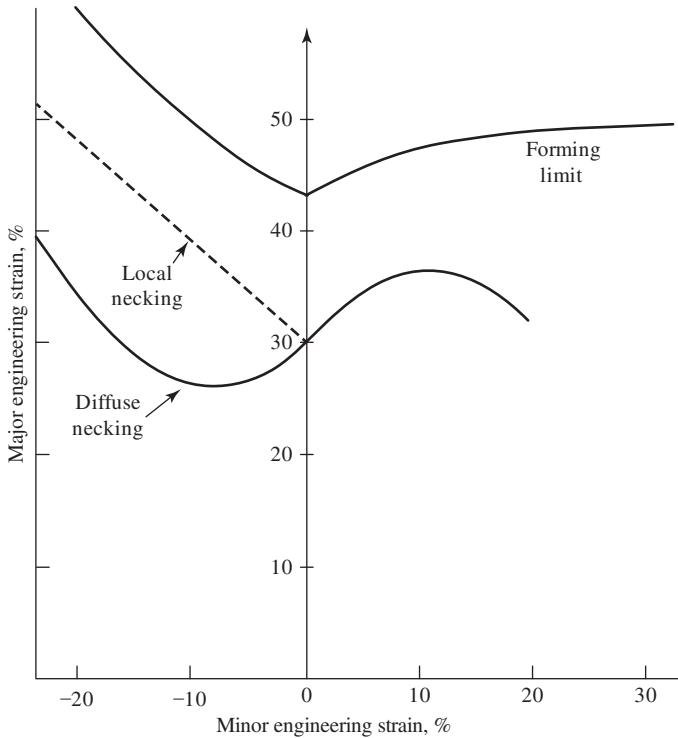
Fig. 7-21. An example of a forming limit diagram for sheet metal. (Adapted from Hosford and Caddell, 10.)

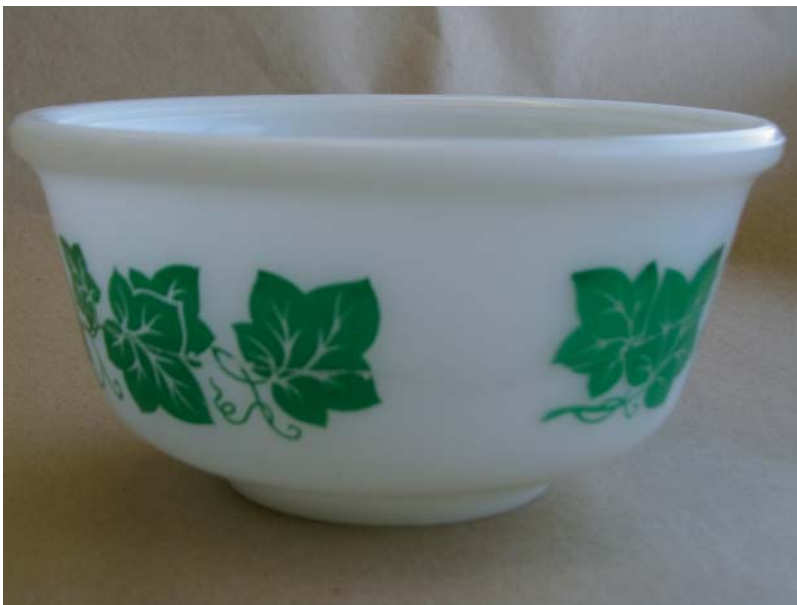
Fig. A8-1. Ceramic bowl containing a circumferential crack. The two halves mated together so well it is difficult to see the crack.

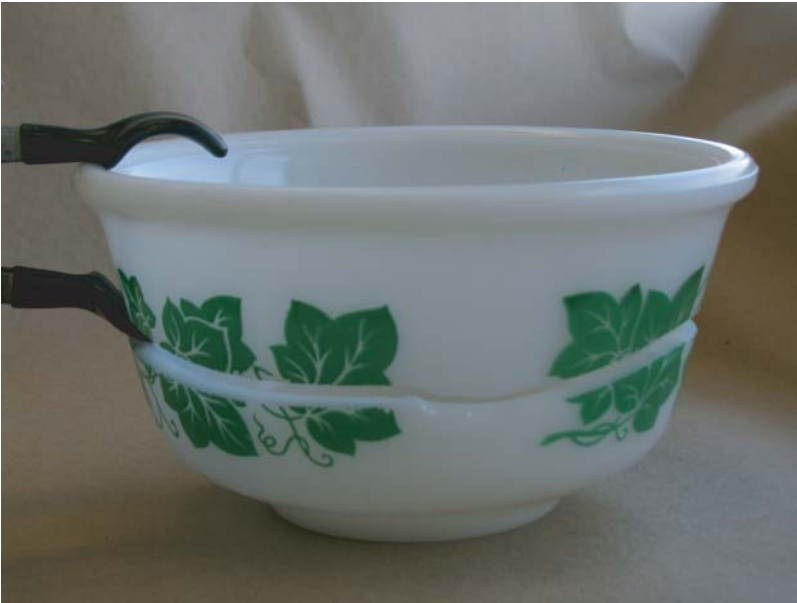
Fig. A8-2. Two halves of bowl shown in Fig. A8-1 separated to show crack.

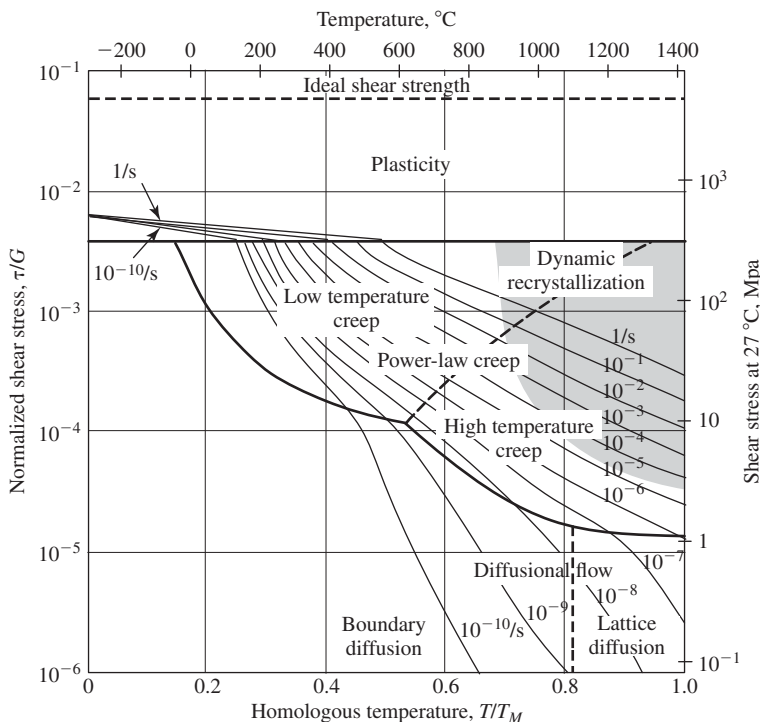
Fig. 9-2. An example of a creep deformation map for pure nickel of grain size 0.1 mm, work hardened. (After Frost and Ashby, 3.)

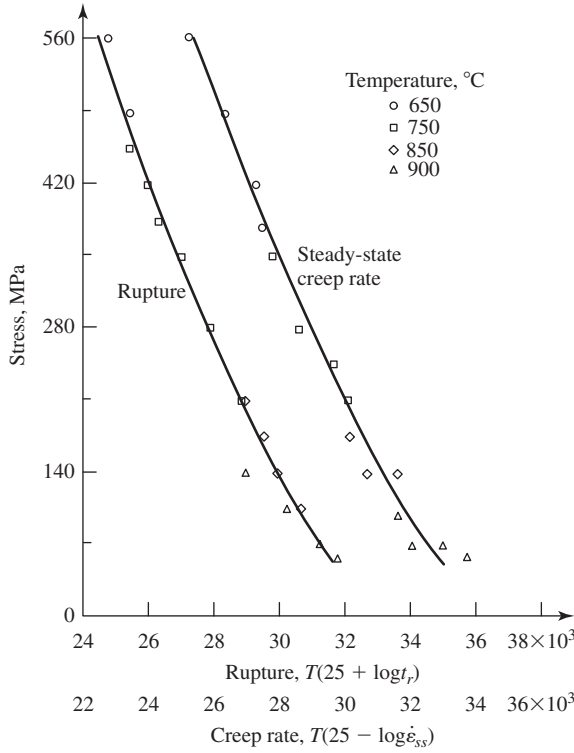
Fig. 9-4. Larson-Miller plot for Inconel X. (After Tetelman and McEvily, 4.)

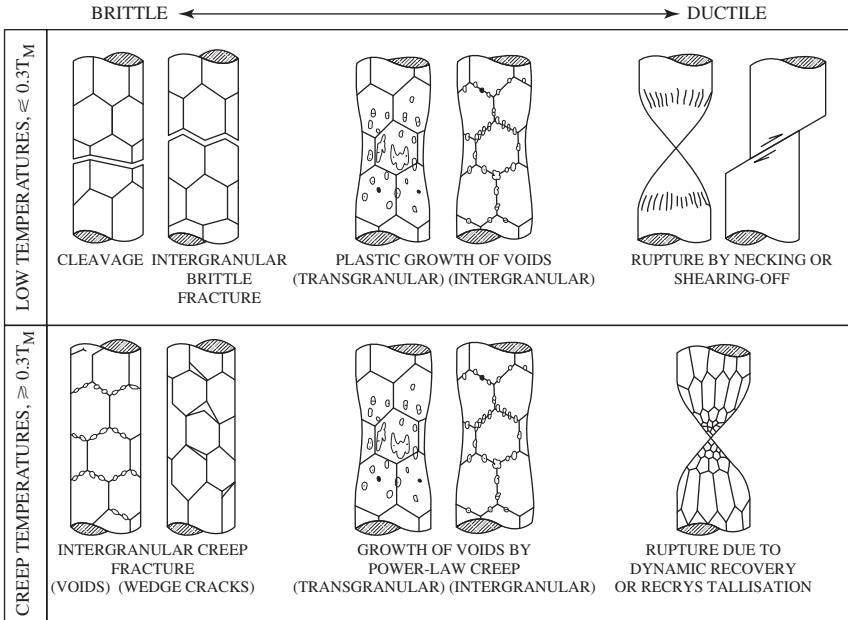
Fig. 9-5. Broad classes of fracture mechanisms. The upper row refers to low temperatures ($< 0.3T_M$) where plastic flow does not depend strongly on temperature or time; the lower row refer to the high temperature range ($> 0.3T_M$) in which materials creep. (After Ashby et al., 7. Reprinted by permission.)

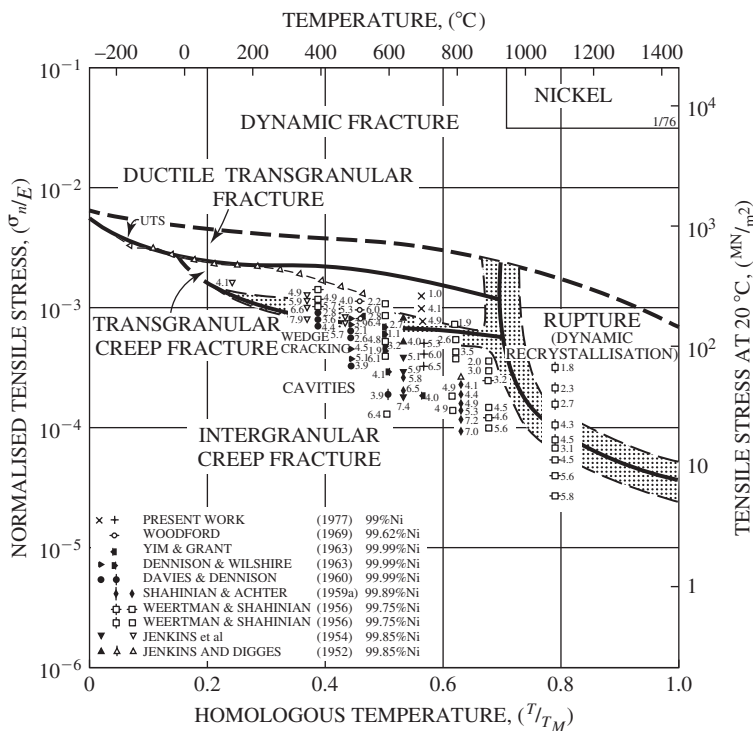
Fig. 9-7. An example of a fracture mechanism map for round bars of commercially pure nickel tested in tension. The map shows four fields corresponding to four modes of failure. Individual tests are marked by symbols and (for creep tests) labeled with the logarithm, to base 10, of the time to fracture in seconds ($\log t_f$). Solid symbols mean that the fracture was identified as intergranular. Shading indicates a mixed mode of fracture. (After Ashby et al., 7. Reprinted with permission.)

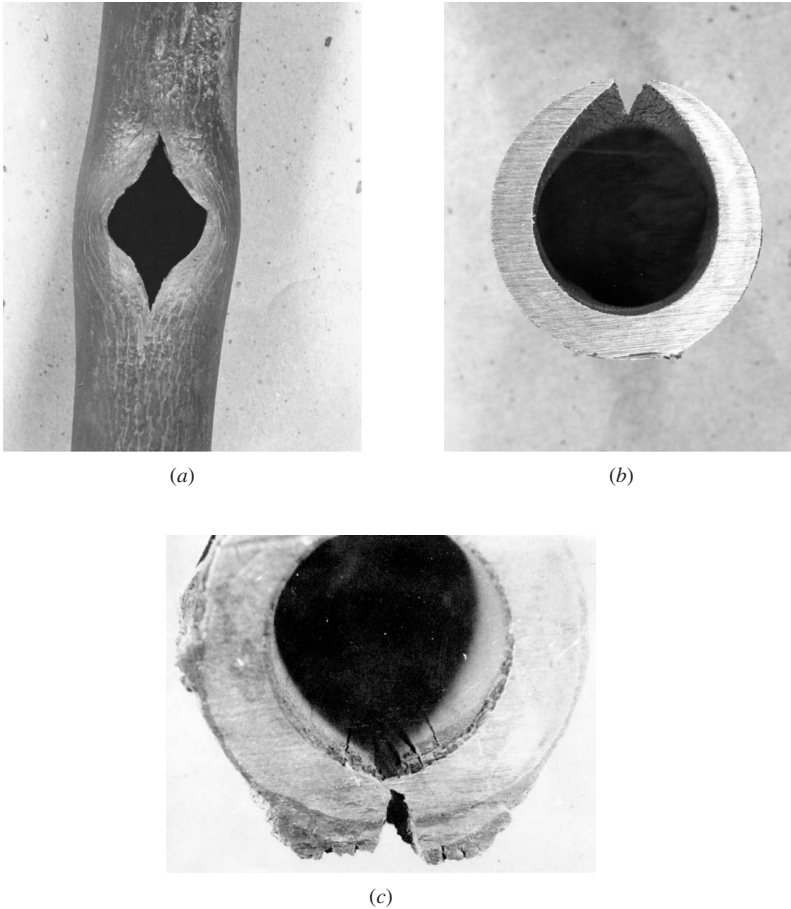
Fig. 9-9. (a) Longitudinal view of a thin-walled creep fracture. (b) Cross-sectional view of a thin-walled creep fracture. (c) Cross-sectional view of a thick-walled creep fracture. (After French, 2. Reprinted with permission.)

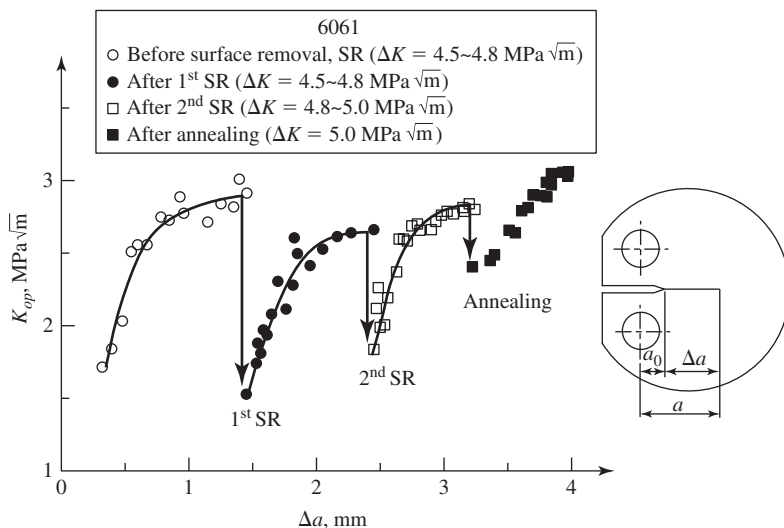
Fig. 10-9. Effect of surface removal (SR) on 6061. (After Ishihara et al., 17.)

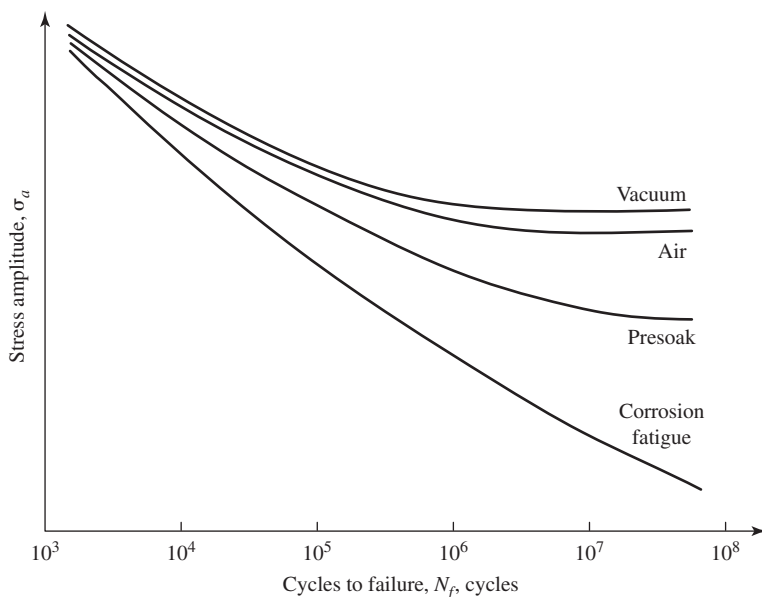
Fig. 10-16. Effect of various environments on the S/N curve of a steel. (After Fuchs and Stephens, 36.)

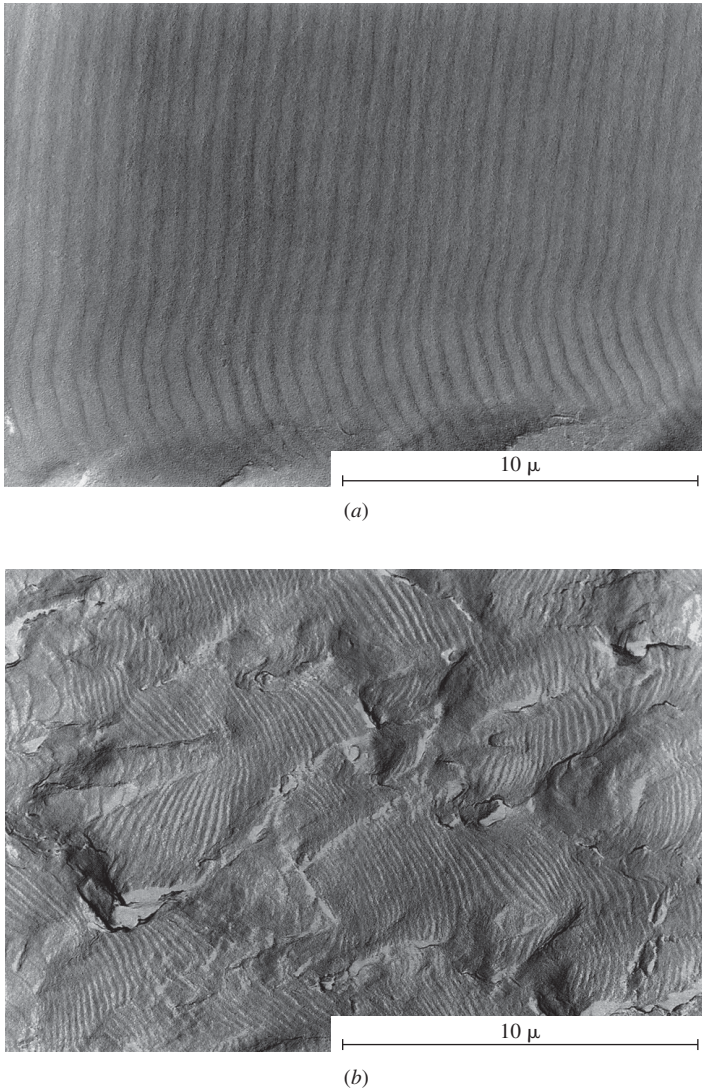
Fig. 10-20. (a, b) Examples of fatigue striations observed in aluminum alloys.

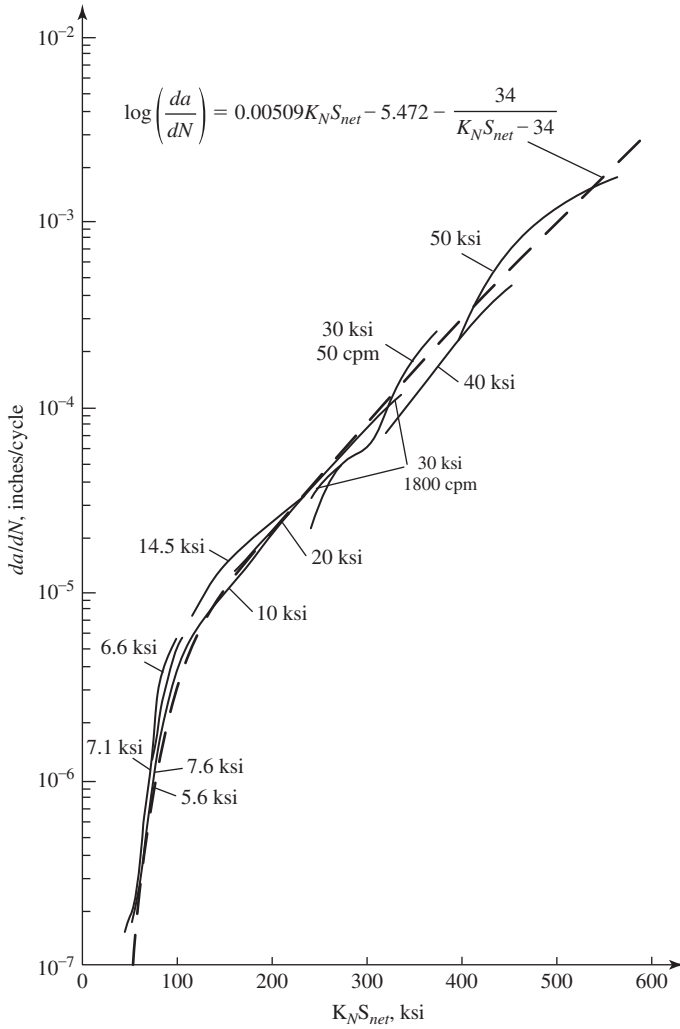
Fig. 10-22. The rate of fatigue crack growth in the aluminum alloy 7075-T6 as a function of $K_N S_{net}$. The stress values on the curve represent the initial values of the net section stress used in the tests. (After McEvily and Illg, 42.)

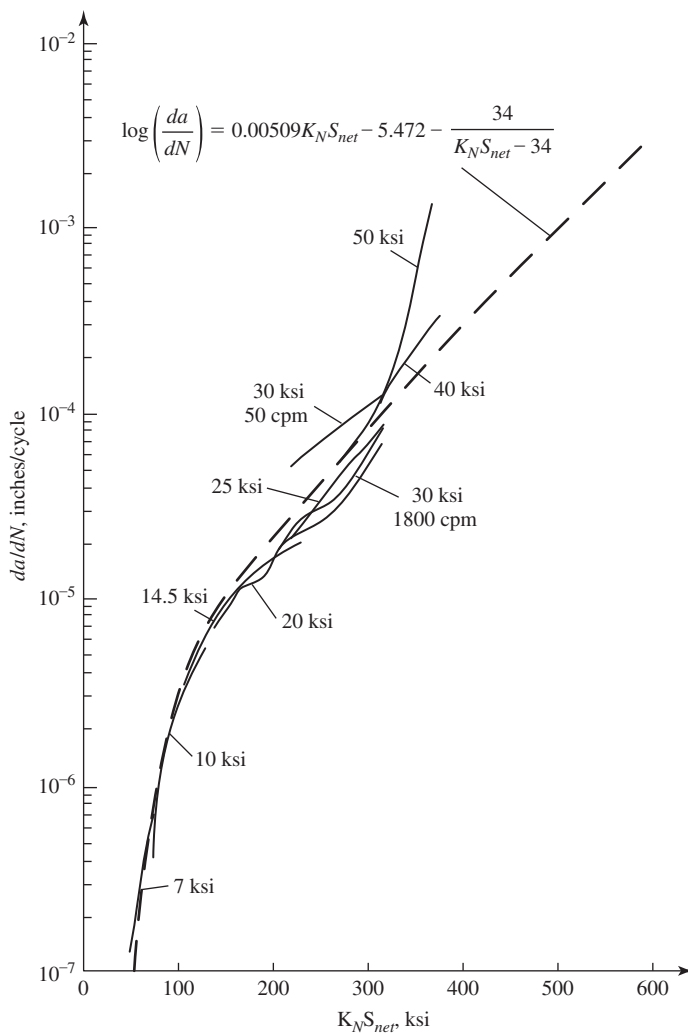
Fig. 10-23. The rate of fatigue crack growth in the aluminum alloy 2024-T3 as a function of $K_N S_{net}$. The stress values on the curve represent the initial values of the net section stress used in the tests. (After McEvily and Illg, 42.)
