METAL FAILURES

MECHANISMS, ANALYSIS, PREVENTION

Second Edition

Arthur J. McEvily

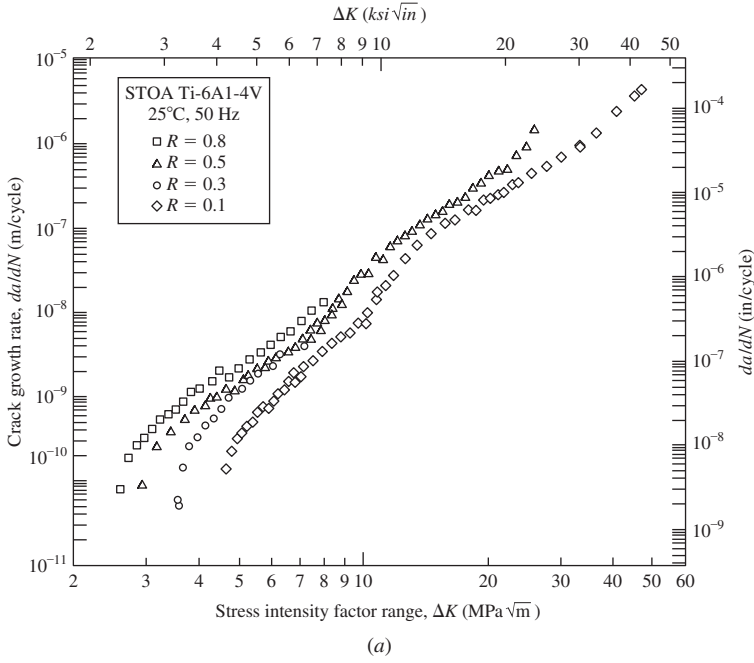
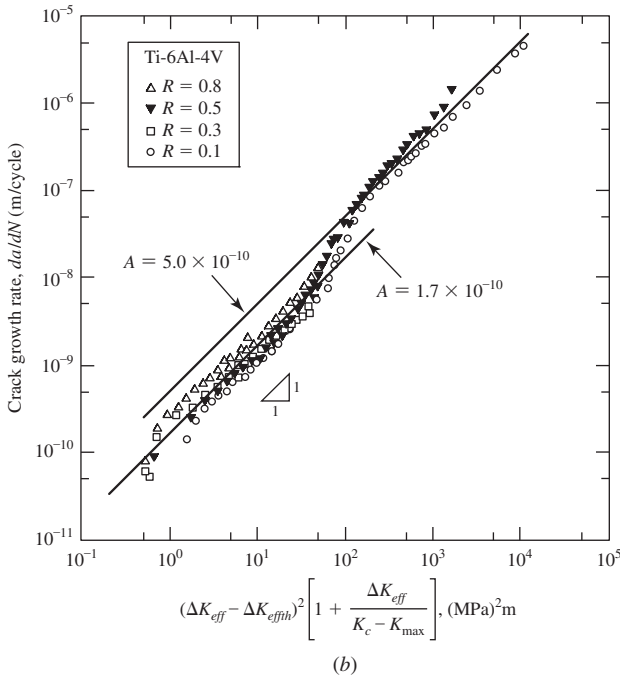
Fig. 10-25. (a) Fatigue crack growth rate for Ti-6Al-4V as a function of ΔK (51). (b) Fatigue crack growth rate for Ti-6Al-4V as a function of ΔK_{eff} (52).

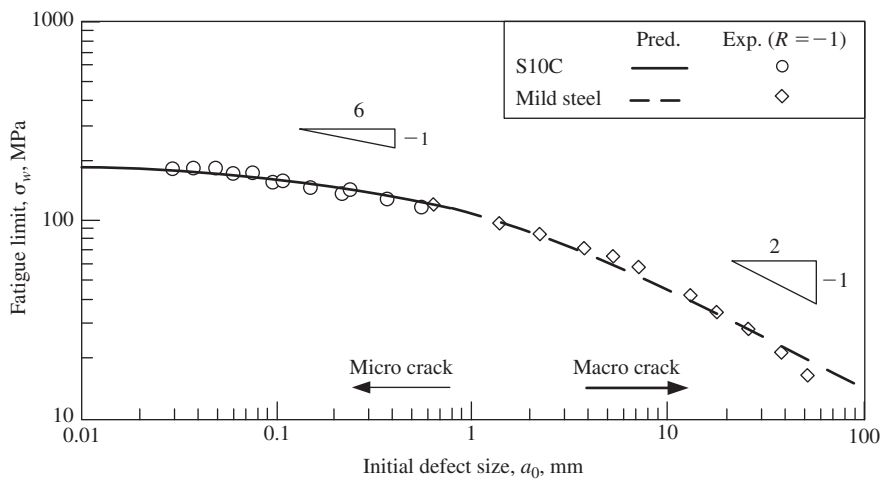
Fig. 10-28. An example of the Kitagawa effect. For very small defect sizes the fatigue strength, σ_w , becomes the controlling parameter. (After Endo and McEvily, 56.)

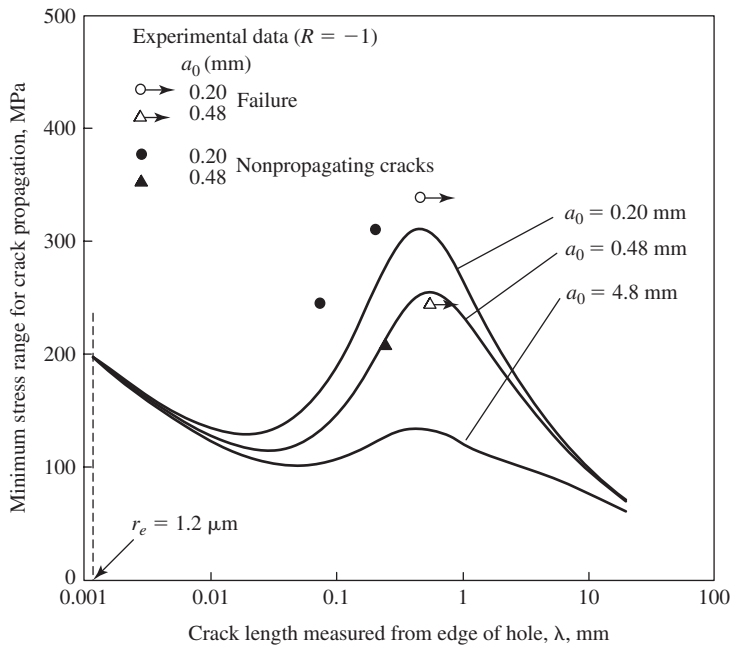
Fig. 10-29. Minimum stress range required to propagate a fatigue crack in a carbon steel at a rate of 10^{-11} m/cycle from small holes of different radii as a function of the distance from the hole. (After Endo and McEvily, 56. Experimental data points are from Haddad et al., 58.)

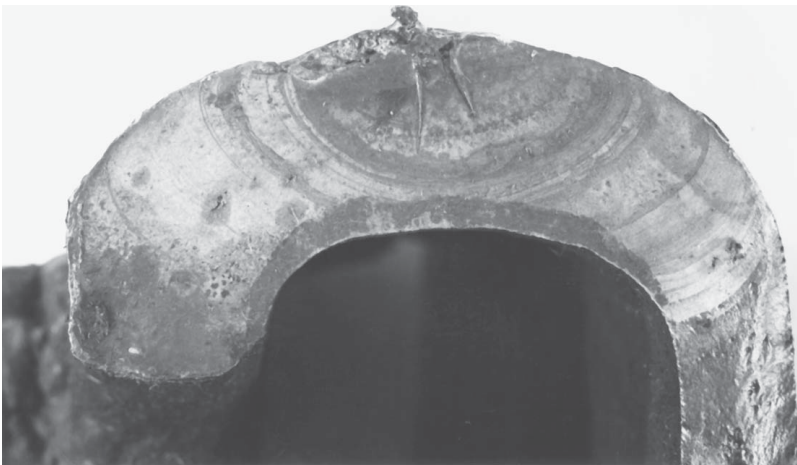
Fig. 10-31. Fatigue beach markings on a steel component. The markings are visible to the eye, and the fatigue crack initiated at a weld defect at the top of the figure.

When a component fails in fatigue, an examination of the fracture surfaces may provide substantiating evidence such as well-defined *beach mark* patterns. These patterns can be created by environmental interactions with the crack front, and the term *thumbnail fracture* is often used to describe their shape around the origin of fatigue cracking. In steel parts that are subjected to reversed loading, the fatigue fracture surfaces can rub together, as in $R = -1$ loading, and develop a highly polished appearance, particularly near the origin of fatigue cracking. In such cases, no fine details will be observed, but the macroscopic beach markings may be apparent, as in Fig. 10-31. Such markings can develop when the part experiences periods of cycling followed by periods of rest. During the rest period, corrosion occurs at the crack tip to outline the crack front, thereby creating the beach mark. Variable-amplitude loading may also create beach marks, particularly if there are many cycles of small amplitude mixed with a few high-amplitude cycles. In this case, the texture of the fracture may vary from smooth for the low-amplitude cycles to rough for the high-amplitude cycles, and it is the roughness that leads to the creation of the beach marks. A well-defined transition between the fatigue region and the region of final overload failure can also establish that the fracture was due to fatigue.

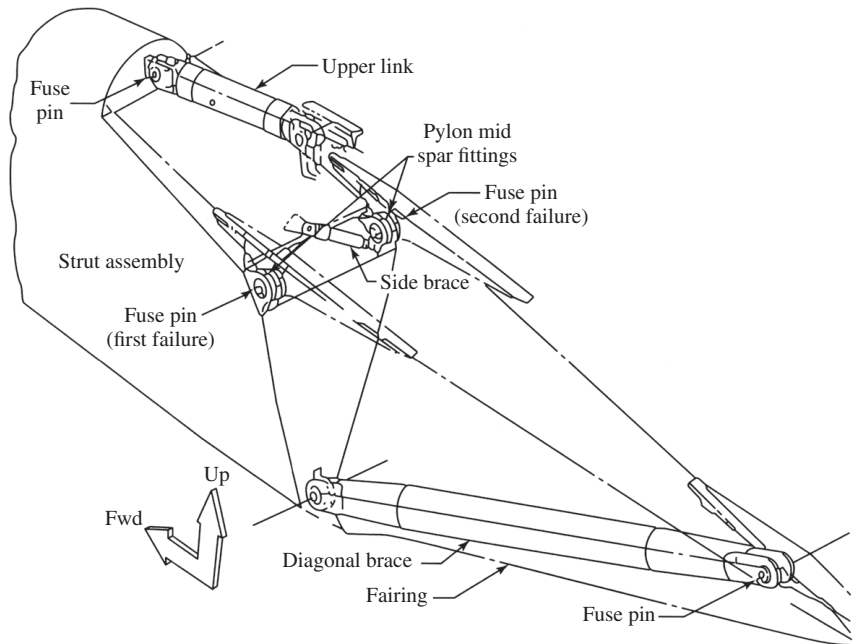
Fig. 10-33. Pylon to wing attachments (63).

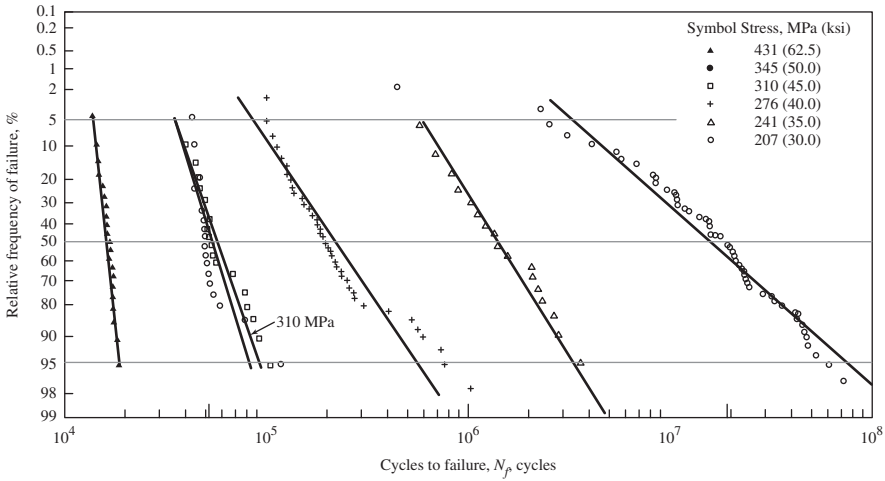
Fig. 11-4. Logarithmic normal probability diagram showing individual fatigue lifetimes obtained at different stress ranges at $R \approx 0$. (After Sinclair and Dolan, 5.)

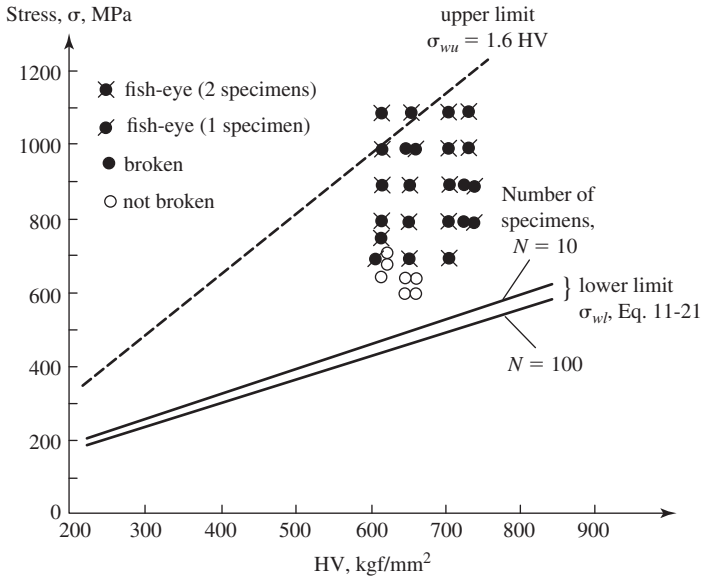
Fig. 11-10. A comparison of the predicted and experimental lower bounds of the fatigue strength of SKH51 tool steel as a function of hardness level, HV. (From Murakami, 9.)

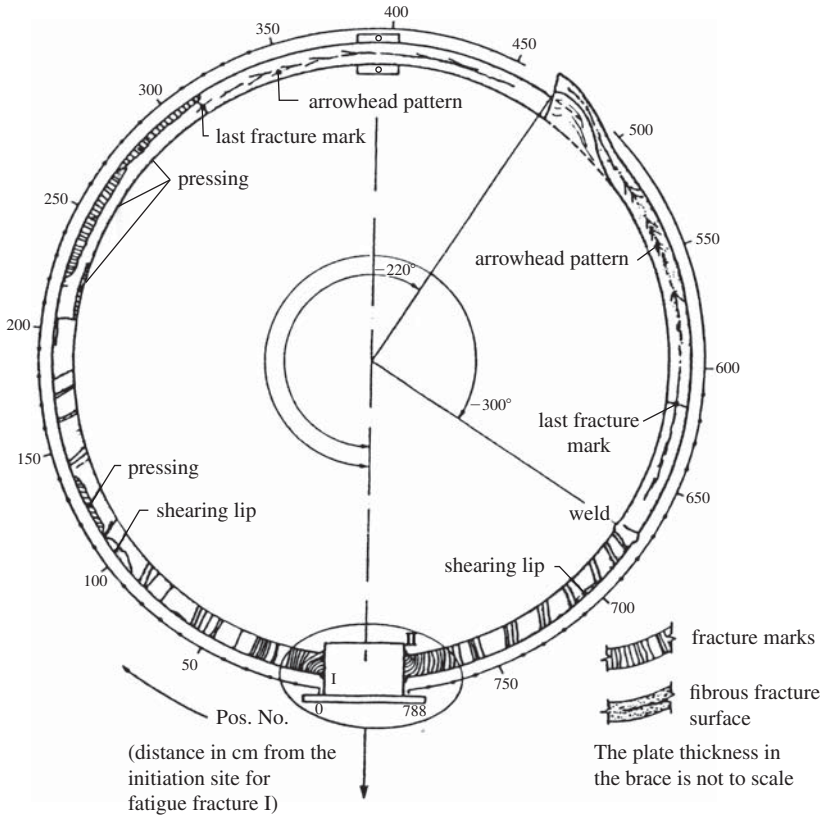
Fig. 12-7. Fracture surface features of the failed brace D-6. Note two fatigue origins at locations I and II at the welded in hydrophone. (From The Alexander Kielland Accident, 4.)

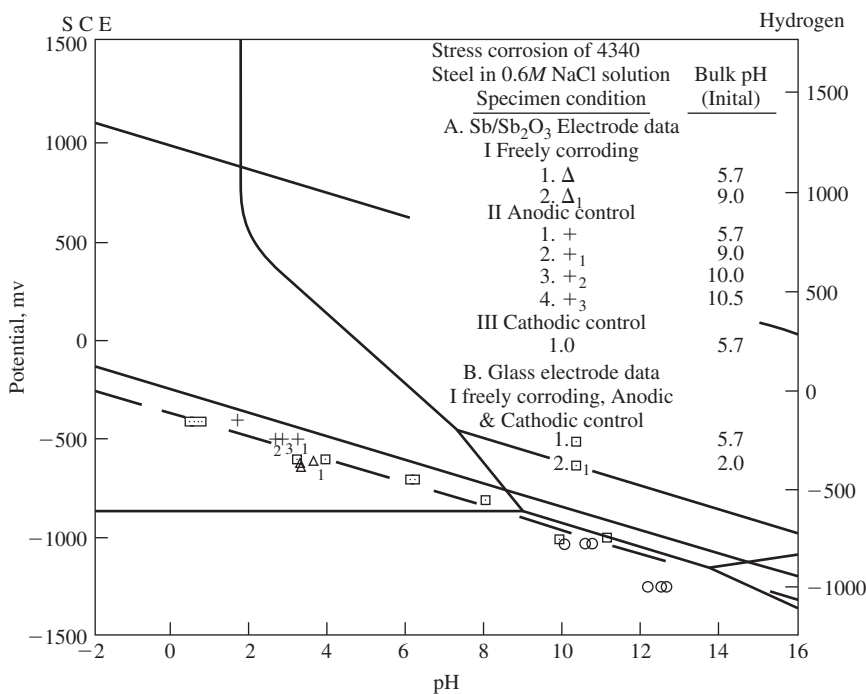
Fig. 13-4. A Pourbaix diagram showing the potential at a crack tip in 4340 steel as a function of the crack tip pH value. (From Brown, 13.)

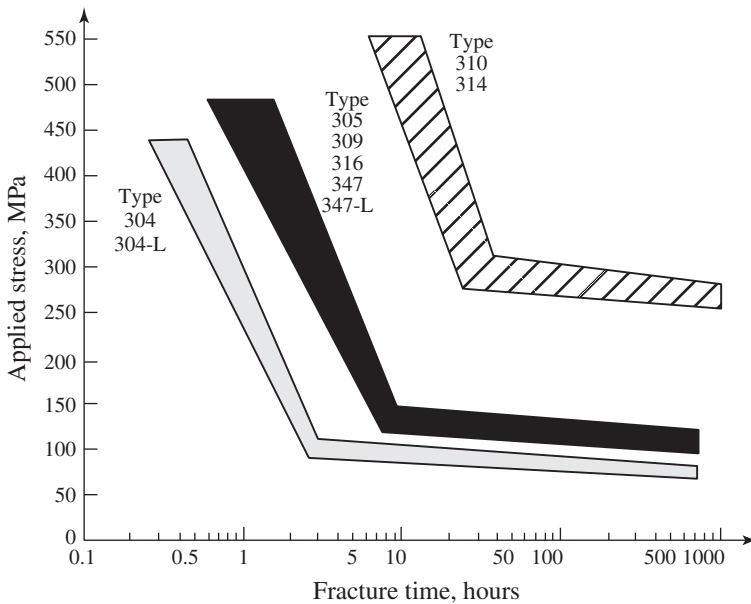
Fig. 13-7. Relative SCC behavior of austenitic stainless steels in boiling magnesium chloride solution. (After Denhard, 16.)

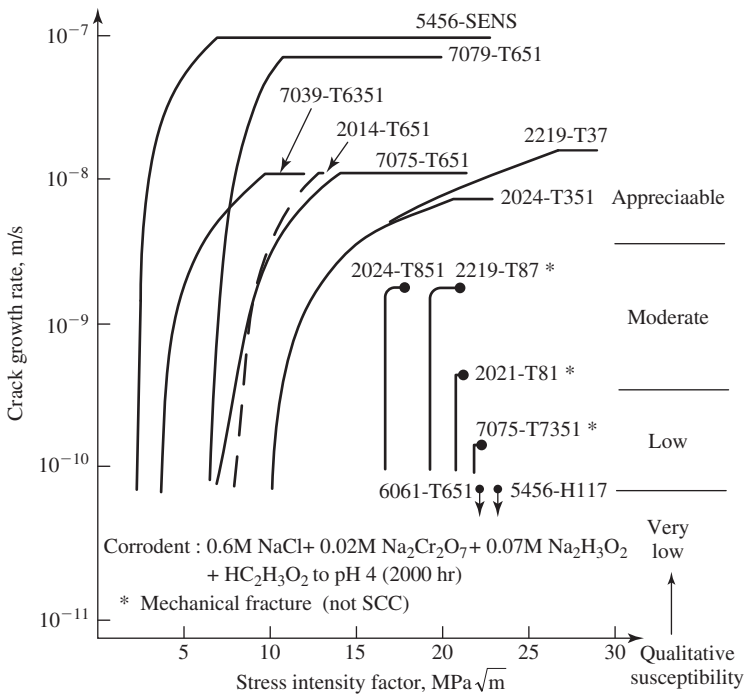
Fig. 13-10. The rate of SCC growth, da/dt , as a function of the stress intensity factor for aluminum alloys showing plateau levels. (After Brown, 14, and Sprowls et al., 18.)

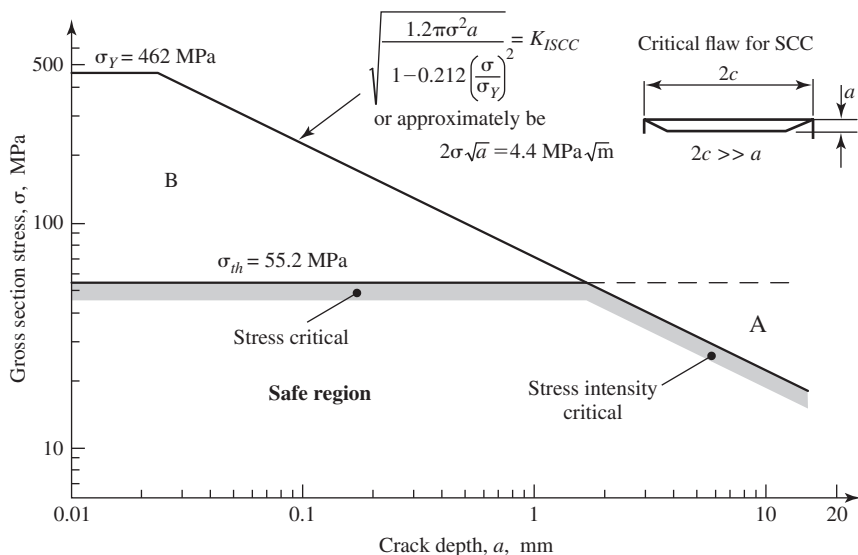
Fig. 13-11. Flaw depth a versus stress, showing the stress critical- (small cracks) and threshold stress critical- (large cracks) boundaries for the aluminum alloy 7079-T651 plate. (After Brown, 14.)

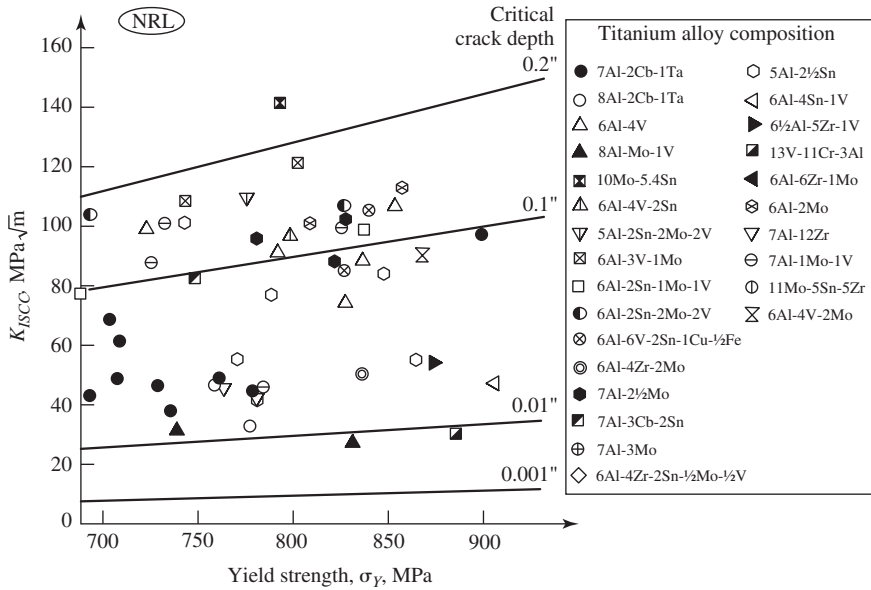
Fig. 13-12. K_{ISCC} data on titanium alloys in sea water. The critical flaw size as a function of K_{ISCC} and yield strength level is indicated (NRL = Naval Research Laboratories). (After Brown, 14.)

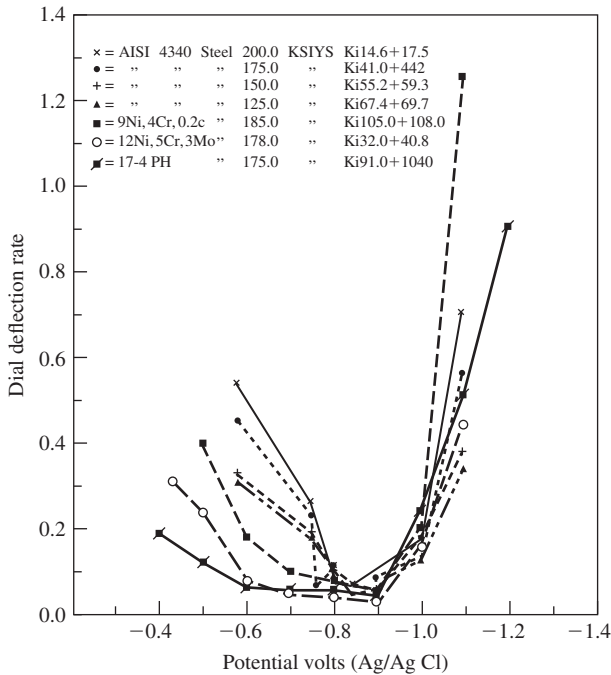
Fig. 13-13. Effect of varying degrees of cathodic protection on the stress-corrosion cracking rates of several steels. The rate of cracking was taken to be proportional to the dial deflection rate. (From Brown, 14.)

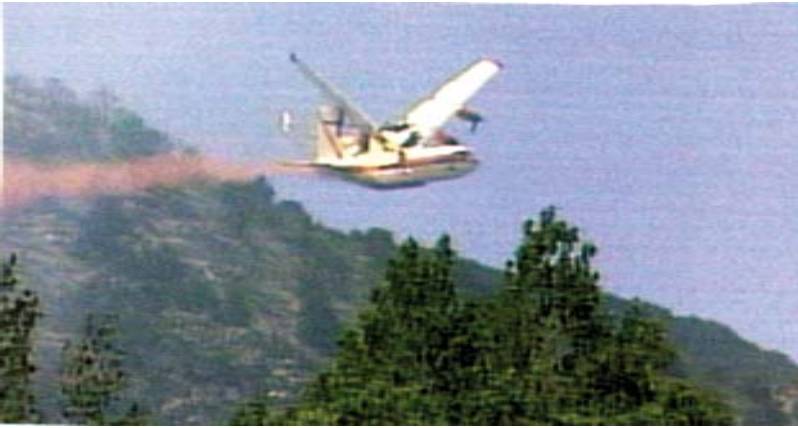
Fig. 14-1. A C-130 forest-fighting plane in the process of losing its wings.

Inspectability is defined to indicate that all critical areas prone to fracture in a given structure are known and that appropriate techniques for the inspection of these areas are available. Figure 14-1 provides an example of a case in which this criterion was not met, and as a result, the consequences were catastrophic. The plane, a C-130 cargo plane, had been used for many years by the U.S. Air Force. At some point, it was declared surplus and sold to a company that fought forest fires. In 2002, while fighting a forest fire in Northern California, the starboard wing came off as the center wing box failed during a pull-out from a drop of a fire-retardant chemical on a forest fire. In less than 1 second the port wing also came off. The fuselage then rolled to an inverted position and crashed, killing all three crew members.

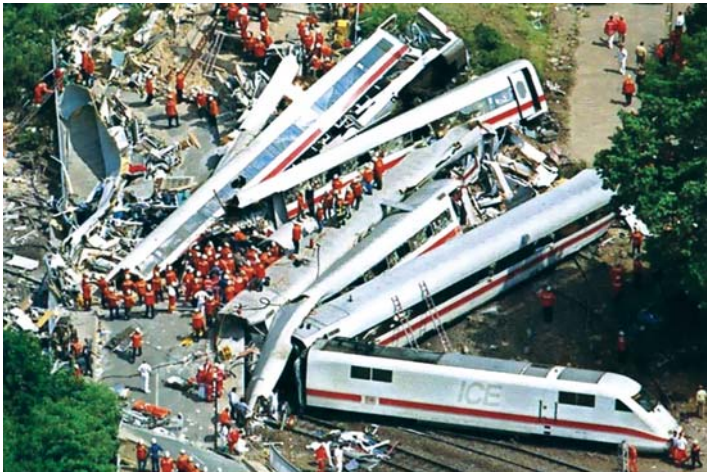
Fig. 14-3. Wreckage of an Inter-City Express (ICE) train in Germany.

Another example of the consequences of lack of inspectability follows. The train wreck shown in Fig. 14-3 occurred in 1998 near the village of Eschede in Germany. The toll of 101 people dead and an estimated 88 injured was the deadliest accident in German history. It was caused by a single fatigue crack in one wheel that, when it failed, caused the train to derail at a switch.

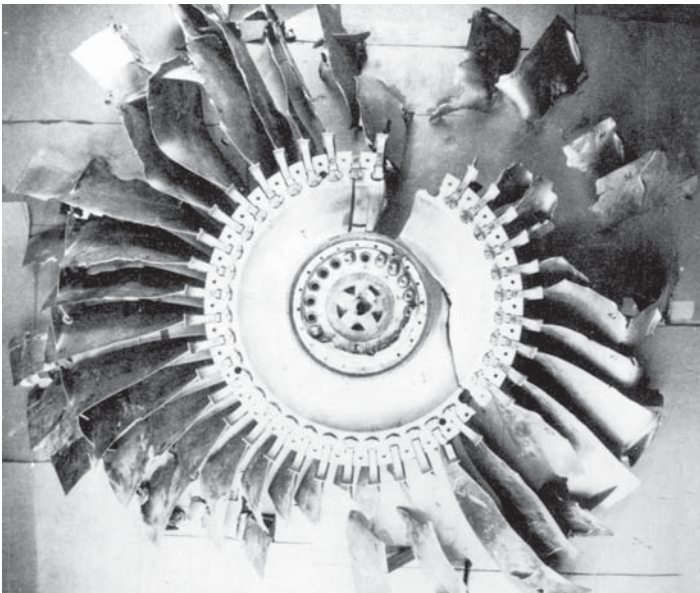
Fig. 14-12. The reconstructed stage 1 fan disk of the No. 2 engine. (From NTSB, 2.)

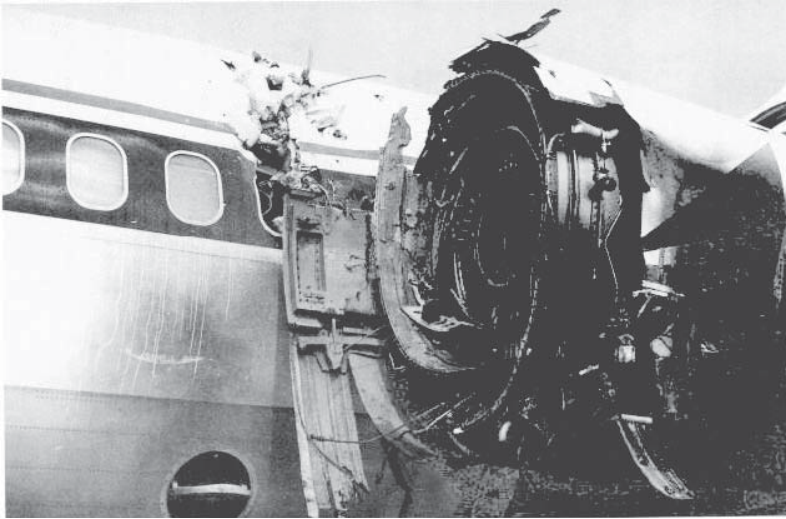
Fig. 14-14. Damaged area of the airplane near the No.1 engine. (From NTSB, 3.)

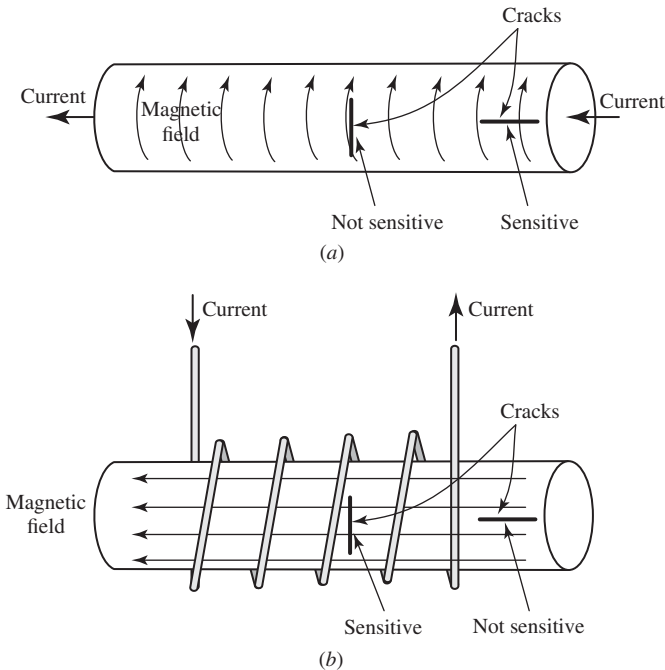
Fig. 14-18. The magnetic fields set up by (a) a "head shot" and (b) a coil.

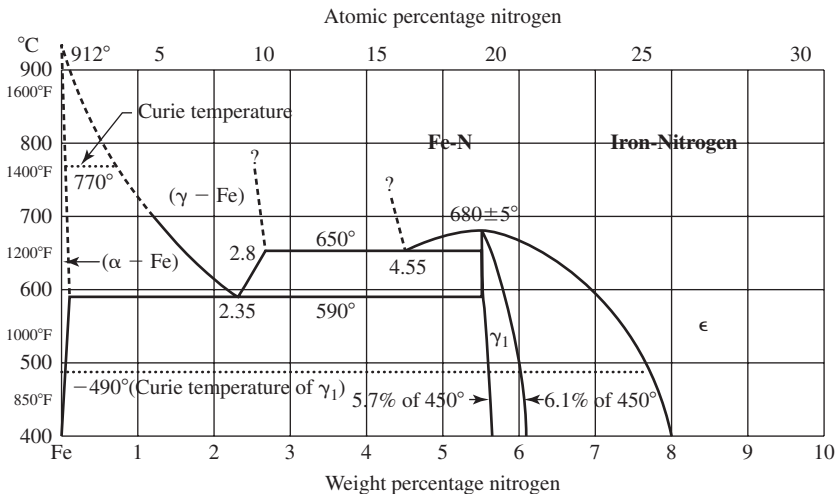
Fig. 14-20. The iron-nitrogen phase diagram. (From ASM Metals Handbook, 5, with permission of ASM International.)

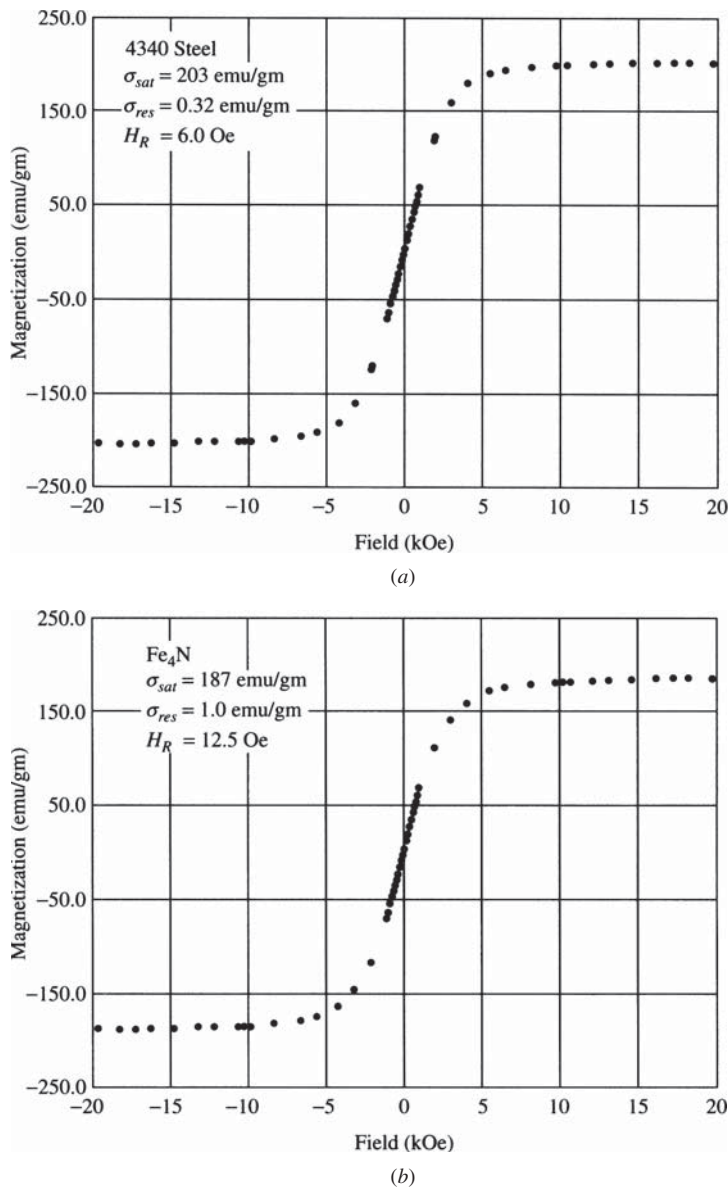
Fig. 14-21. (a, b) Comparison of the magnetization behavior of 4340 steel with Fe₄N (γ'). (Courtesy of W. A. Hines, University of Connecticut.)

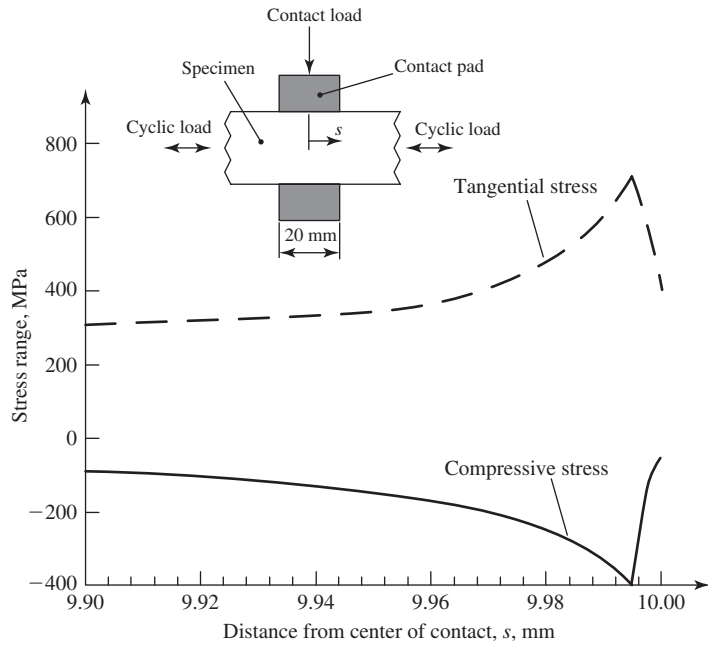
Fig. 15-3. Stress distribution in the fretting region.

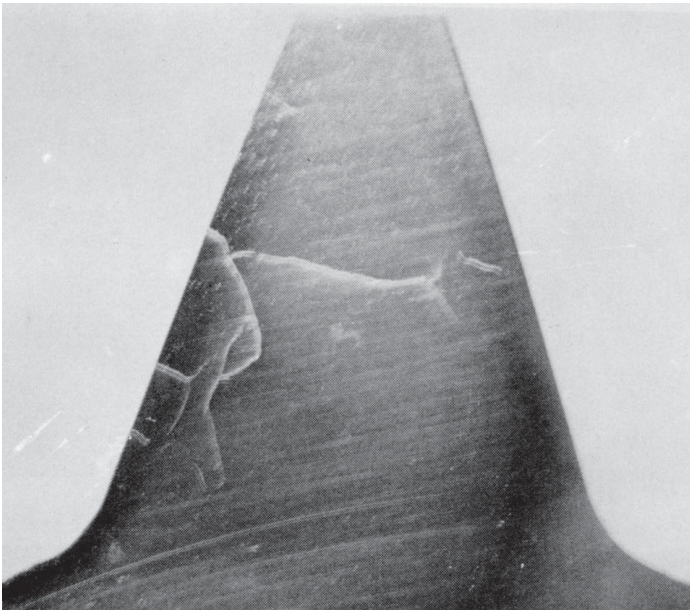
Fig. 15-12. An example of case crushing. (From Mackaldener and Olssen, 12.)
