# Seawater Corrosion Handbook

Edited by M. Schumacher

NOYES DATA CORPORATION

1979

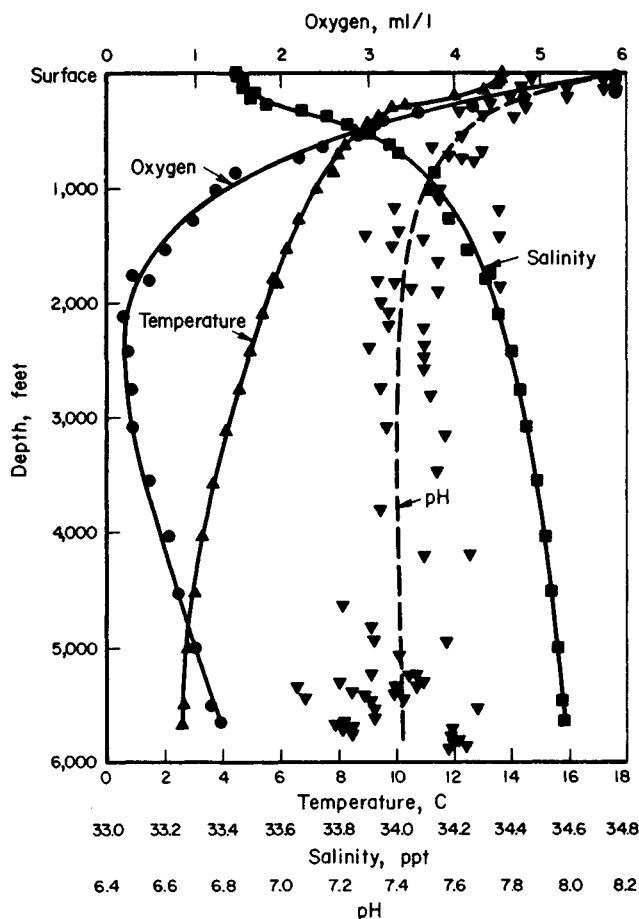
FIGURE 1. OCEANOGRAPHIC DATA TAKEN IN THE PACIFIC OCEAN AT A SITE WEST OF PORT HUENEME, CALIFORNIA<sup>(1)</sup>

Another factor that affects corrosion is the change in pH, as shown in Figure 1. The lower pH found in waters at great depth may be partly explained on thermodynamic grounds, since the pH is reduced by extreme pressure alone. However, it is also known that the carbon dioxide-calcium bicarbonate-calcium carbonate equilibrium tends to be shifted; that is, the dissolved calcium carbonate in the deep ocean tends to be slightly below saturation, while, conversely, at the surface it is frequently supersaturated.<sup>(3)</sup> One would, therefore, expect that

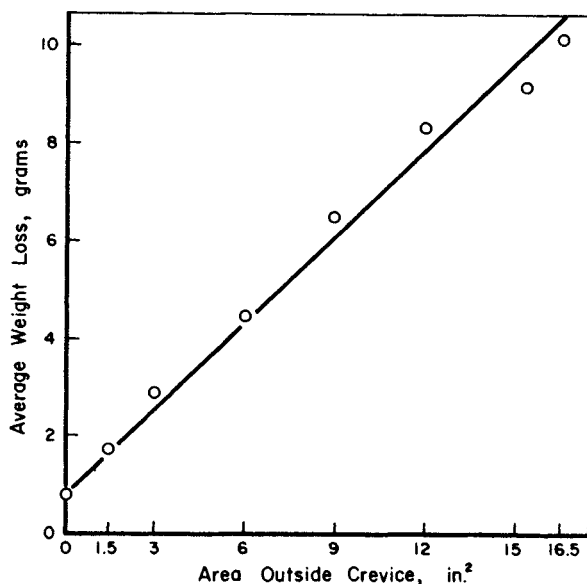
FIGURE 4. AVERAGE WEIGHT LOSS OF SPECIMENS AS RELATED TO AREA OF SPECIMEN OUTSIDE THE CREVICE(11)

Ellis and LaQue(11) have demonstrated, using Type 430 stainless steel, the effect of enlarging the area external to the crevice on attack. Figure 4 shows a straight-line relation between weight loss and external area as might be expected from Faraday's law. A plot of pit depth against area in Figure 5 shows more scatter. This experiment was conducted in seawater flowing at 1 to 2 feet per second for 87 days. Crevice attack can be controlled, as demonstrated here, by reducing the area of metal external to the crevice. Cathodic protection will largely eliminate the attack by polarizing the cathodic area to that of the anode under the crevice.

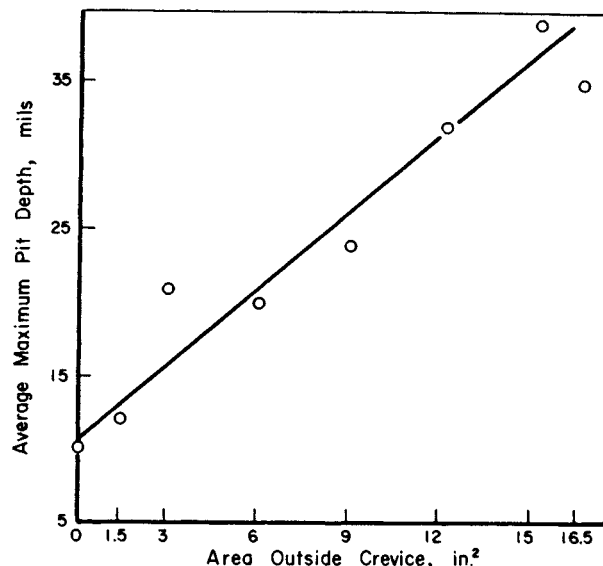
FIGURE 5. RELATION BETWEEN AVERAGE MAXIMUM PIT DEPTH WITHIN THE CREVICE VERSUS AREA OF SPECIMEN OUTSIDE THE CREVICE(11)

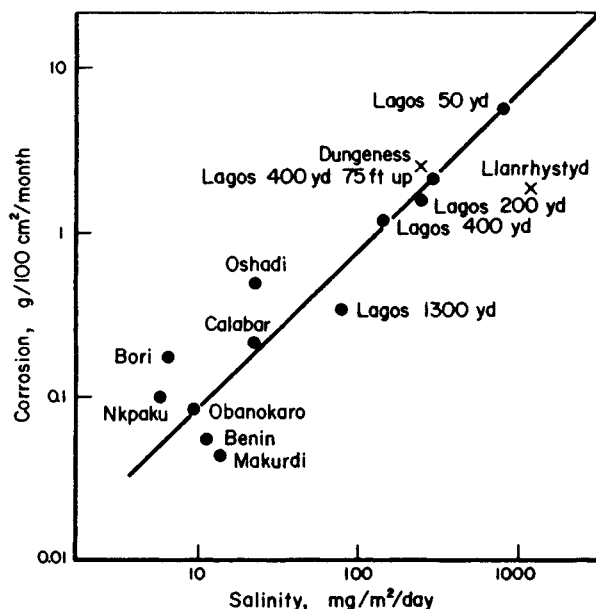
FIGURE 6. RELATION BETWEEN CORROSION OF MILD STEEL AND SALINITY AT EXPOSURE SITES IN NIGERIA(14)

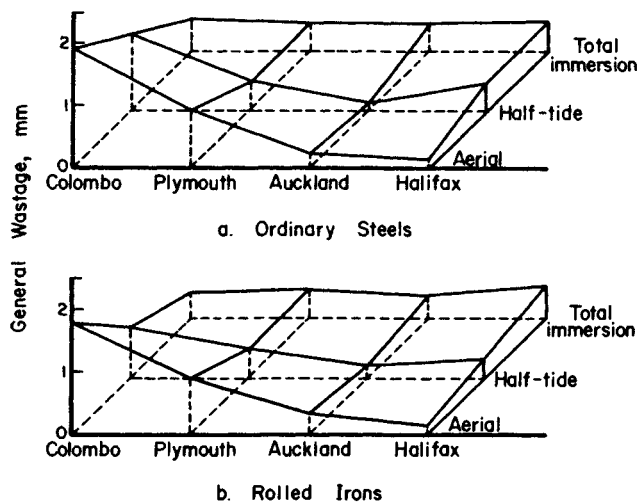
FIGURE 7. INFLUENCE OF CLIMATE AND CONDITIONS OF 5 YEARS' EXPOSURE ON THE GENERAL WASTAGE OF THE ORDINARY STEELS AND ROLLED IRONS<sup>(15)</sup>

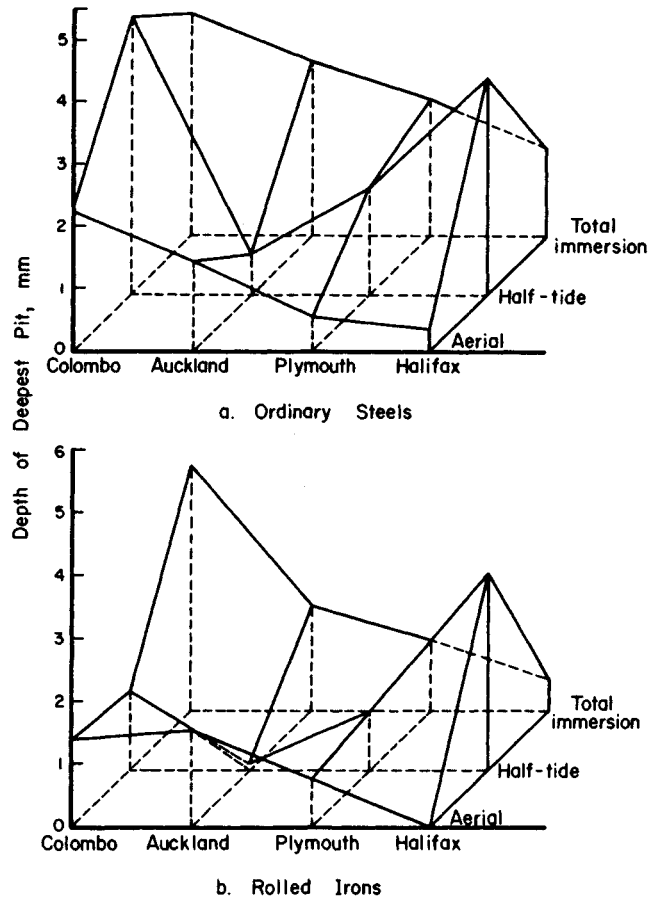
FIGURE 8. INFLUENCE OF CLIMATE AND CONDITIONS OF 5 YEARS' EXPOSURE ON THE PITTING OF THE ORDINARY STEELS AND ROLLED IRONS<sup>(15)</sup>

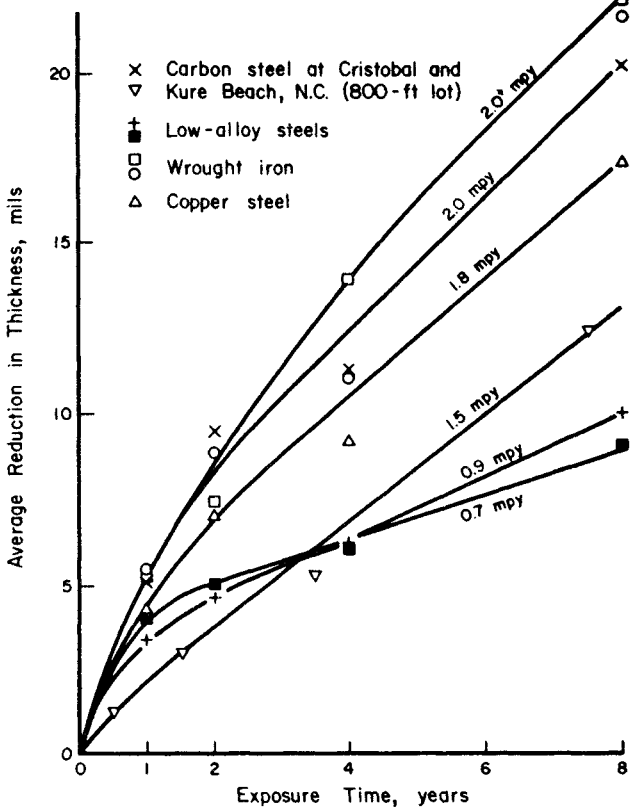
FIGURE 10. CORROSION RESULTS FOR WROUGHT IRON AND STEELS AFTER EIGHT YEARS' ATMOSPHERIC EXPOSURE AT CRISTOBAL, CANAL ZONE(12,13,17)

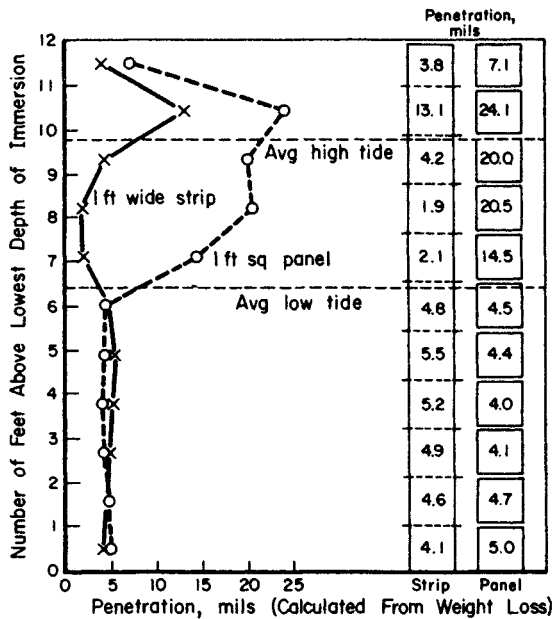
FIGURE 11. CORROSION OF STEEL EXPOSED ABOVE, IN, AND BELOW TIDAL RANGE FOR 151 DAYS AT KURE BEACH, N.C.(18)

Carbon steel corrodes particularly rapidly in the splash zone. The corrosion rates in the splash zone may be of the order of ten times higher than those for the same metal in the submerged condition. The ready access of oxygen and the fact that the surface is continuously wet with seawater tends to make the splash zone the most aggressive of marine environments. Figure 11 gives the results of a short-term experiment in which continuous 12-foot steel strips as well as individual steel panels were exposed to the splash and tide zones. Note that one individual panel in the splash zone had a weight-loss penetration of 24.1 mils or about 50 mpy.(16) This was about five to six times that for the completely submerged panels. Note also that the continuous-strip panel evinced a rate of attack in the splash zone about half that for an individual panel at the same location. Humble(18), see Figure 12, shows the typical corrosion profile of a steel pile after a 5-year exposure at Kure Beach, N. C. The splash zone shows more than four times the rate of the immersed zone.

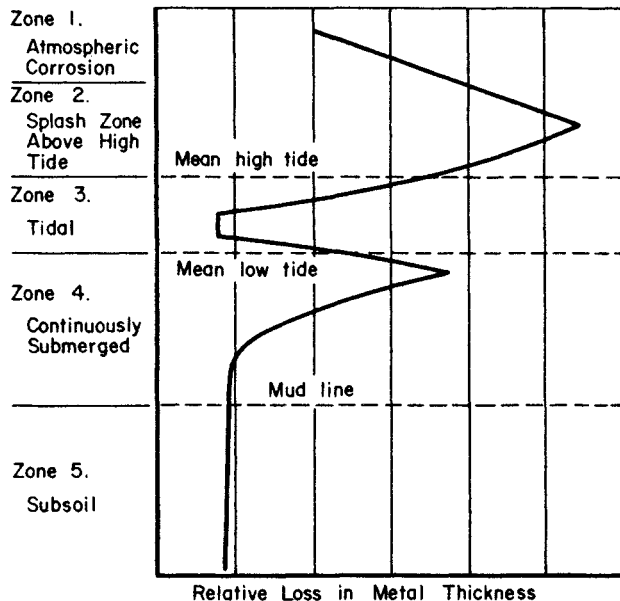
FIGURE 12. CORROSION PROFILE OF STEEL PILING AFTER 5 YEARS' EXPOSURE IN SEAWATER AT KURE BEACH, N.C. (INTERNATIONAL NICKEL CO.)(18)

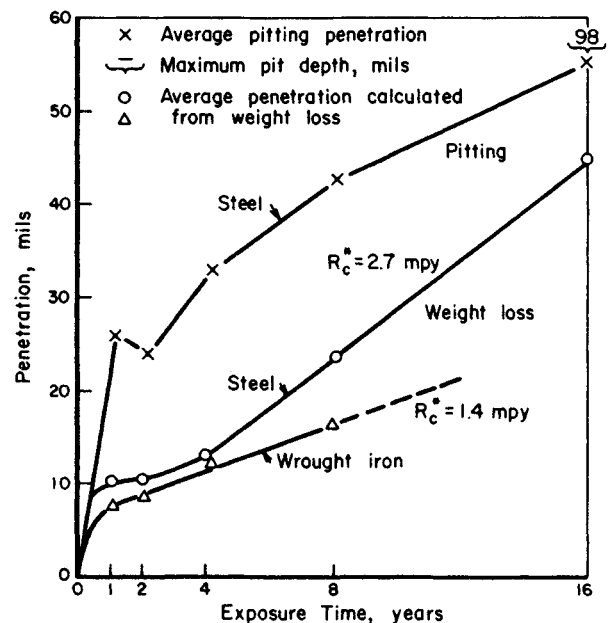
FIGURE 13. CORROSION OF CARBON STEEL AND WROUGHT IRON AT MEAN TIDE IN PACIFIC OCEAN OFF PANAMA CANAL(19)

The results of exposing carbon steel at the mean tide level in the Pacific Ocean off the Panama Canal Zone are shown in Figure 13(19). The average rate of penetration, calculated from weight loss, was 2.7 mpy. The maximum pit depth, however, was 98 mils for the 16-year period. Wrought iron tested for 8 years showed a lower rate of attack, i.e., 1.4 mpy.

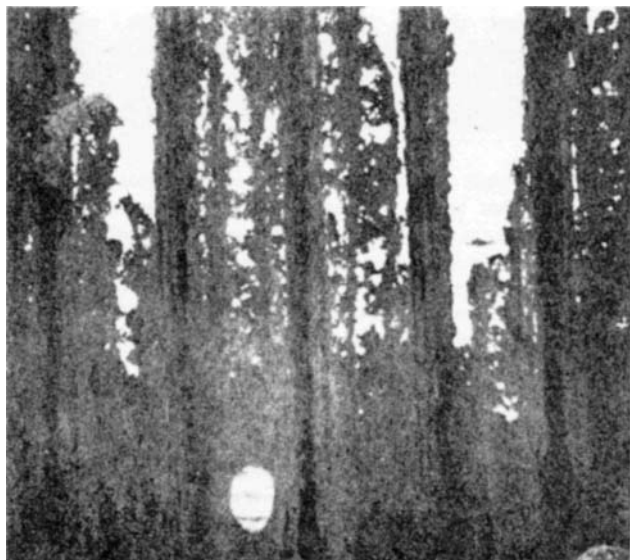
FIGURE 14. LOCALIZED CORROSION IN SPLASH ZONE OF BULKHEAD AND SHEET STEEL PILING ON PACIFIC ISLAND(20)

It should be emphasized that the splash zone and also, in some cases, the tide zone are the sites where corrosion protection is most needed. Figures 14 and 15 illustrate the severely localized deterioration in the splash zone when no provision is made for corrosion control. Either extra wall thickness or a suitable protective coating should have been provided.

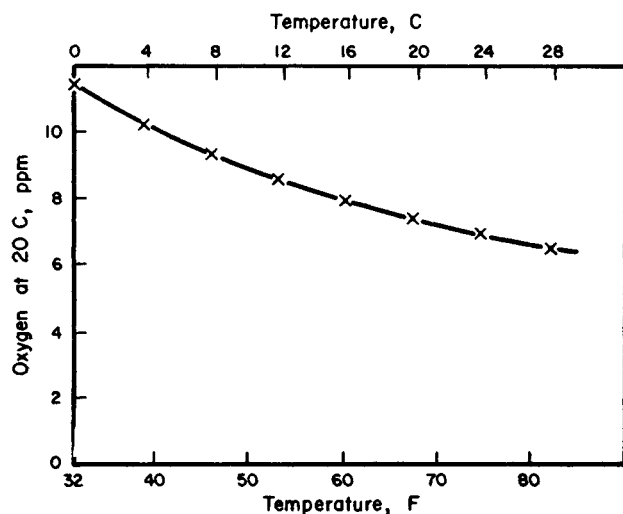
FIGURE 17. SOLUBILITY OF OXYGEN IN SEAWATER OF 35 o/oo SALINITY(22)

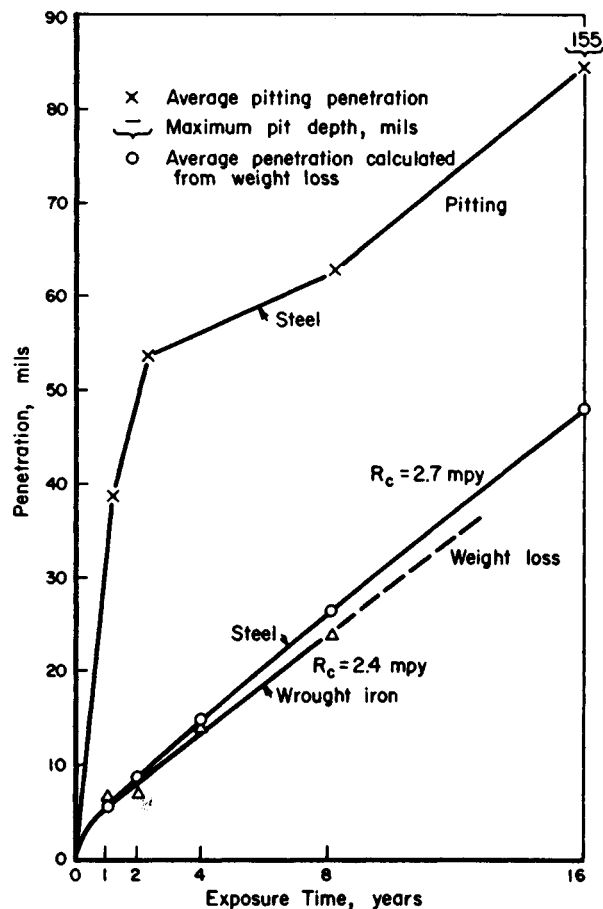
FIGURE 18. CORROSION OF CARBON STEEL AND WROUGHT IRON CONTINUOUSLY IMMERSSED IN SEAWATER(19)

**Specific Results.** In panel tests in seawater at widely different marine locations, average rates of penetration for steel and other related ferrous materials were found to range from 2 to 5 mpy. For example, carbon-steel panels immersed for periods up to 16 years in the Pacific Ocean near the Panama Canal Zone showed an average corrosion rate between the 2nd and 16th year of 2.7 mpy (Figure 18), while wrought iron showed 2.4 mpy between the 2nd and 8th year. Reinhart's data showing the relation between corrosion rate and exposure time for ferrous metals is presented in Figure 16. A rapid decline in rate after the first few years is evident.

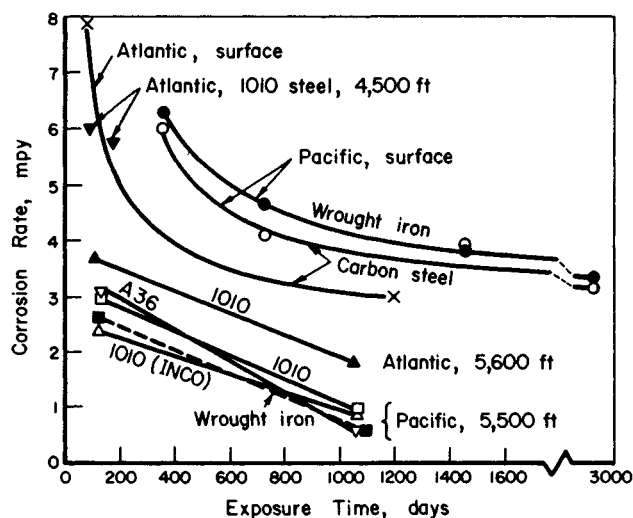
FIGURE 19. CORROSION RATES OF CARBON STEELS IN THE ATLANTIC AND PACIFIC OCEANS AT VARIOUS DEPTHS<sup>(1)</sup>

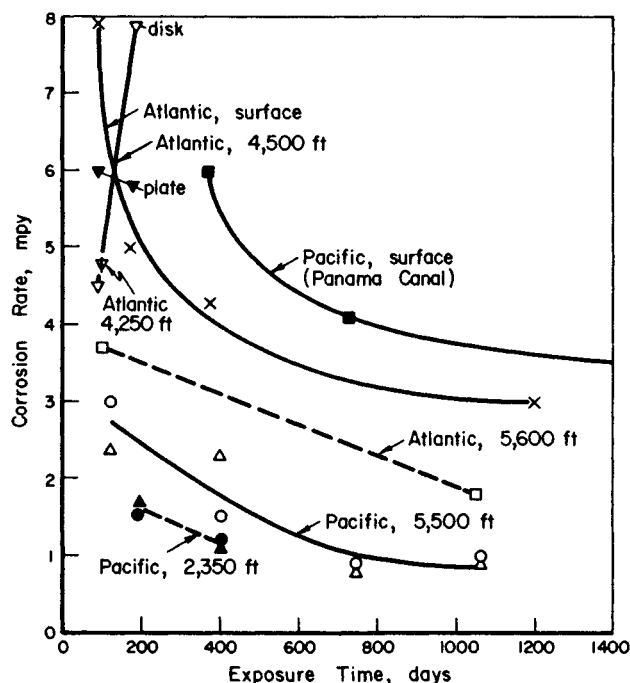
FIGURE 20. CORROSION RATES OF LOW-CARBON STEELS AT VARIOUS LOCATIONS<sup>(1)</sup>

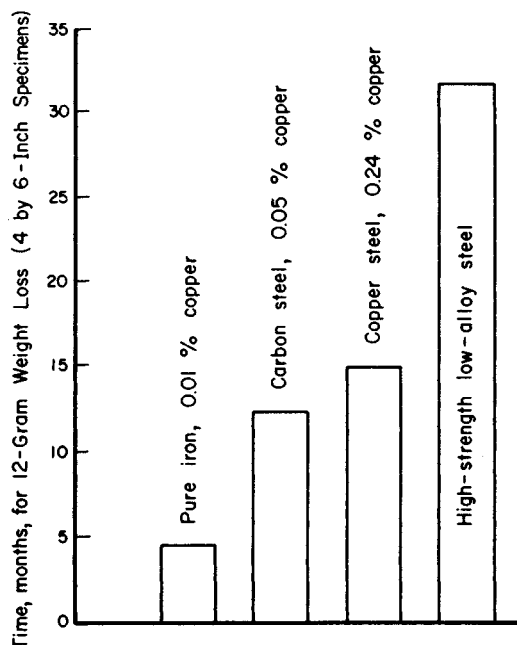
FIGURE 22. RELATIVE DURABILITIES OF STEELS IN A MARINE ATMOSPHERE(27)

A general picture of the relative resistance of low-alloy steels, copper-bearing steels, and pure iron in a marine atmosphere is shown in Figure 22. Endurance is shown as the time required for a 4 x 6-inch panel to lose 12 grams. For a pure iron panel, the time required was only 5 months, but for a typical low-alloy steel panel, 32 months was required, or over 6 times as long.

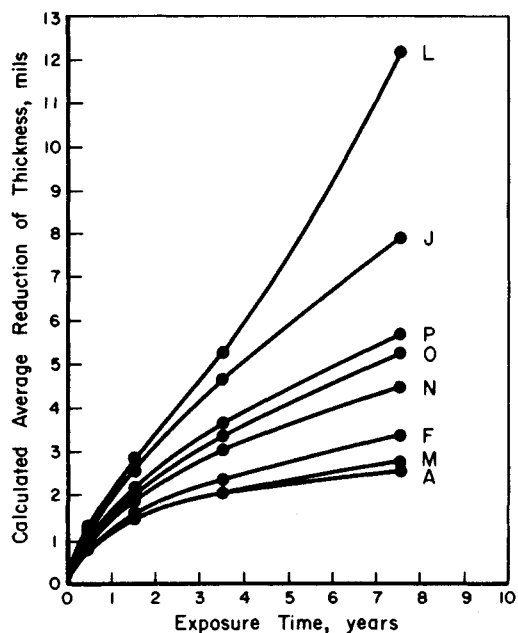
FIGURE 27. EFFECT OF EXPOSURE TIME ON CORROSION OF STEELS IN MARINE ATMOSPHERE AT KURE BEACH, N.C.(28)

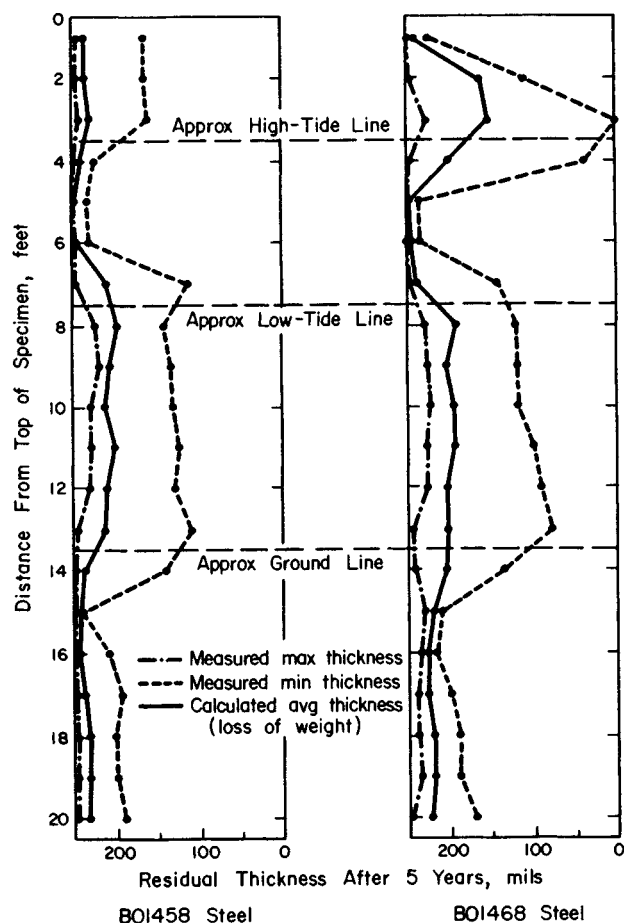
FIGURE 29. COMPARISON OF CORROSION RESULTS FOR TWO STEELS IN MARINE ENVIRONMENTS(30)  
 Used with permission of National Association of Corrosion Engineers

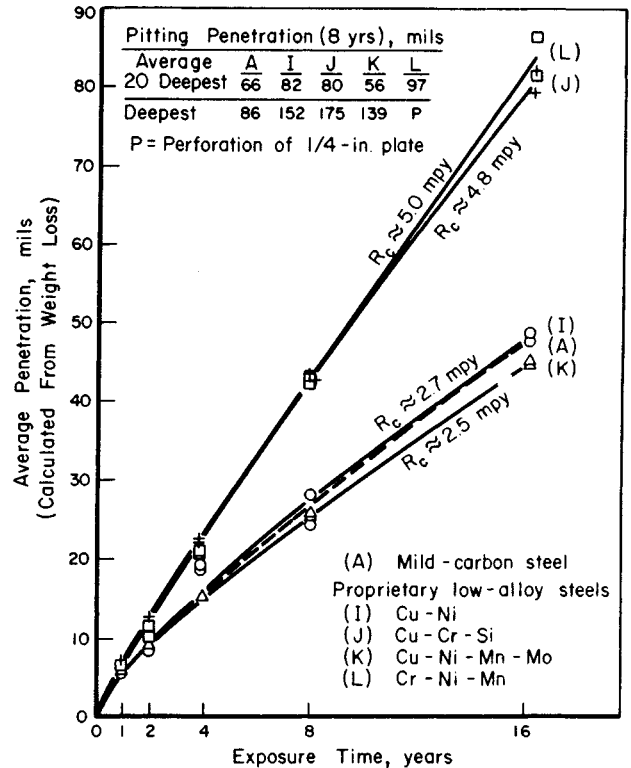
FIGURE 31. SEA-IMMERSION CORROSION OF PROPRIETARY LOW-ALLOY STEELS<sup>(19)</sup>

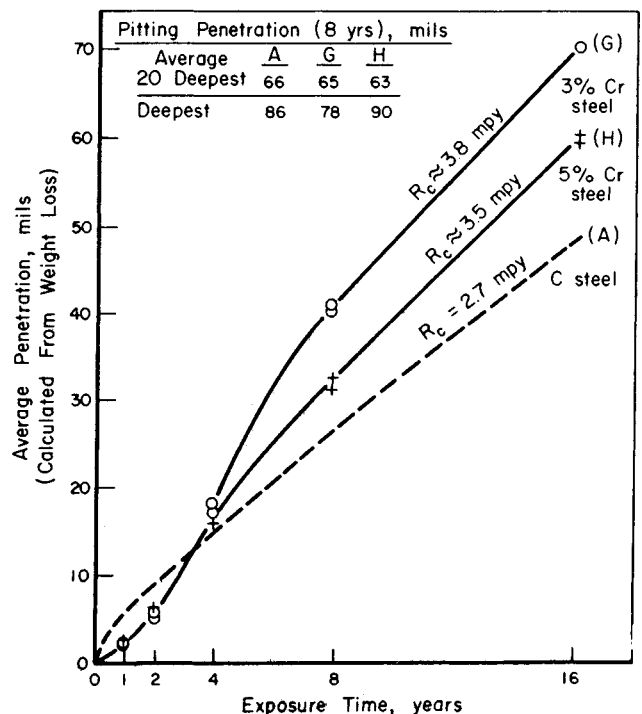
FIGURE 32. SEA-IMMERSION CORROSION OF 3 PERCENT AND 5 PERCENT CHROMIUM STEEL<sup>(19)</sup>

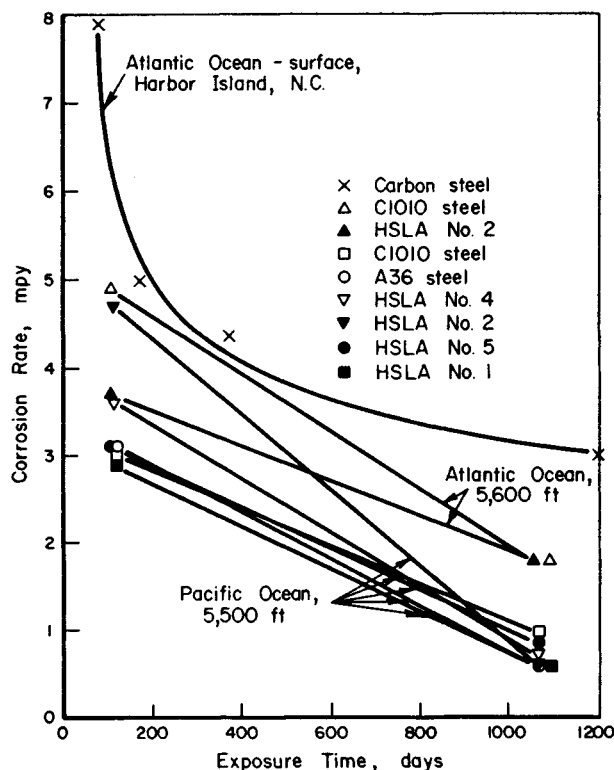
FIGURE 33. CORROSION RATES OF LOW ALLOY STEELS(1)

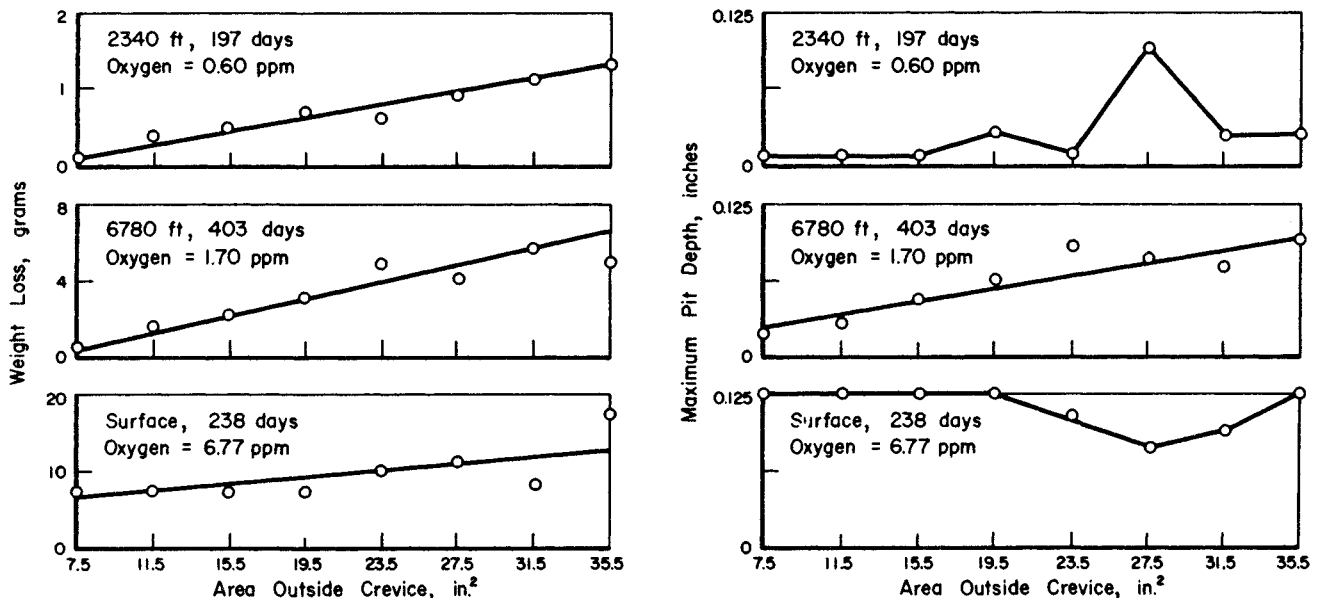
FIGURE 36. RELATION OF WEIGHT LOSS AND MAXIMUM PIT DEPTH IN THE CREVICE TO AREA OF SPECIMEN OUTSIDE THE CREVICE FOR TYPE 304 STAINLESS STEEL AT VARIOUS DEPTHS<sup>(34)</sup>

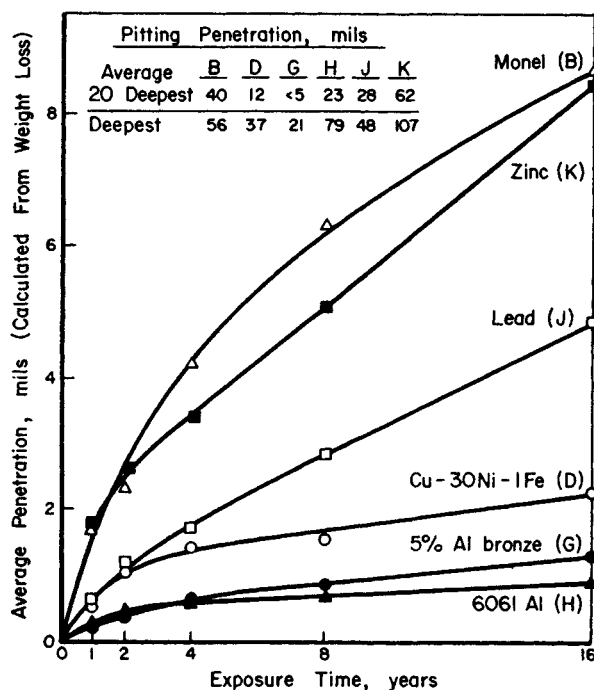
FIGURE 40. COMPARISON OF VARIOUS METALS AFTER 16 YEARS' IMMERSION IN LOW-VELOCITY PACIFIC SEAWATER OFF THE PANAMA CANAL(40)

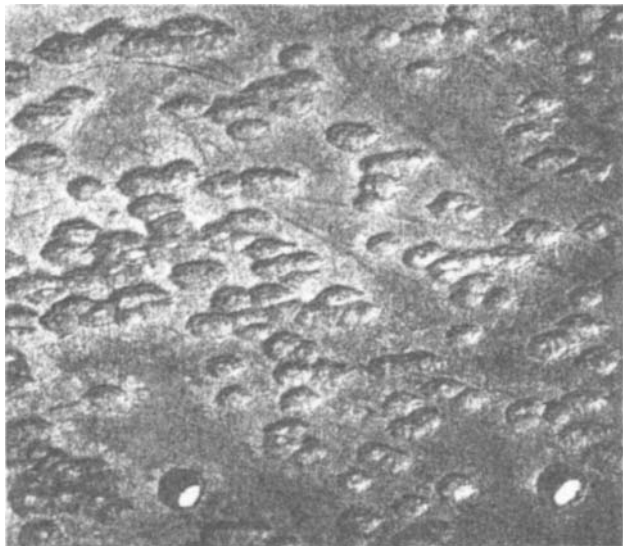
FIGURE 42. PITTING CORROSION OF MONEL 400 AFTER 1,064 DAYS OF EXPOSURE AT A DEPTH OF 5300 FEET(43)

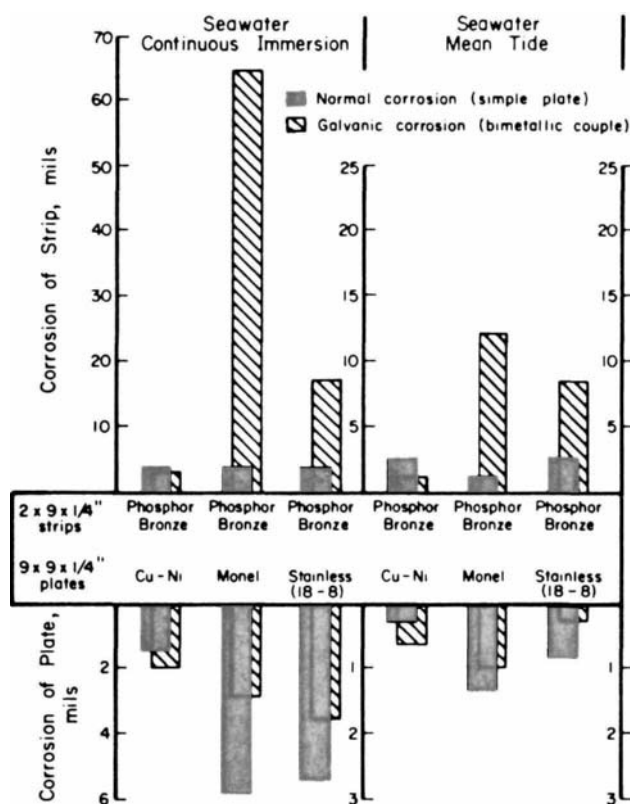
FIGURE 44. GALVANIC EFFECTS WITH SEMIONOBLE METAL COUPLES IN TROPICAL SEAWATER(40)

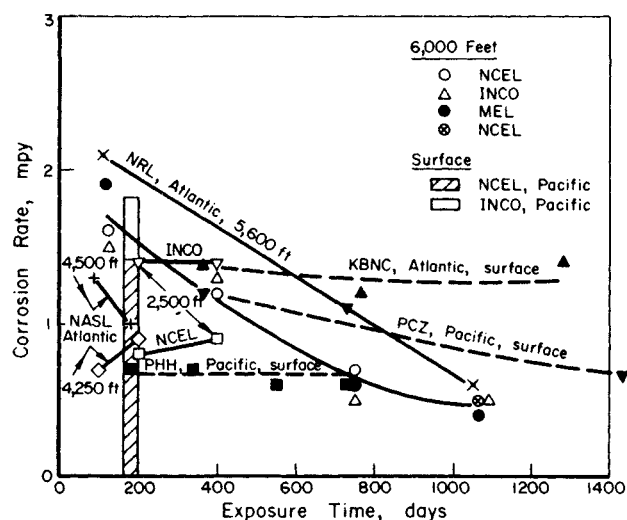
FIGURE 49. CORROSION RATES OF COPPER IN SEAWATER(54)

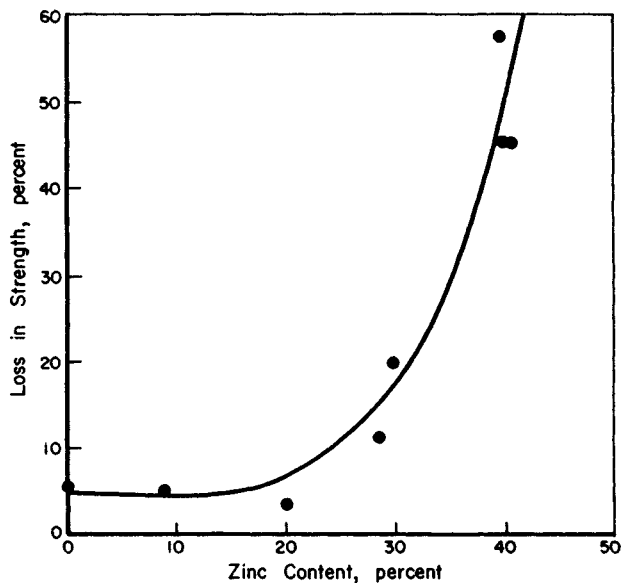
FIGURE 50. EFFECT OF ZINC CONTENT ON LOSS IN STRENGTH FOR BRASSES AFTER 16 YEARS' SUBMERSION IN THE PACIFIC OCEAN NEAR THE PANAMA CANAL ZONE(52)

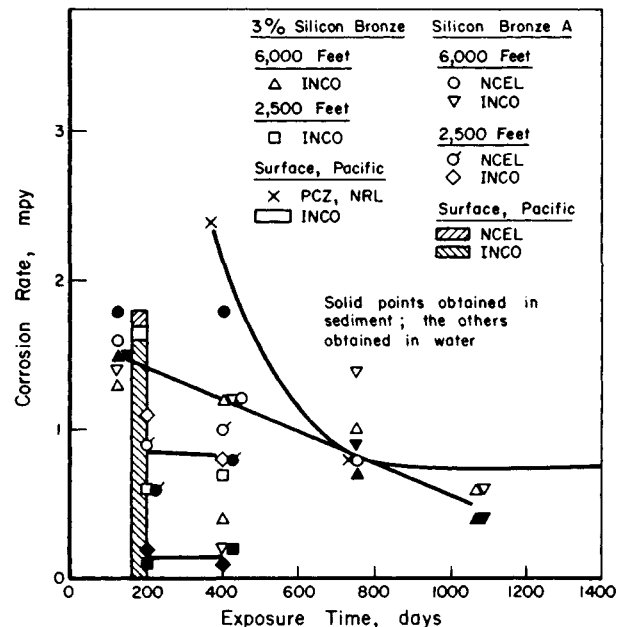
FIGURE 54. CORROSION RATES OF SILICON BRONZES(54)

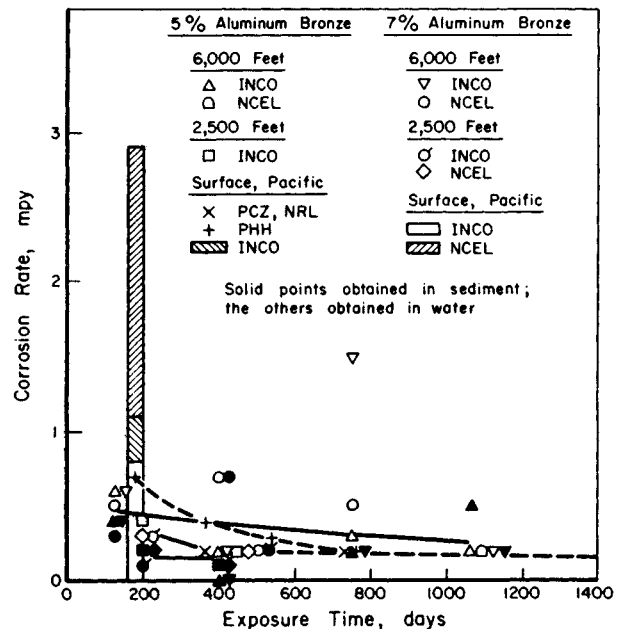
FIGURE 55. CORROSION RATES OF WROUGHT ALUMINUM BRONZES(54)

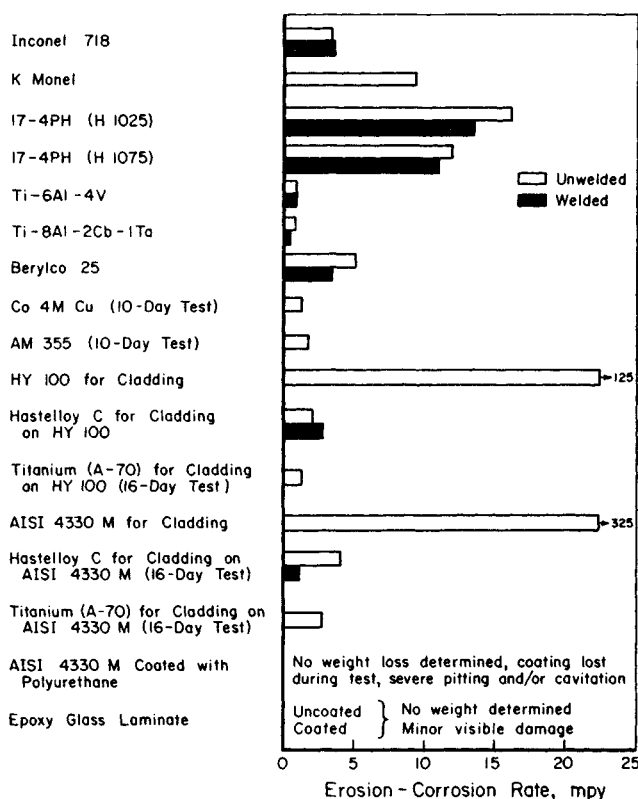
FIGURE 58. RATES FOR JET EROSION-CORROSION IN SEAWATER FOR 30 DAYS AT 90 KNOTS<sup>(72)</sup>

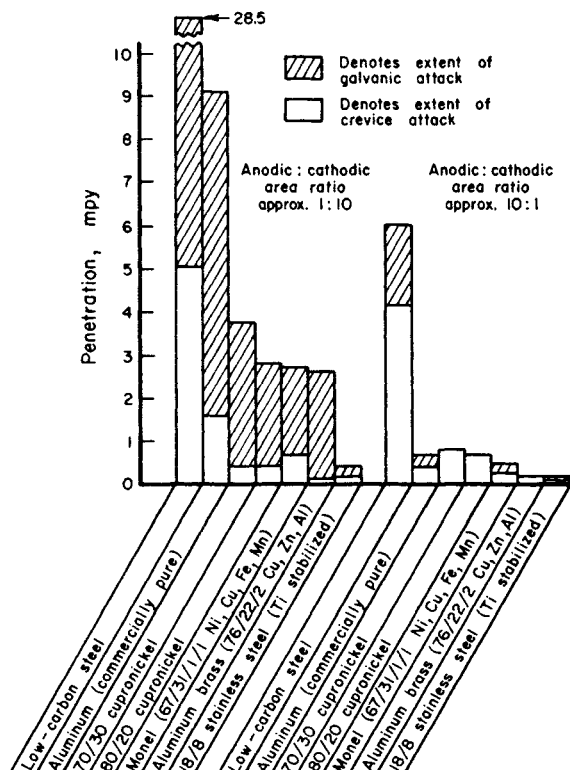
FIGURE 59. BEHAVIOR OF METAL-TO-TITANIUM GALVANIC COUPLES EXPOSED FOR 2,500 HOURS IN AERATED SEAWATER<sup>(73)</sup>

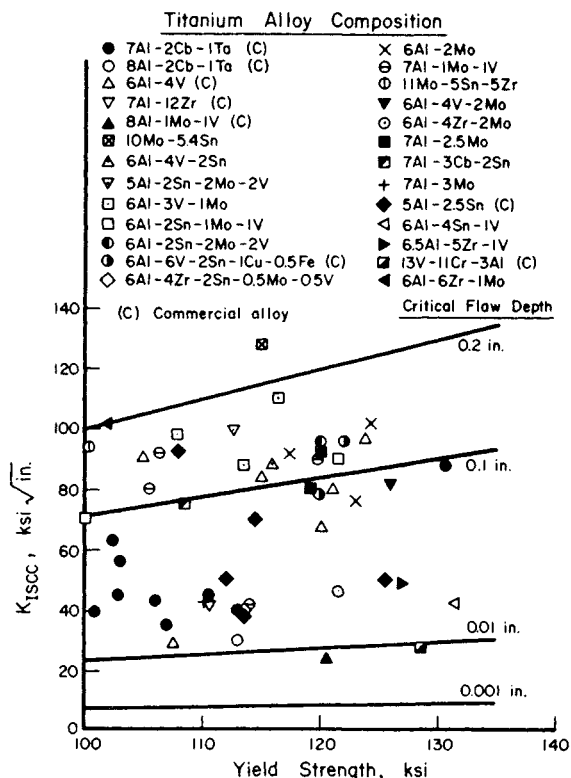
FIGURE 61. STRESS-CORROSION-CRACKING RESISTANCE INDEX FOR TITANIUM ALLOYS IN 3.5 PERCENT SALT WATER(77)

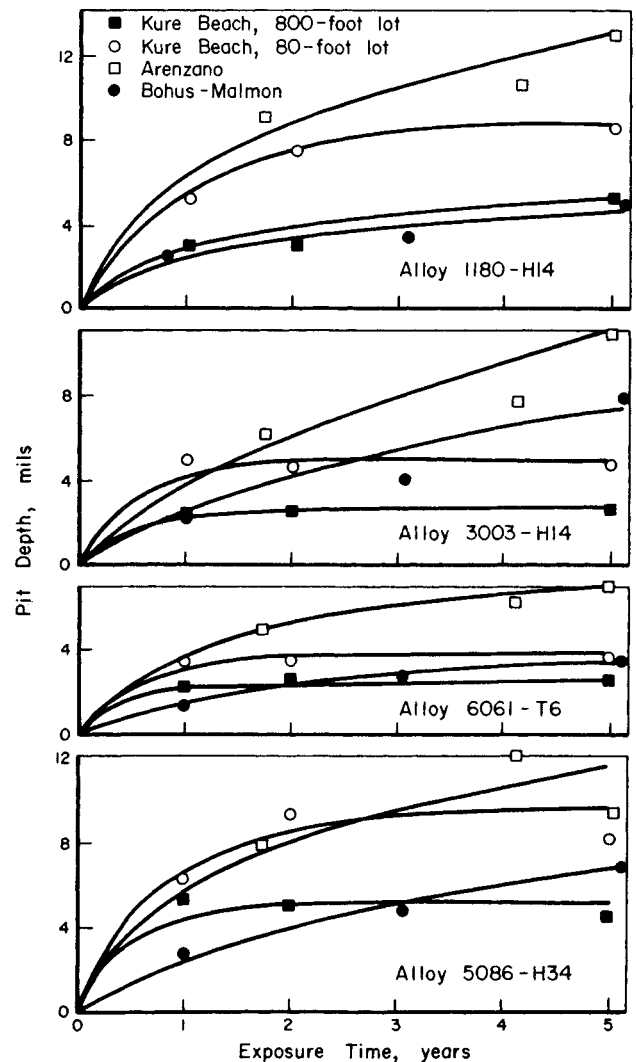
FIGURE 65. MAXIMUM MEASURED PIT DEPTHS FOR ALUMINUM ALLOYS IN SELECTED MARINE ATMOSPHERES(87)

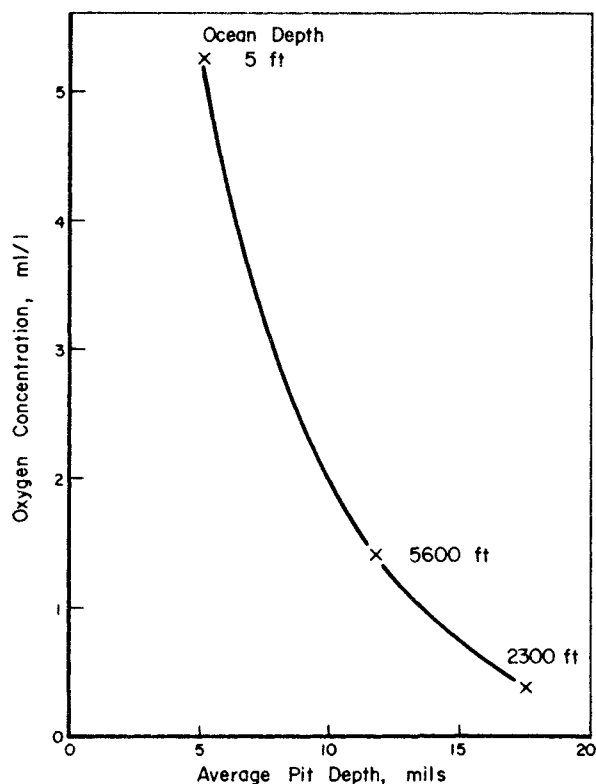
FIGURE 67. RELATION BETWEEN AVERAGE PIT DEPTHS OF ALUMINUM-MAGNESIUM ALLOYS (5000 SERIES) AND OXYGEN CONCENTRATION OF SEAWATER<sup>(90)</sup>

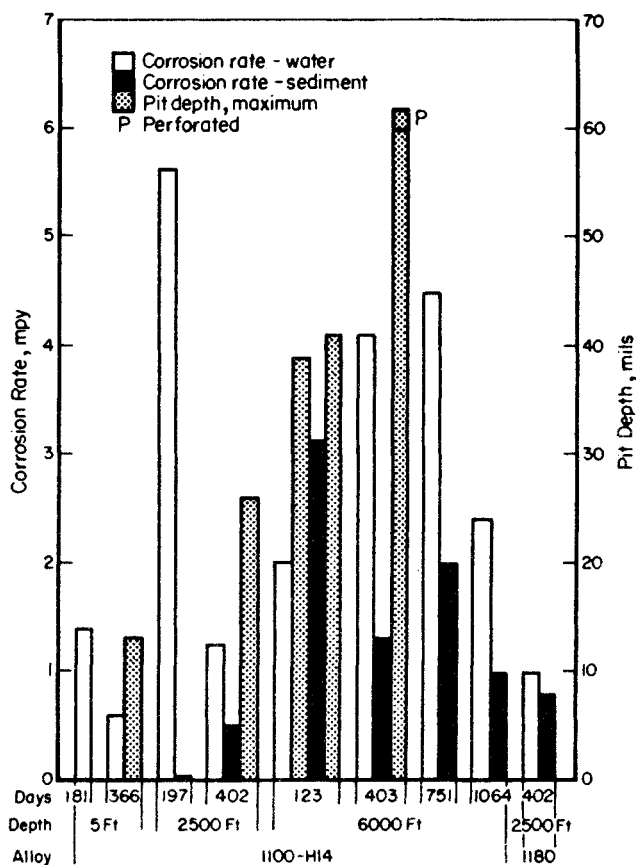
FIGURE 70. CORROSION RATES AND MAXIMUM AND AVERAGE PIT DEPTHS OF 1000 SERIES ALLOYS IN PACIFIC OCEAN WEST OF PORT HUENEME(90)

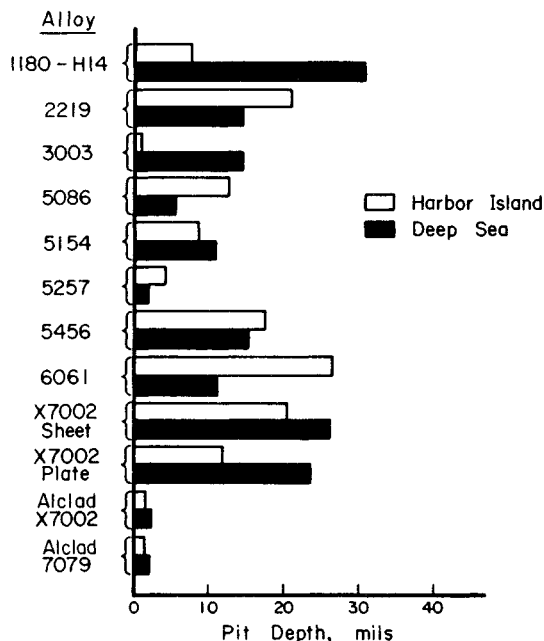
FIGURE 73. RELATION BETWEEN AVERAGE PIT DEPTH (20 DEEPEST PITS) AFTER 1-YEAR EXPOSURE AT THE SURFACE AND AT 2,370 FEET AT HARBOR ISLAND, N. C., AND IN PACIFIC OFF PORT HUENEME, CALIFORNIA(93)

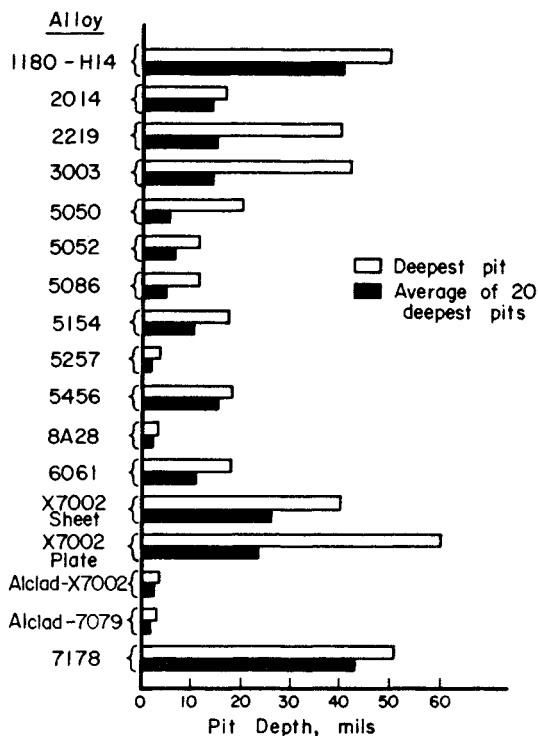
FIGURE 74. MEASURED PIT DEPTHS AFTER 1-YEAR EXPOSURE AT 2,370 FEET IN PACIFIC OCEAN WEST OF PORT HUENEME, CALIFORNIA(93)

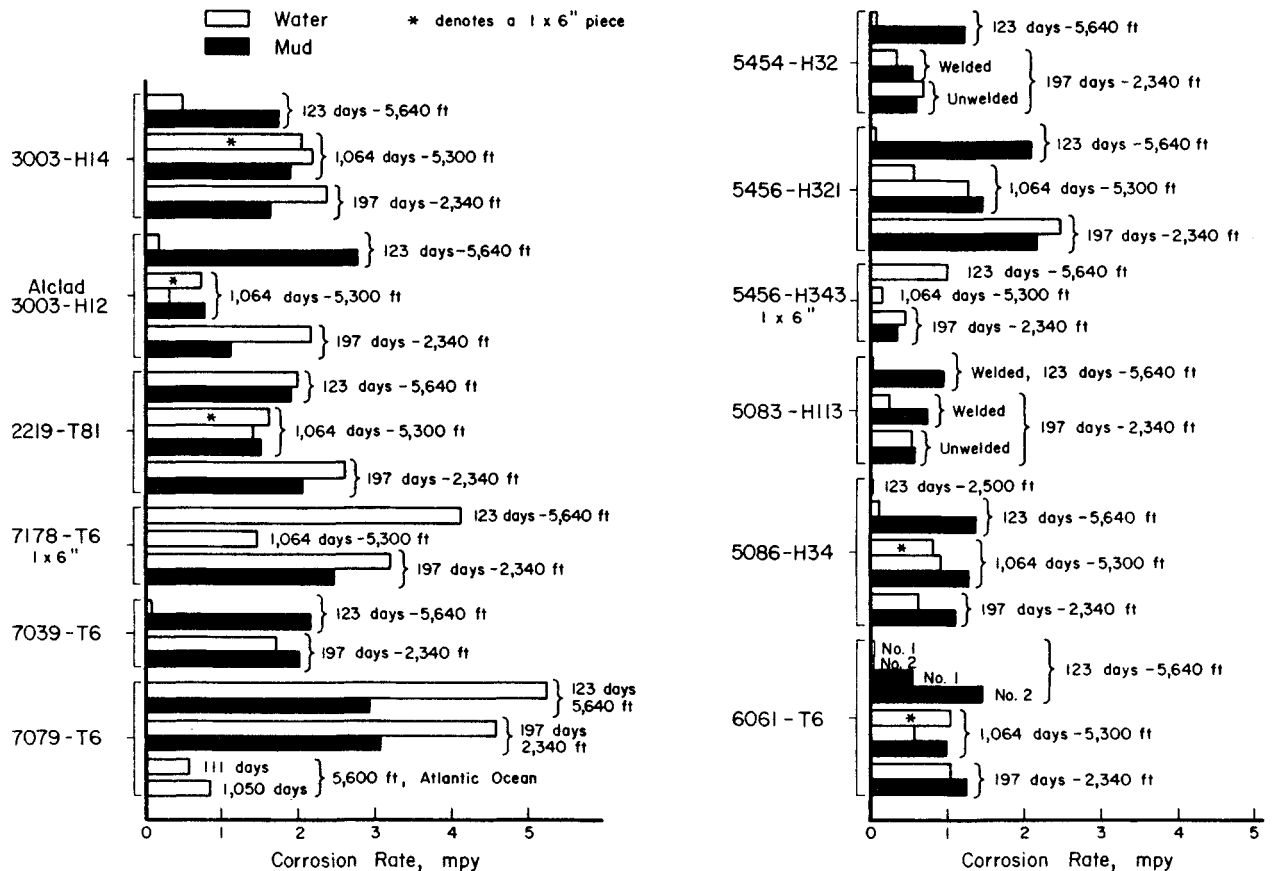
FIGURE 75. CORROSION RATES OF ALUMINUM ALLOYS IN THE DEEP OCEAN (PACIFIC OCEAN UNLESS OTHERWISE SPECIFIED)(1)

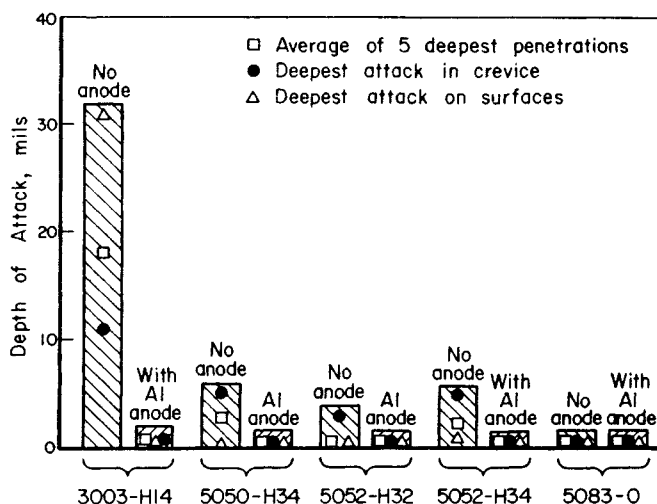
FIGURE 78. CORROSION AND EFFECT OF CATHODIC PROTECTION OF 3000 AND 5000 SERIES ALUMINUM ALLOYS EXPOSED FOR 368 DAYS IN SEAWATER AT KEY WEST, FLORIDA(91)

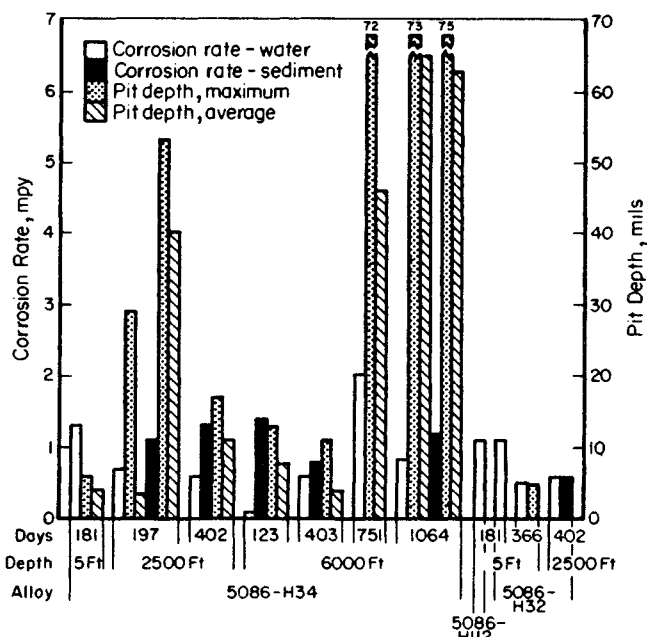
FIGURE 80. CORROSION RATES AND MAXIMUM AND AVERAGE PIT DEPTHS OF 5086 ALLOY(90)

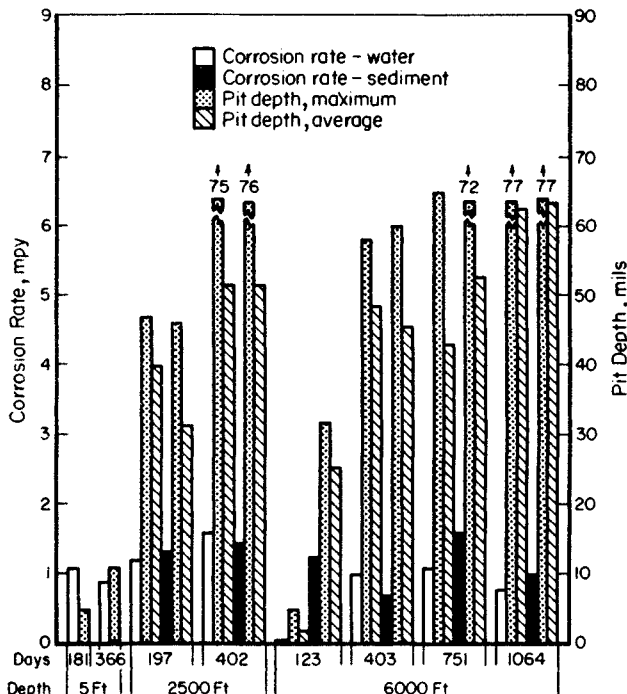
FIGURE 82. CORROSION RATES AND MAXIMUM AND AVERAGE PIT DEPTHS OF 6061-T6 ALLOY<sup>(90)</sup>

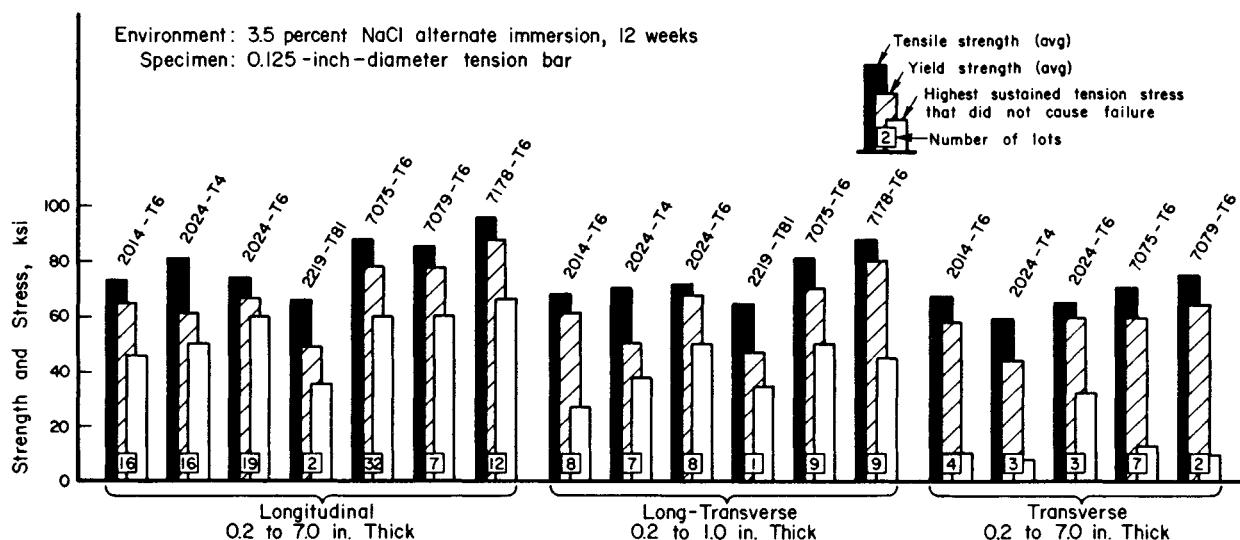
FIGURE 85. COMPARISON OF THE RESISTANCE TO STRESS-CORROSION CRACKING OF ALUMINUM-ALLOY EXTRUSIONS TO SALT WATER<sup>(97)</sup>

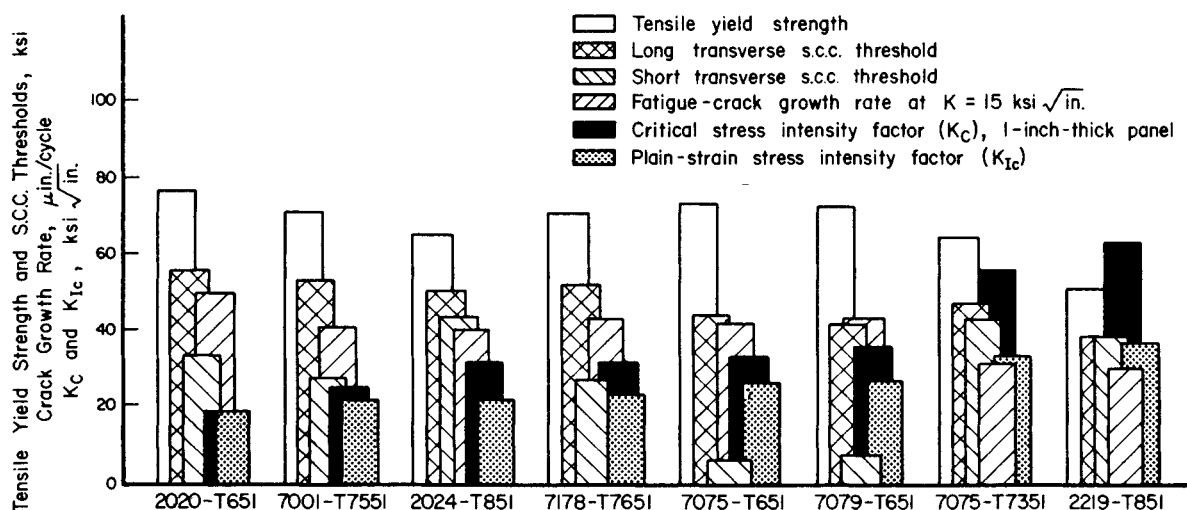
FIGURE 86. COMPARISON OF THE EIGHT ALUMINUM ALLOY-TEMPER COMBINATIONS ON THE BASIS OF TENSILE YIELD STRENGTH, STRESS-CORROSION-CRACKING THRESHOLDS (USING 3.5% NaCl ALTERNATE IMMERSION), FATIGUE-CRACK GROWTH RATES, AND FRACTURE-TOUGHNESS CRITERIA,  $K_{IC}$  AND  $K_{IC}$ <sup>(98)</sup>

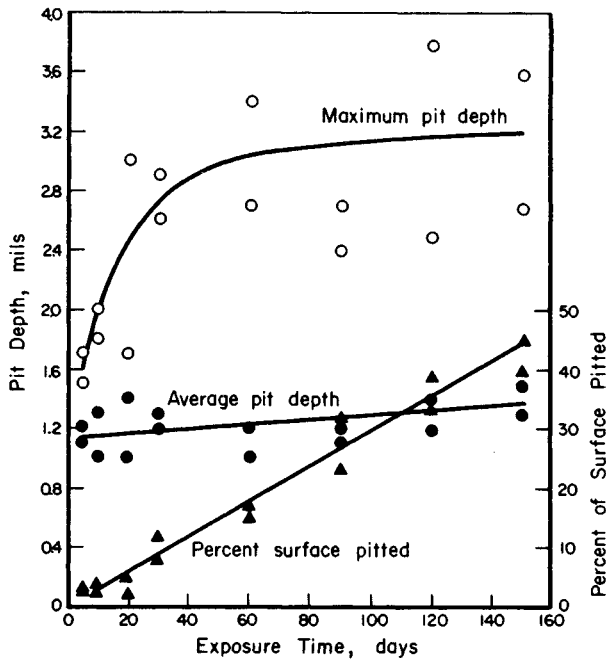
FIGURE 89. PITTING ATTACK OF UNSTRESSED, PICKLED BERYLLIUM SHEET MATERIAL EXPOSED TO SYNTHETIC SEAWATER AT 77 F(105)

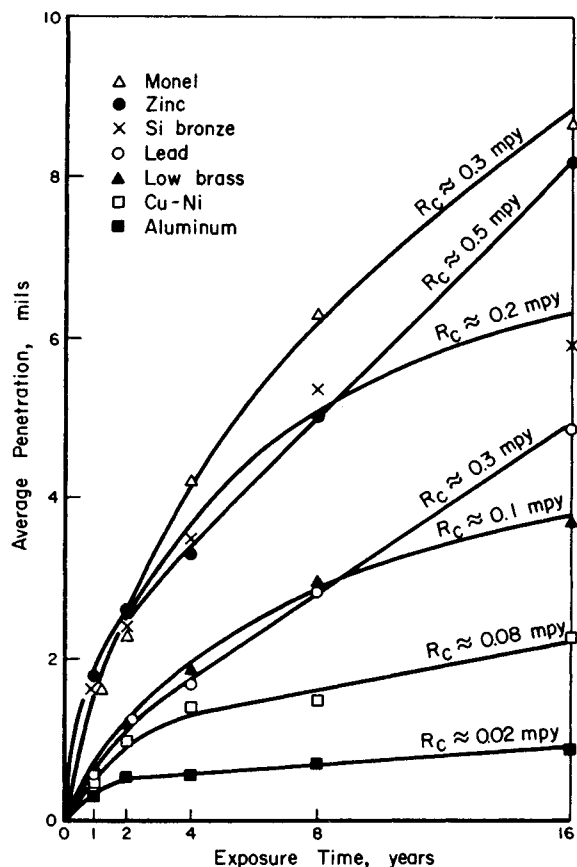
FIGURE 93. COMPARISON OF AVERAGE PENETRATION OF WROUGHT NONFERROUS METALS AFTER 16 YEARS' CONTINUOUS IMMERSION IN SEAWATER(109)
