# Seawater Corrosion Handbook

Edited by M. Schumacher

NOYES DATA CORPORATION

1979

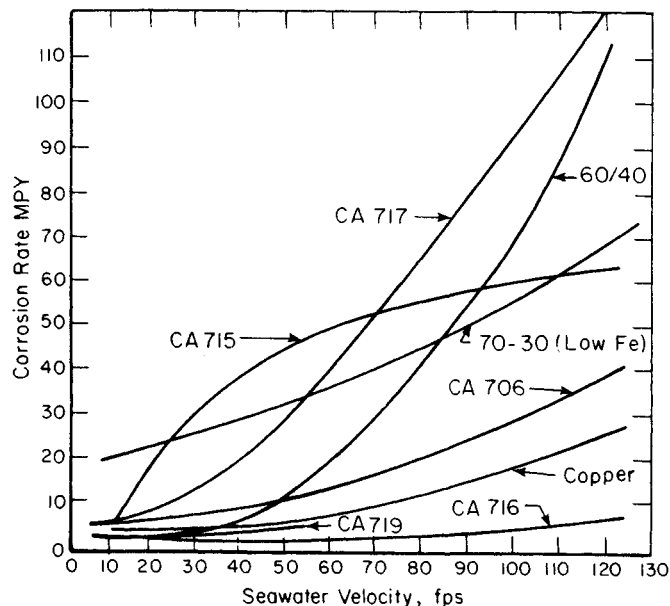
FIGURE 99. RESULTS OF MULTIVELOCITY AND HIGH VELOCITY JET TESTS ON COPPER AND COPPER ALLOYS<sup>(176)</sup>

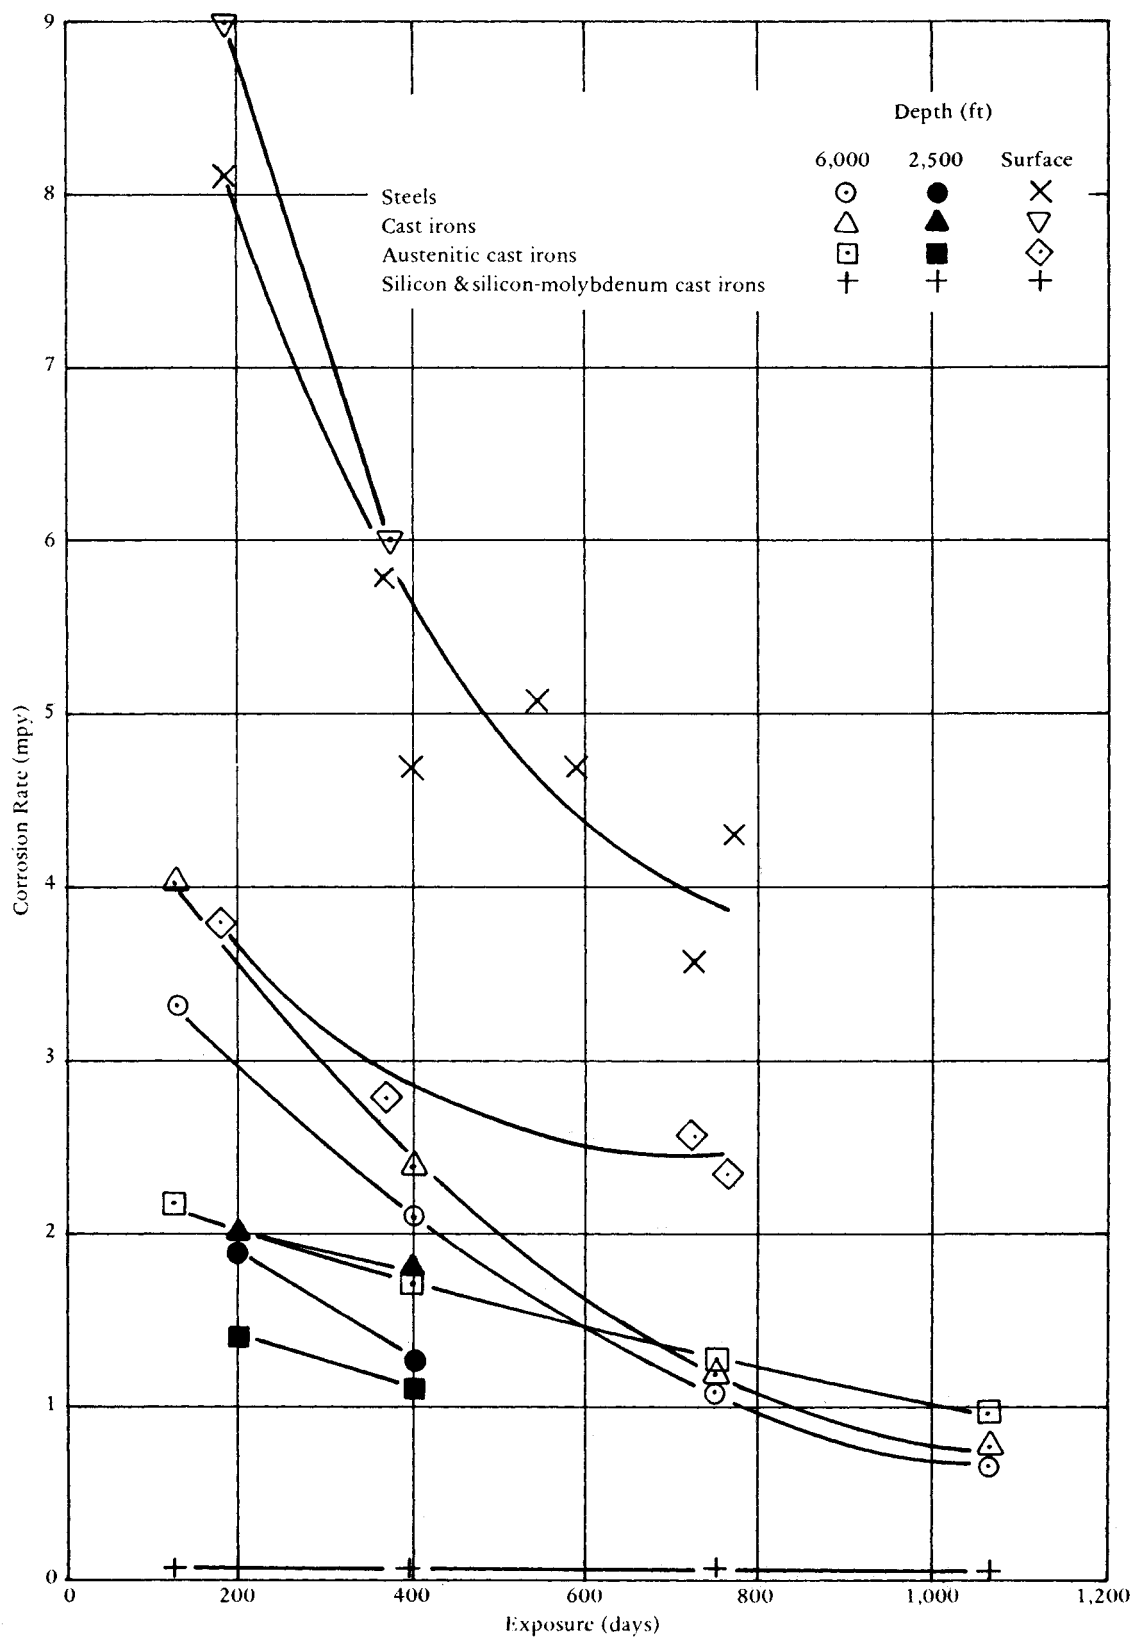
Figure 3. Effect of duration of exposure on corrosion of steels and cast irons.

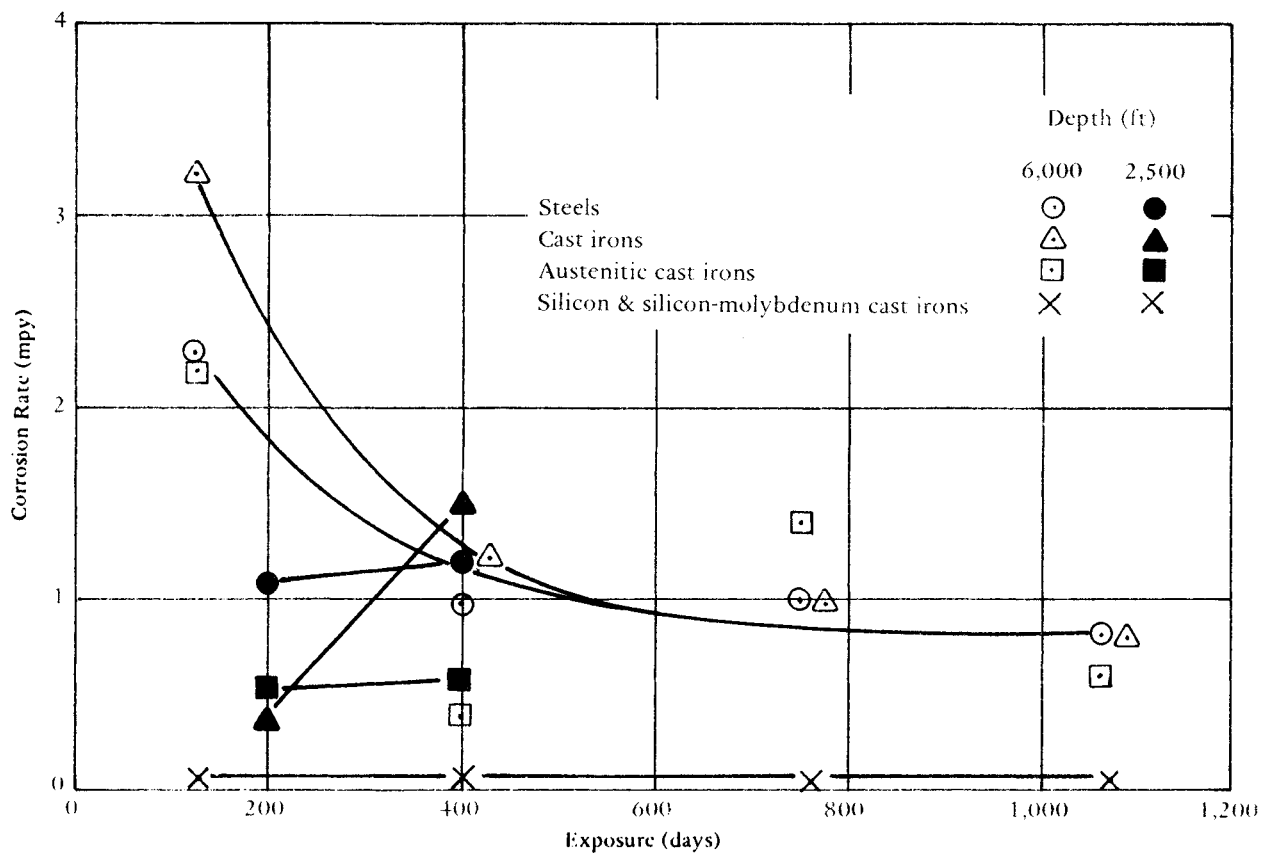
Figure 4. Effect of duration of exposure on corrosion of steels and cast irons in bottom sediments.

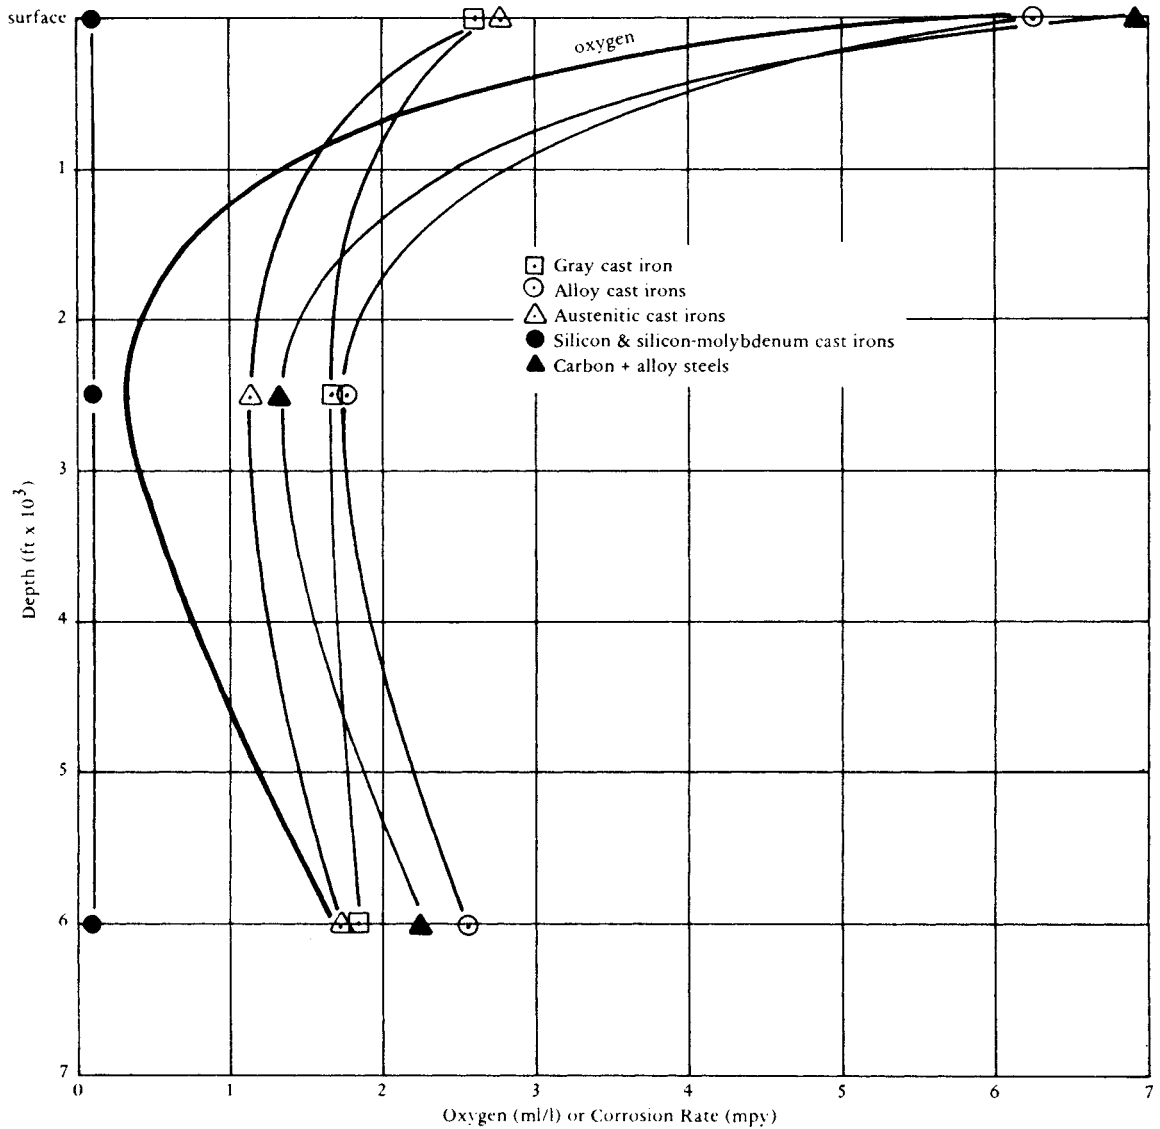
Figure 5. Effect of depth on the corrosion of steels and cast irons after 1 year of exposure in seawater.

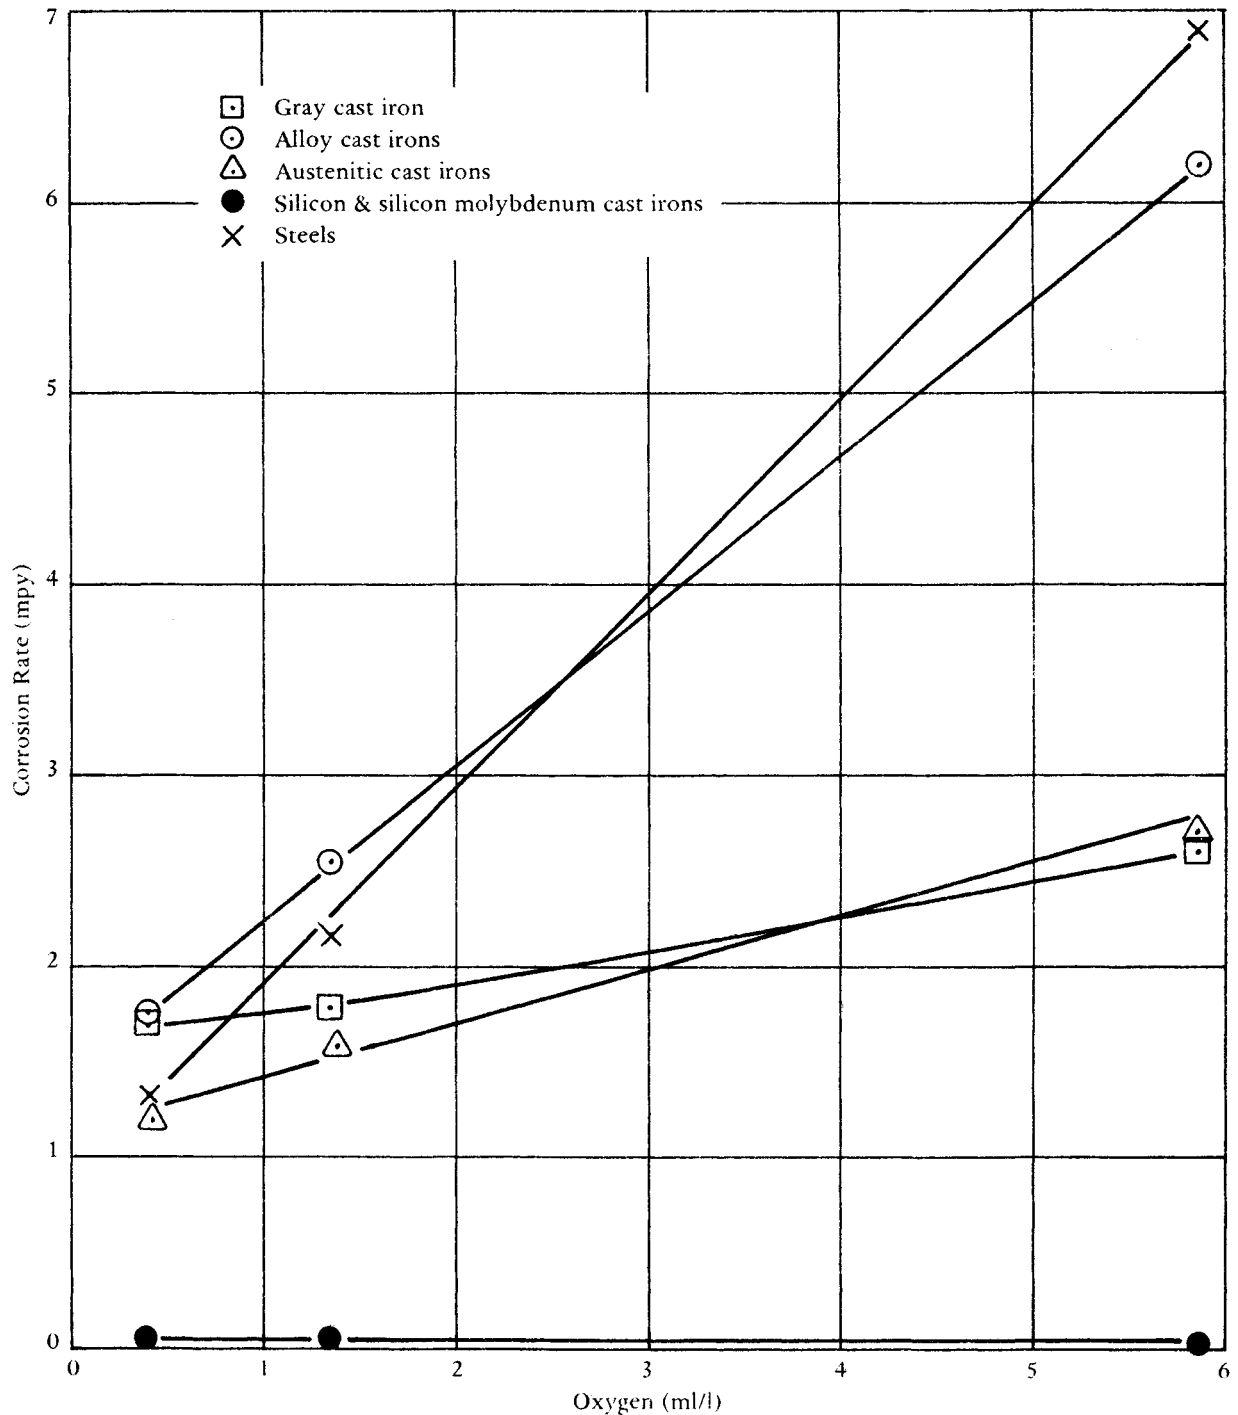
Figure 6. Effect of concentration of oxygen in seawater on the corrosion of steels and cast irons after 1 year of exposure.

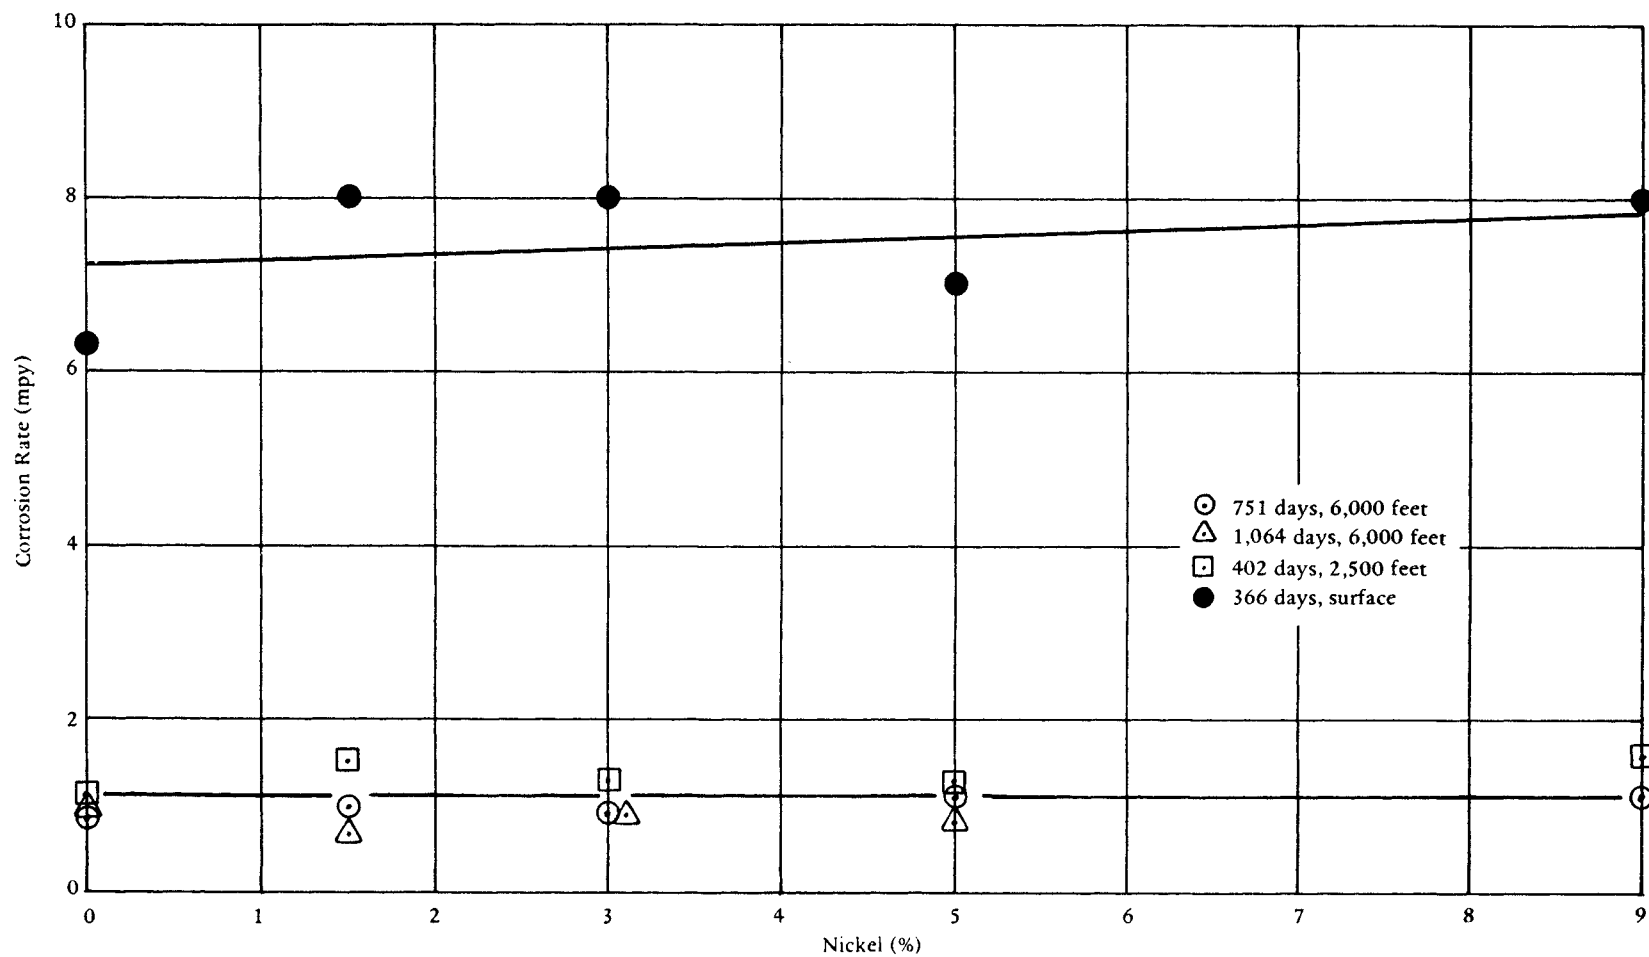
Figure 7. Effect of nickel on the corrosion of steel in seawater.

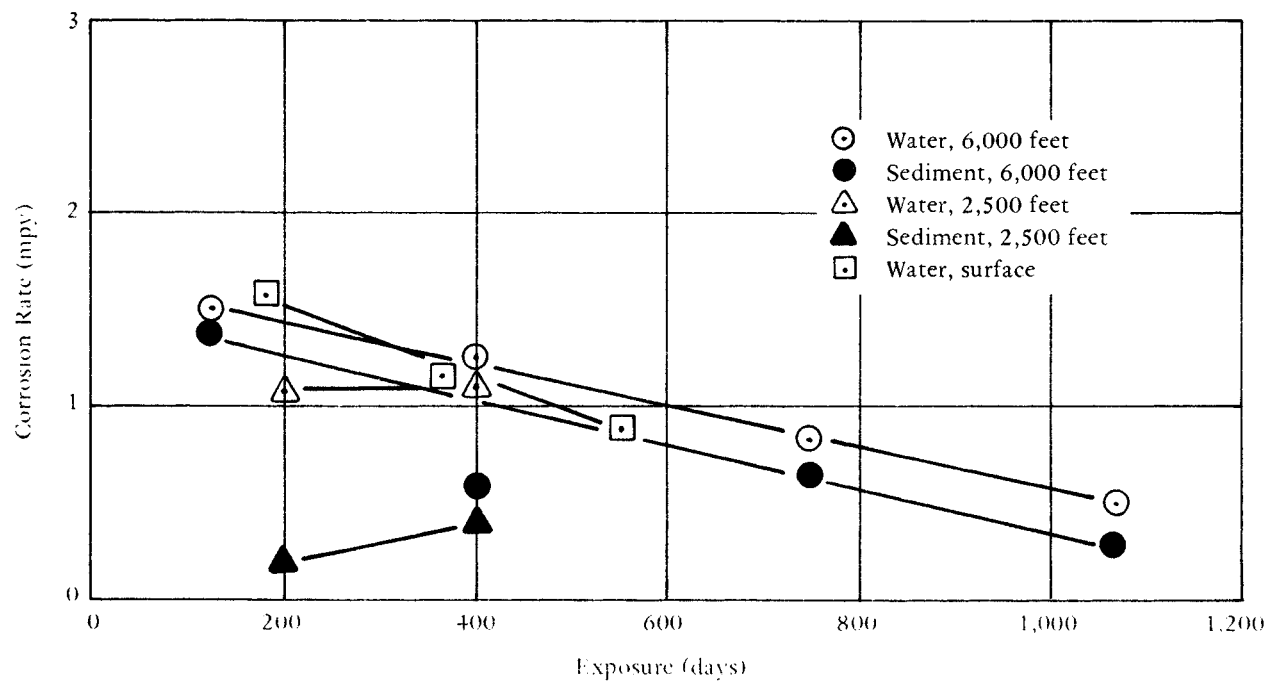
Figure 8. Effect of the duration of exposure on the corrosion of copper in seawater.

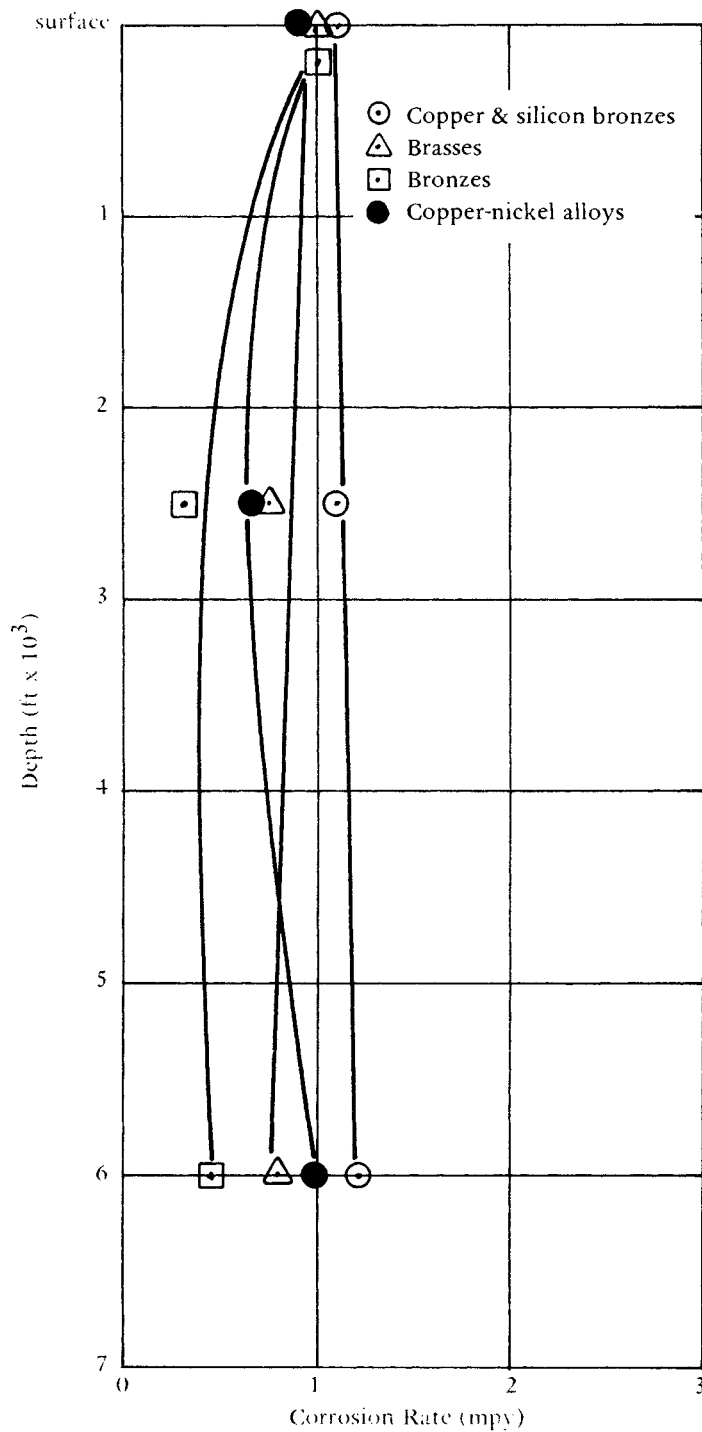
Figure 9. Effect of depth on the corrosion of copper alloys after 1 year of exposure in seawater.

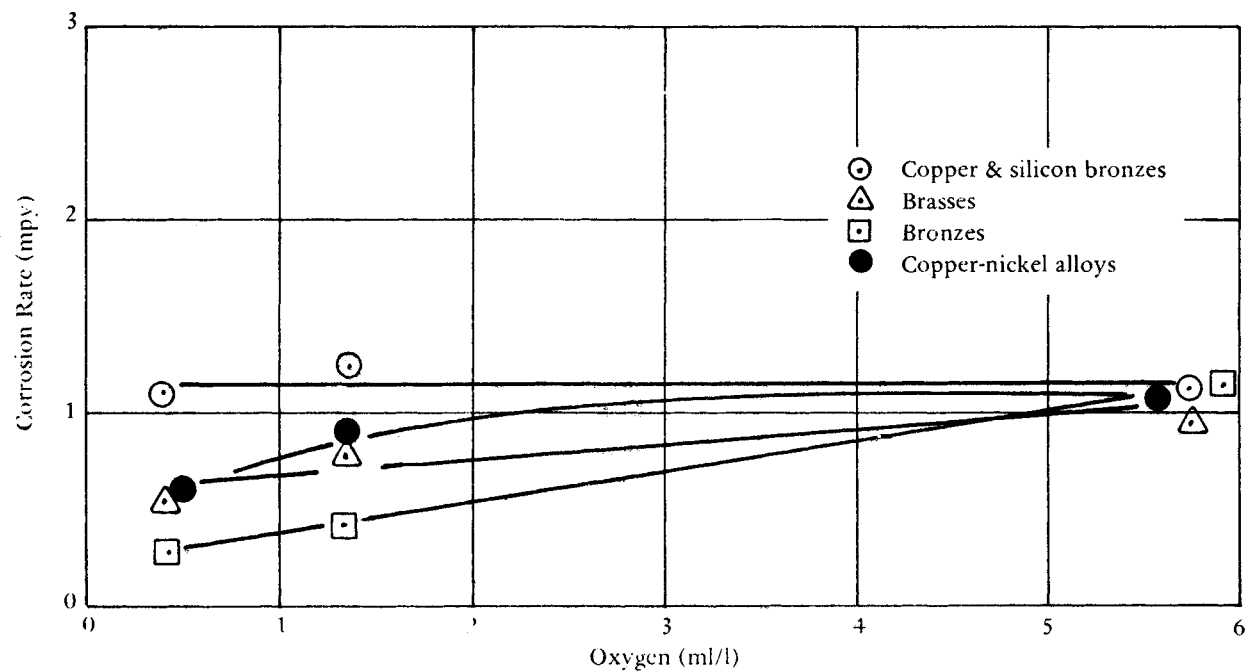
Figure 10. Effect of concentration of oxygen in seawater on the corrosion of copper alloys after 1 year of exposure.

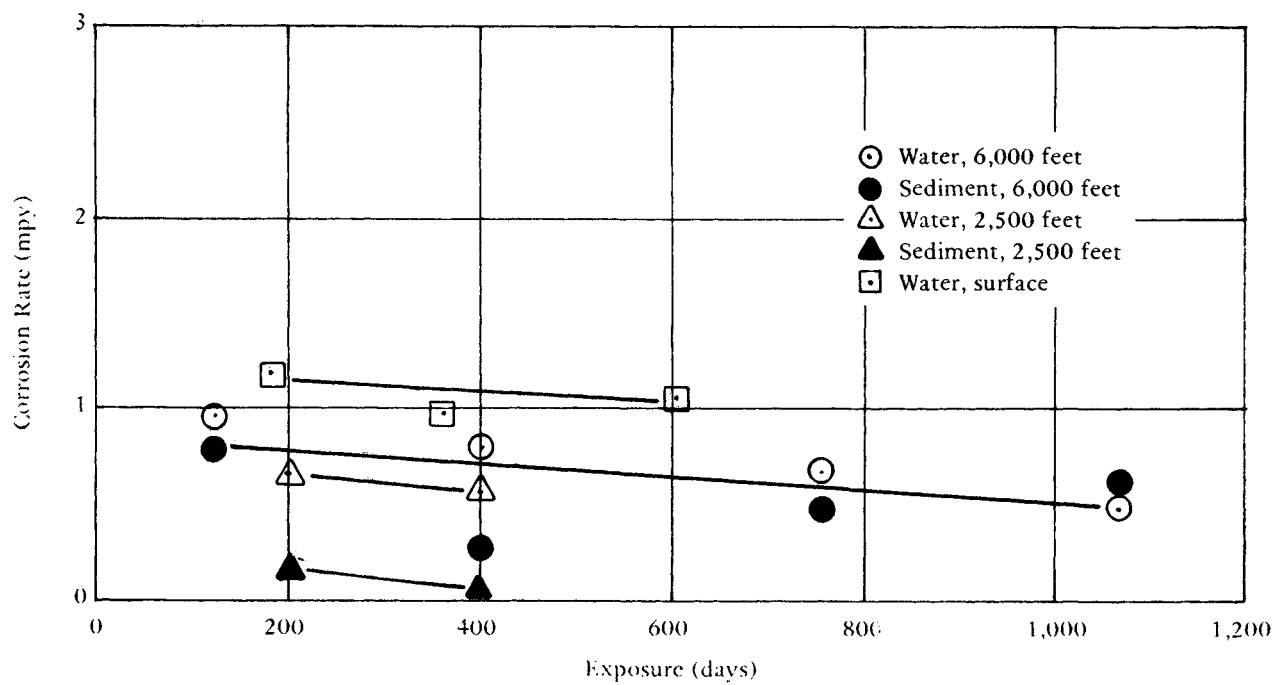
Figure 11. Effect of duration of exposure on the corrosion of brasses in seawater.

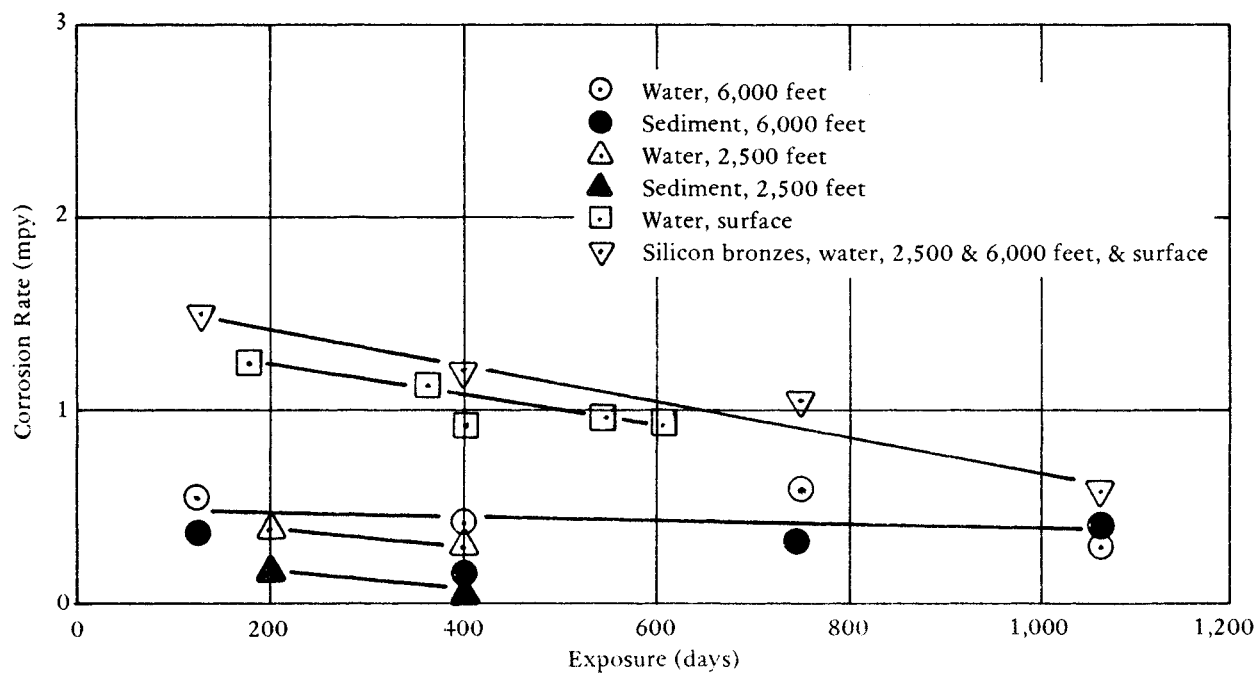
Figure 12. Effect of duration of exposure on the corrosion of bronzes in seawater.

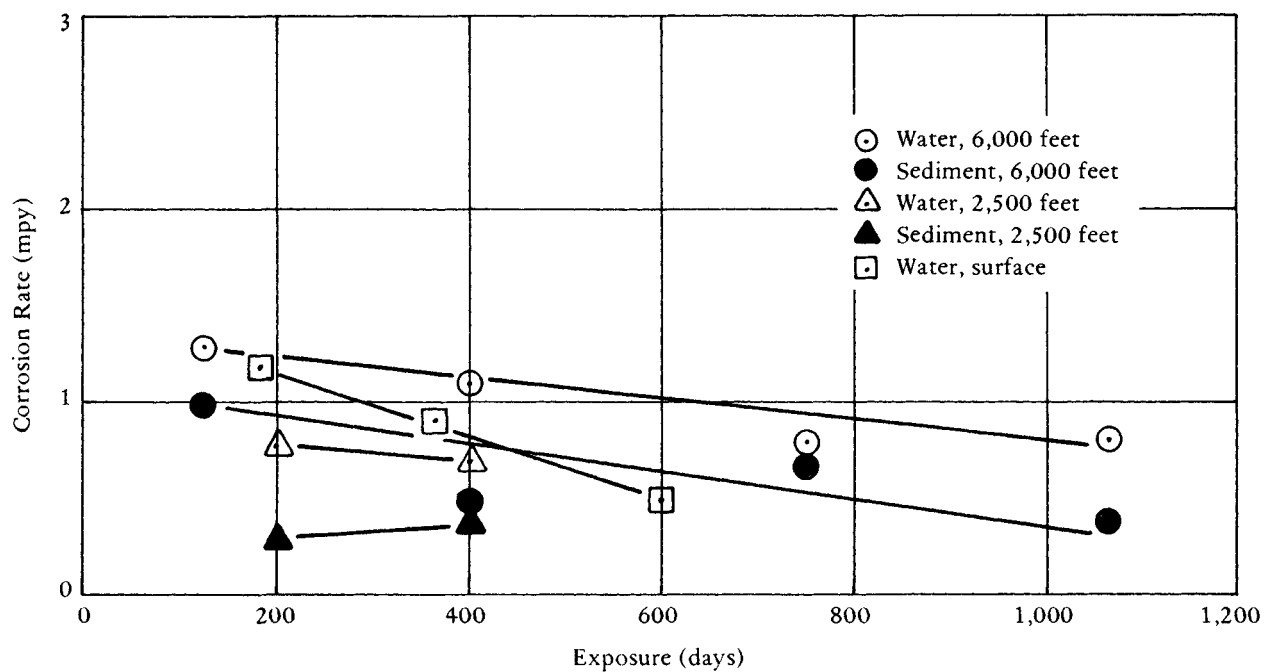
Figure 13. Effect of duration of exposure on the corrosion of copper-nickel alloys in seawater.

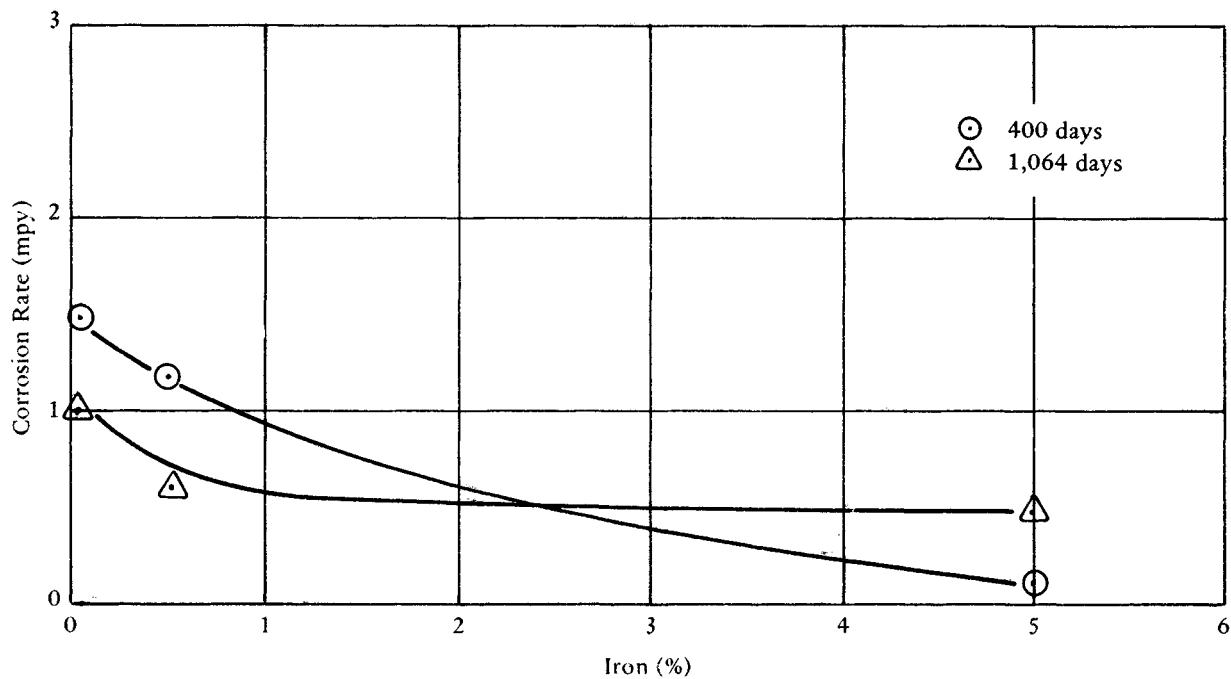
Figure 14. Effect of concentration of iron on the corrosion of the copper-nickel alloys in seawater at the 6,000-foot depth.

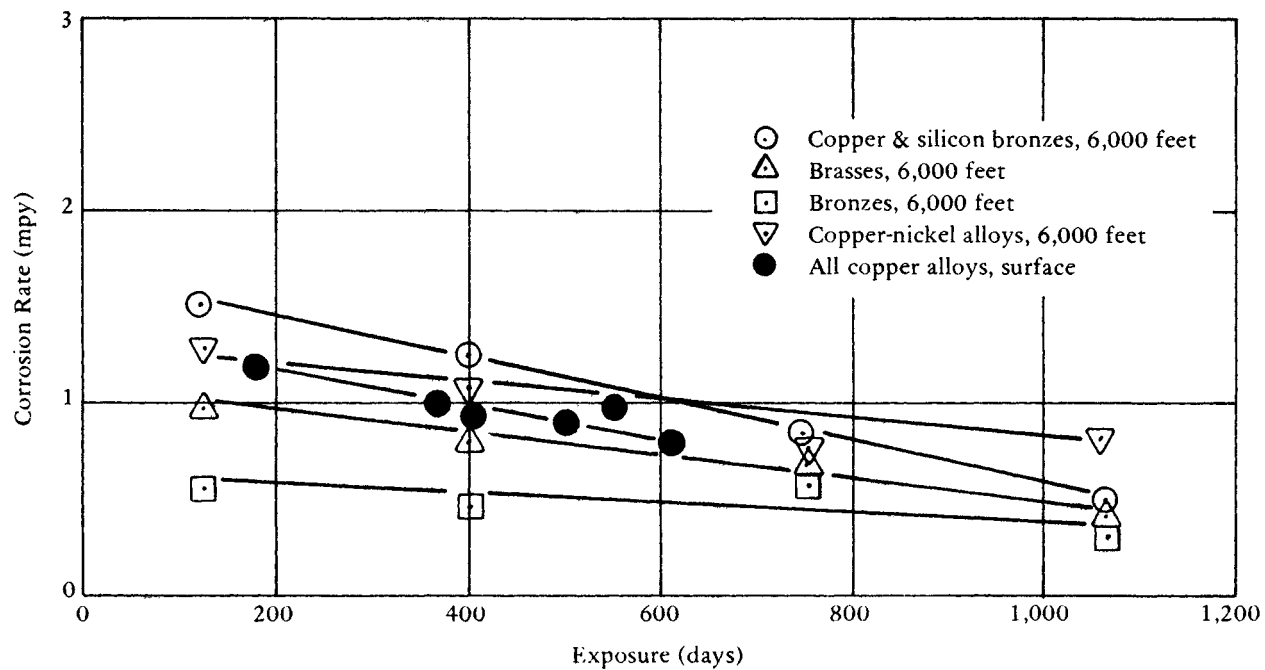
Figure 15. Effect of duration of exposure on the corrosion of copper alloys in seawater.

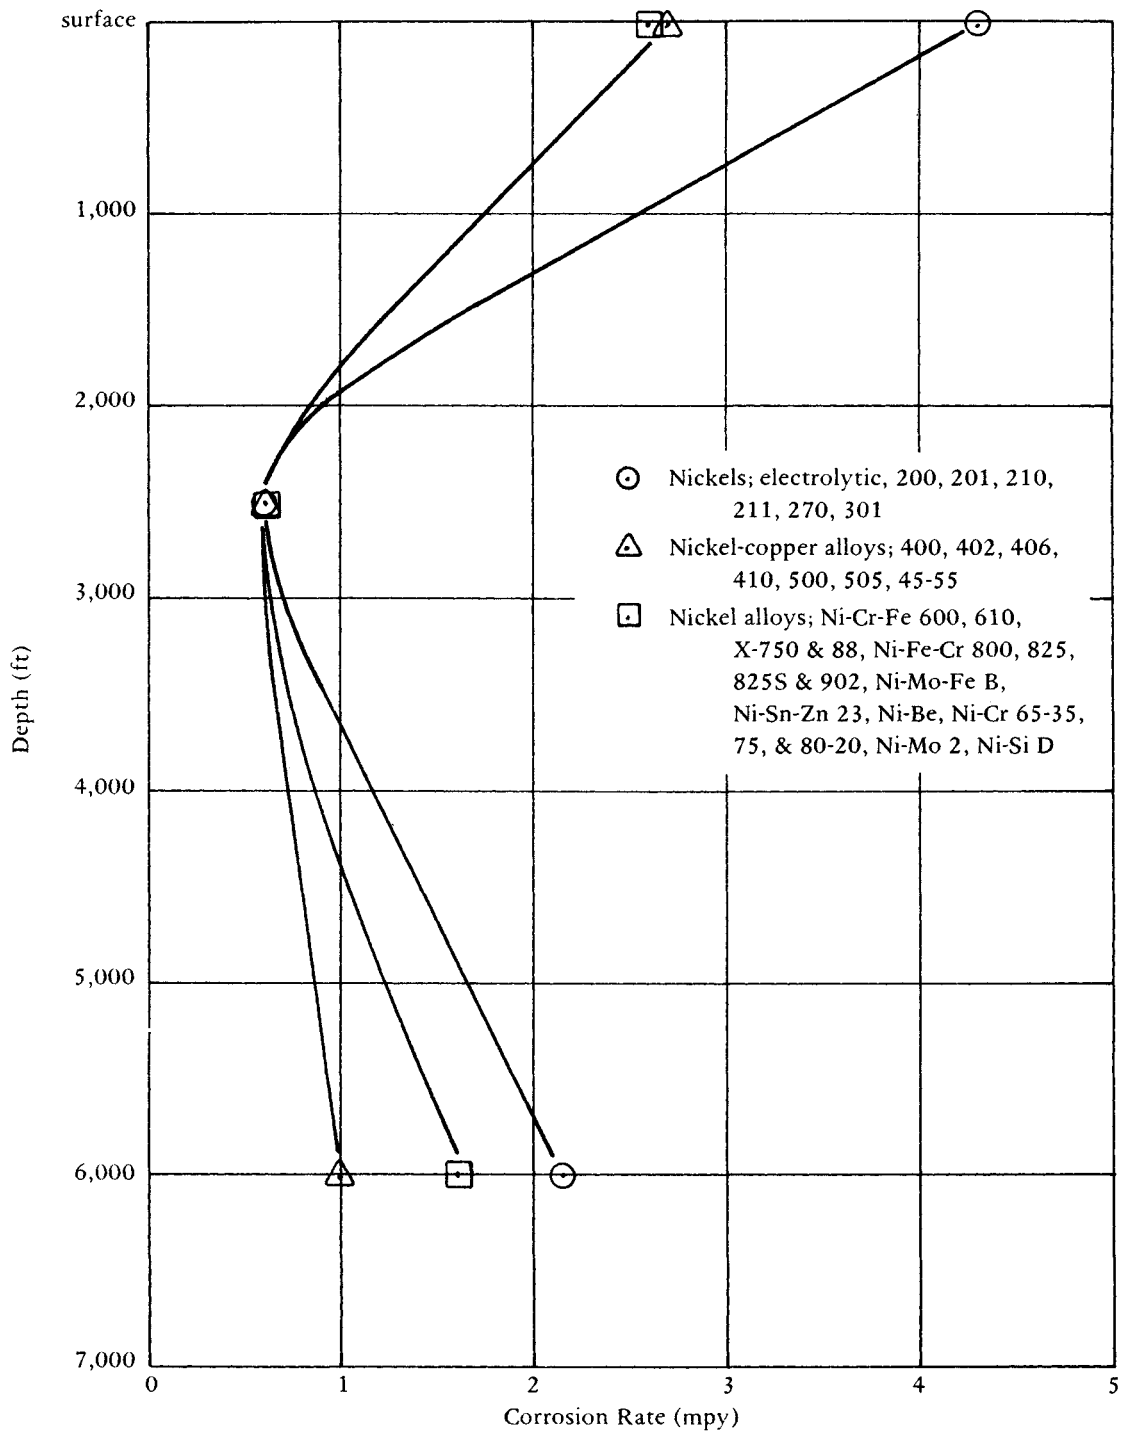
Figure 16. Effect of depth on the corrosion of nickel alloys after 1 year of exposure.

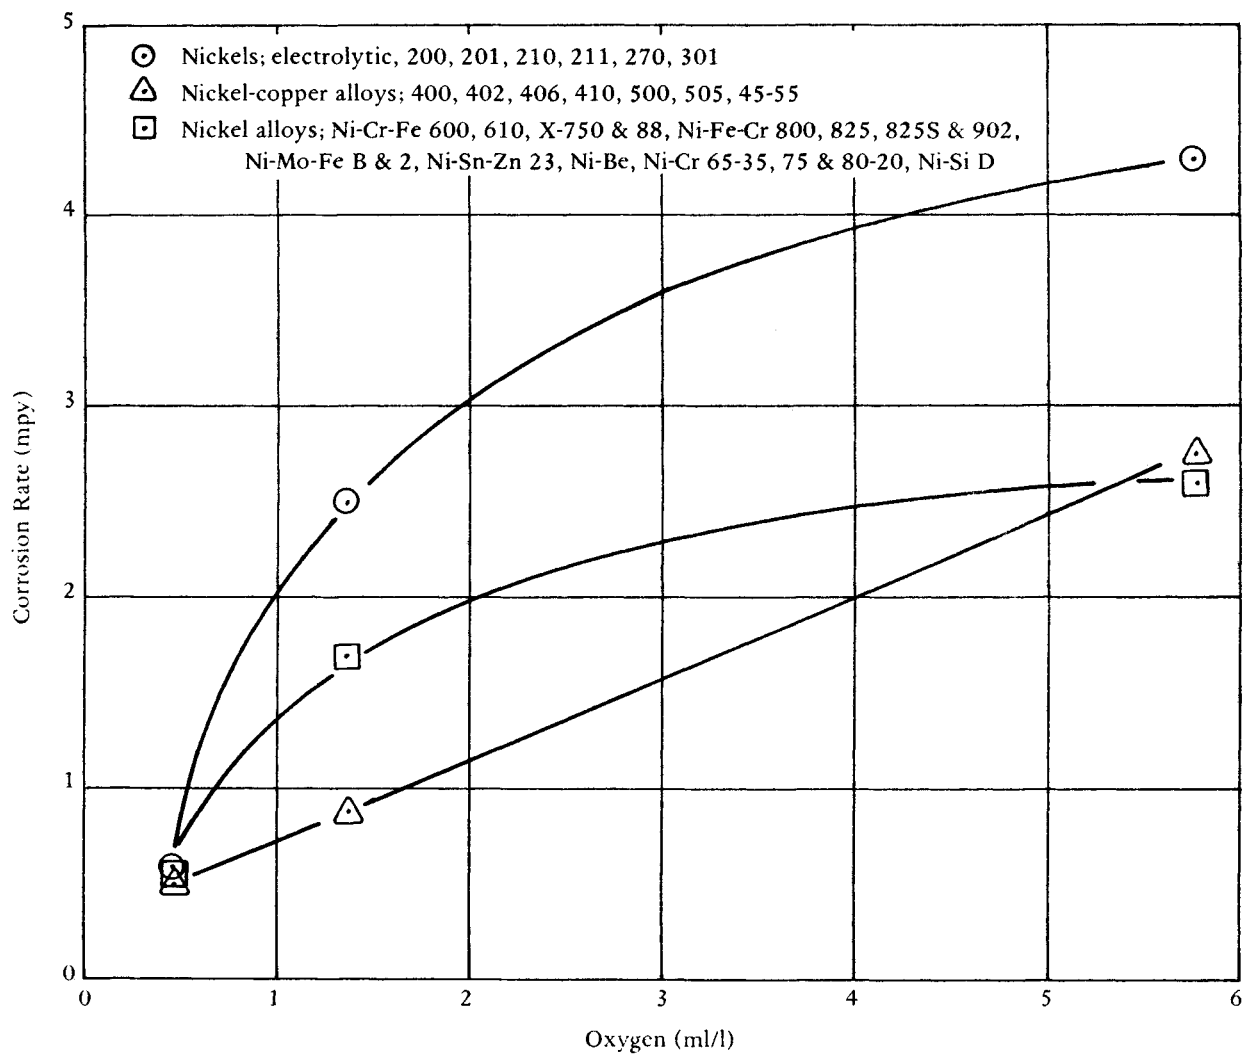
Figure 17. Effect of concentration of oxygen in seawater on the corrosion of nickel alloys after 1 year of exposure.

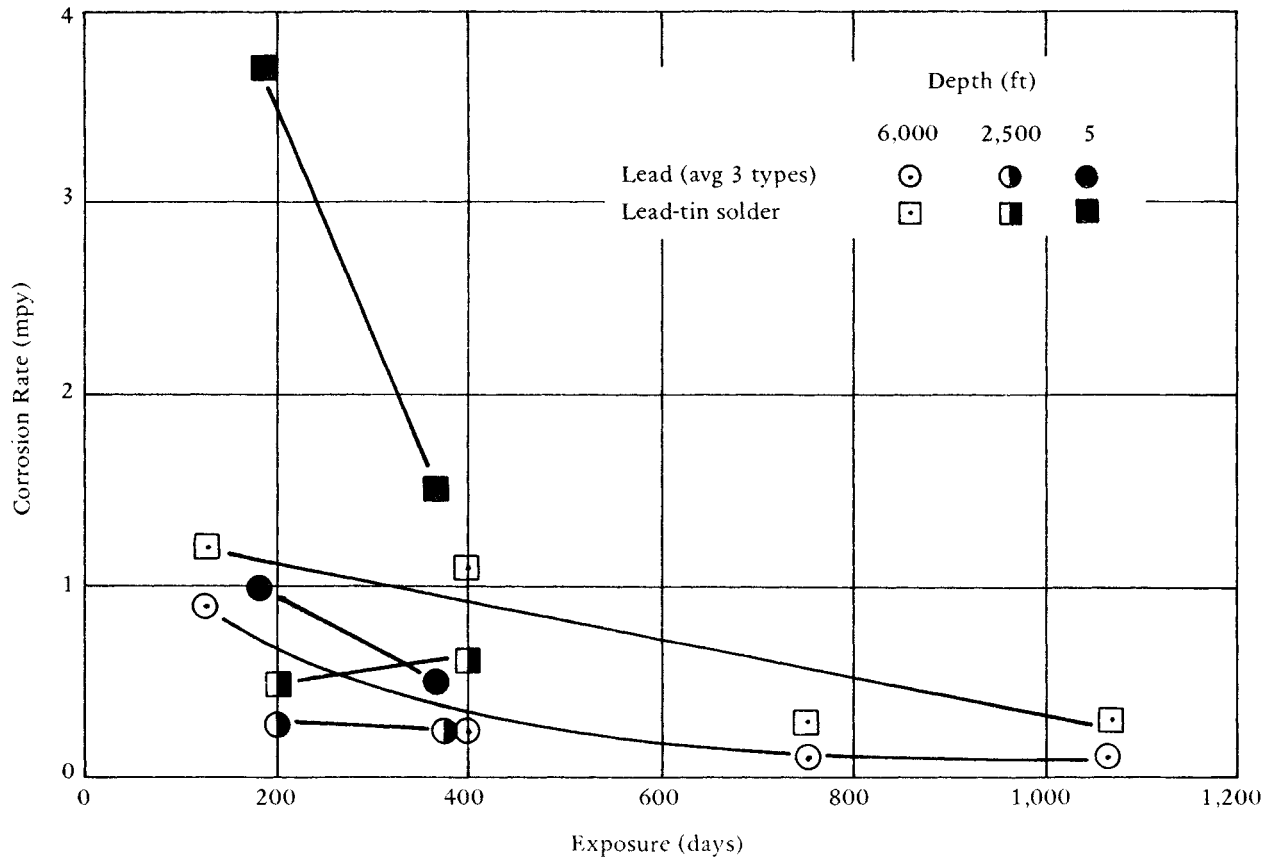
Figure 18. Effect of duration of exposure in seawater on the corrosion of lead and lead-tin solder at the surface and at depth.

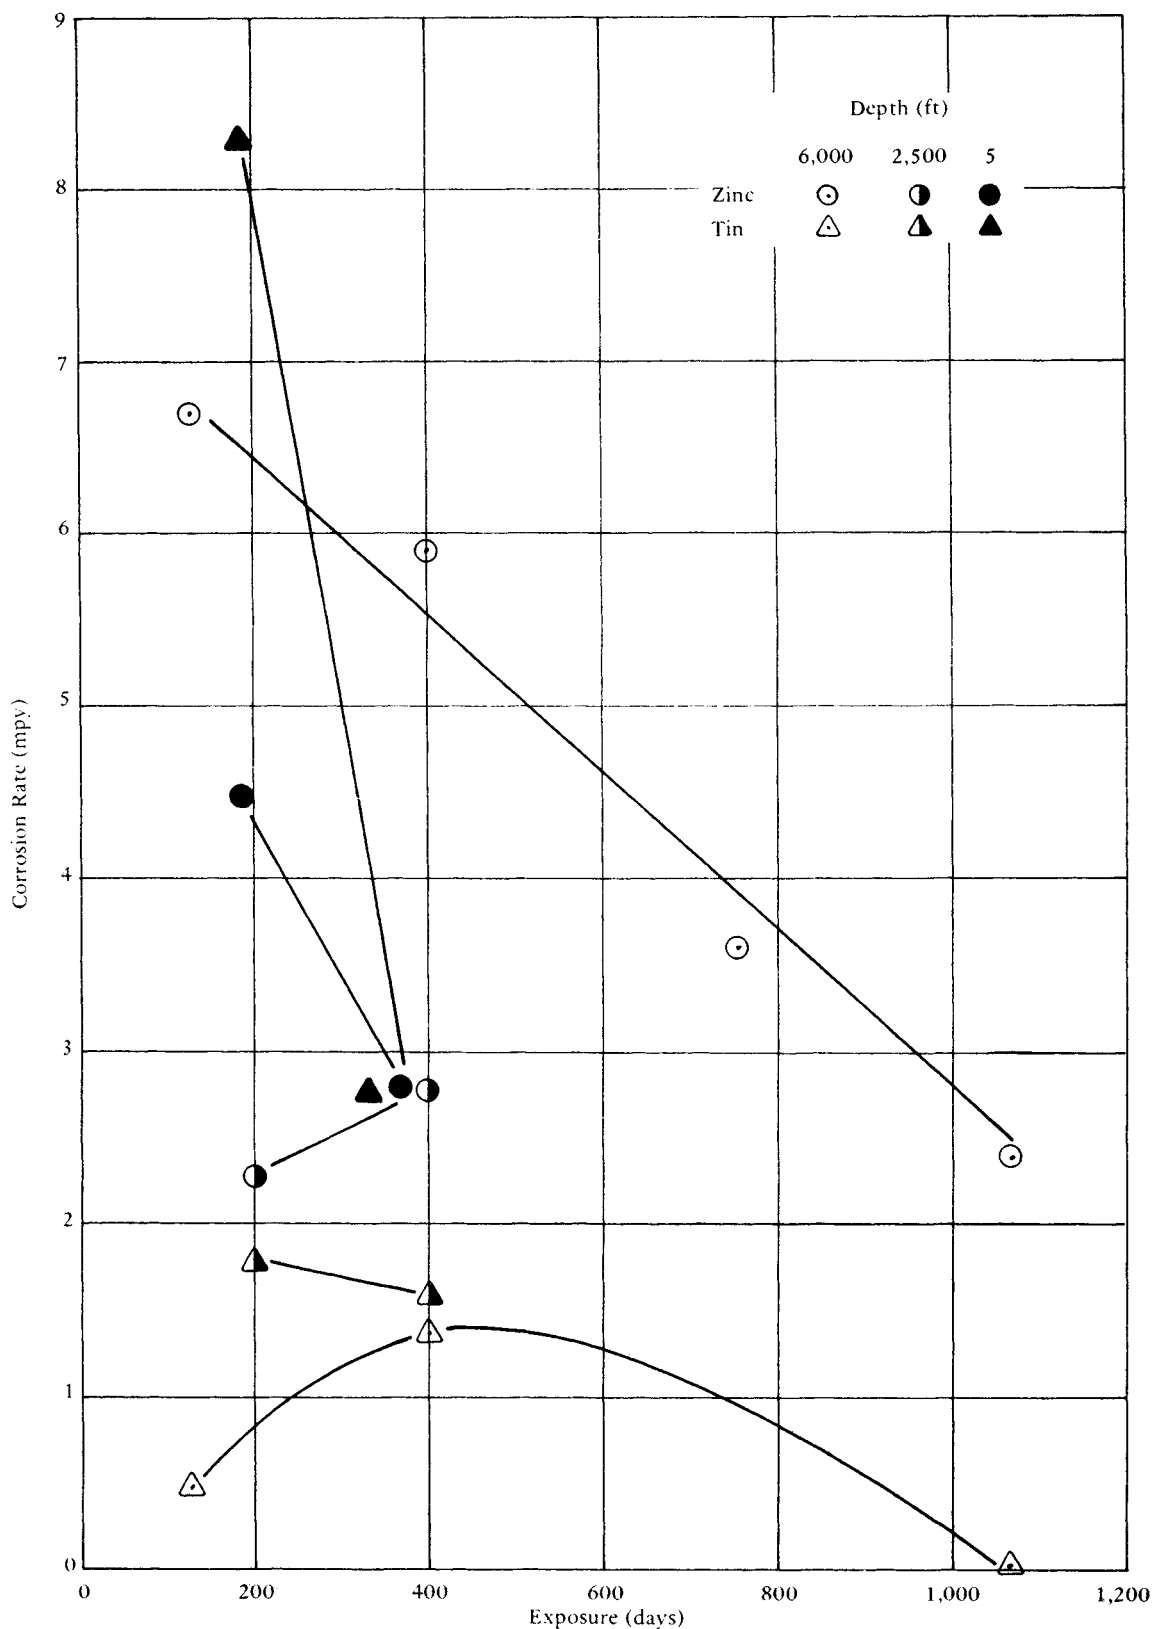
Figure 19. Effect of duration of exposure in seawater on the corrosion of tin and zinc at the surface and at depth.

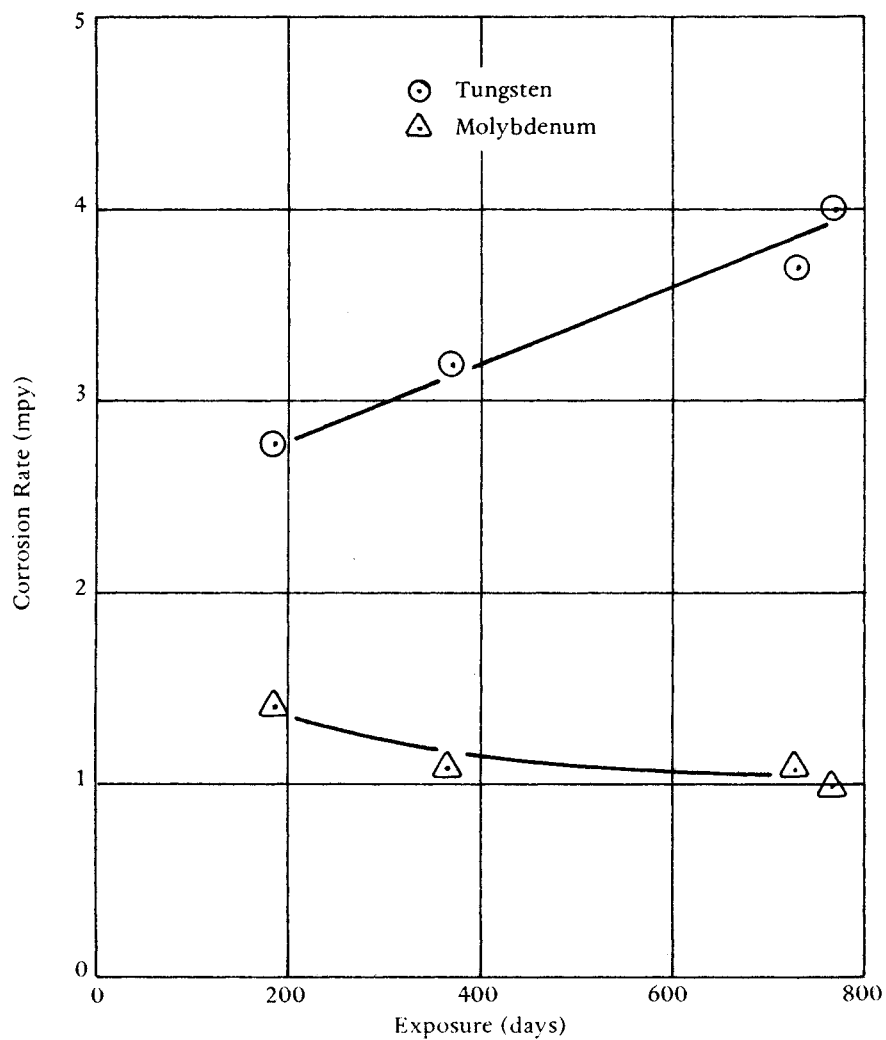
Figure 20. Effect of duration of exposure in surface seawater on the corrosion of molybdenum and tungsten.
