# Seawater Corrosion Handbook

Edited by M. Schumacher

NOYES DATA CORPORATION

1979

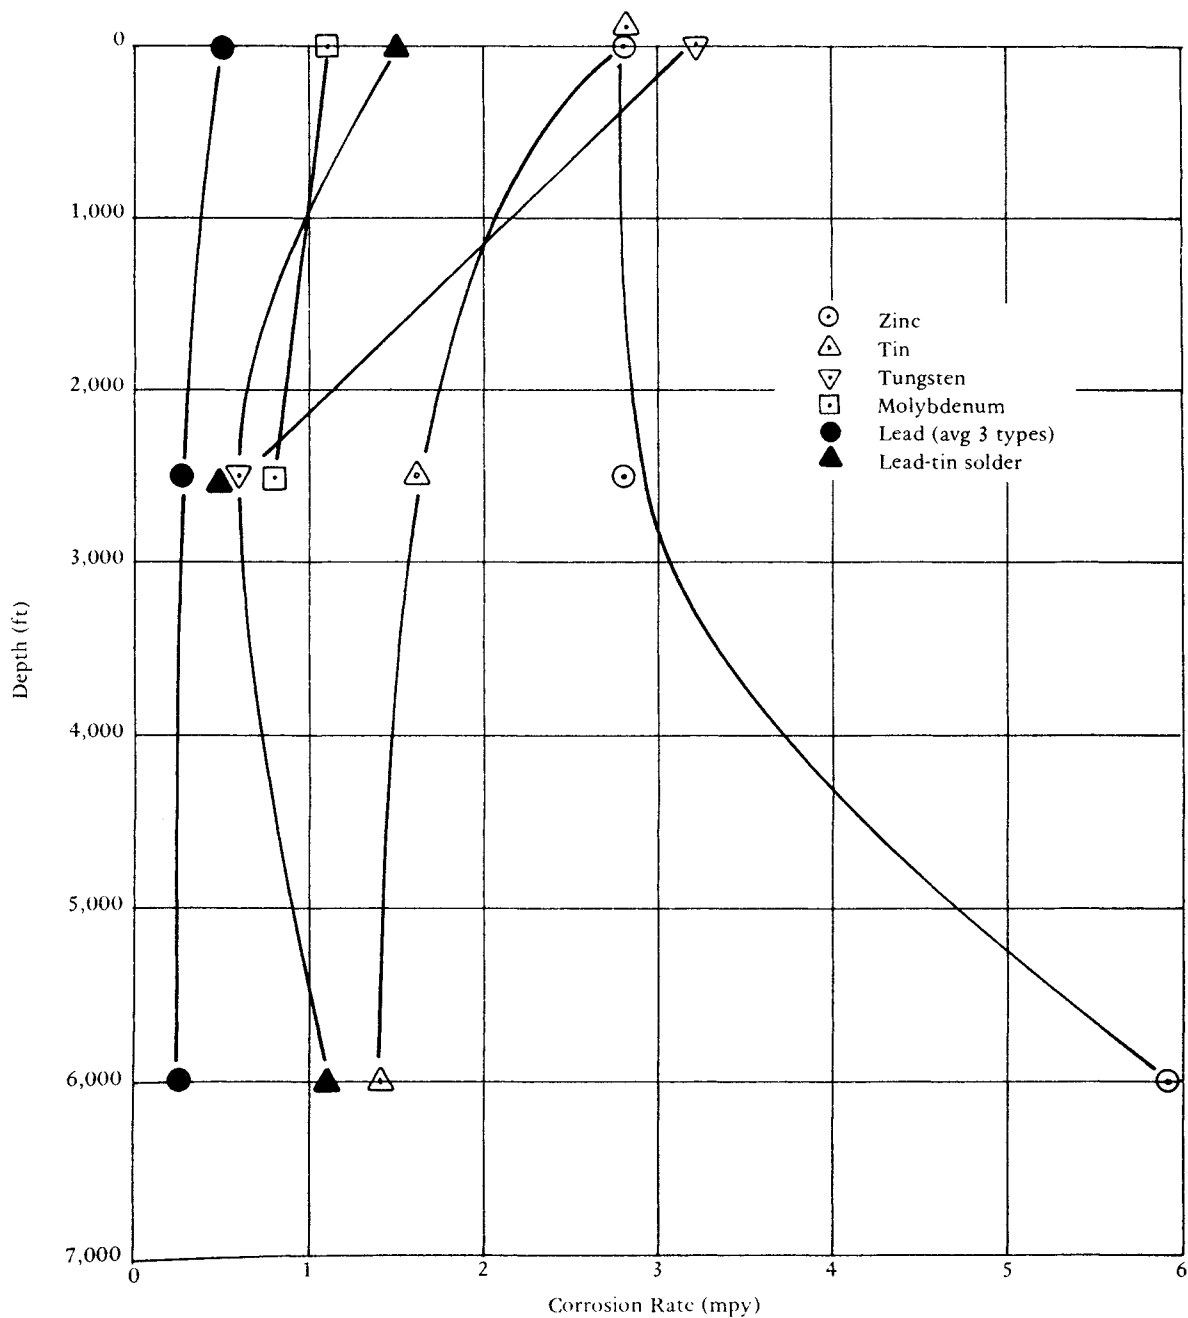
Figure 21. Effect of depth on the corrosion of miscellaneous alloys after 1 year of exposure.

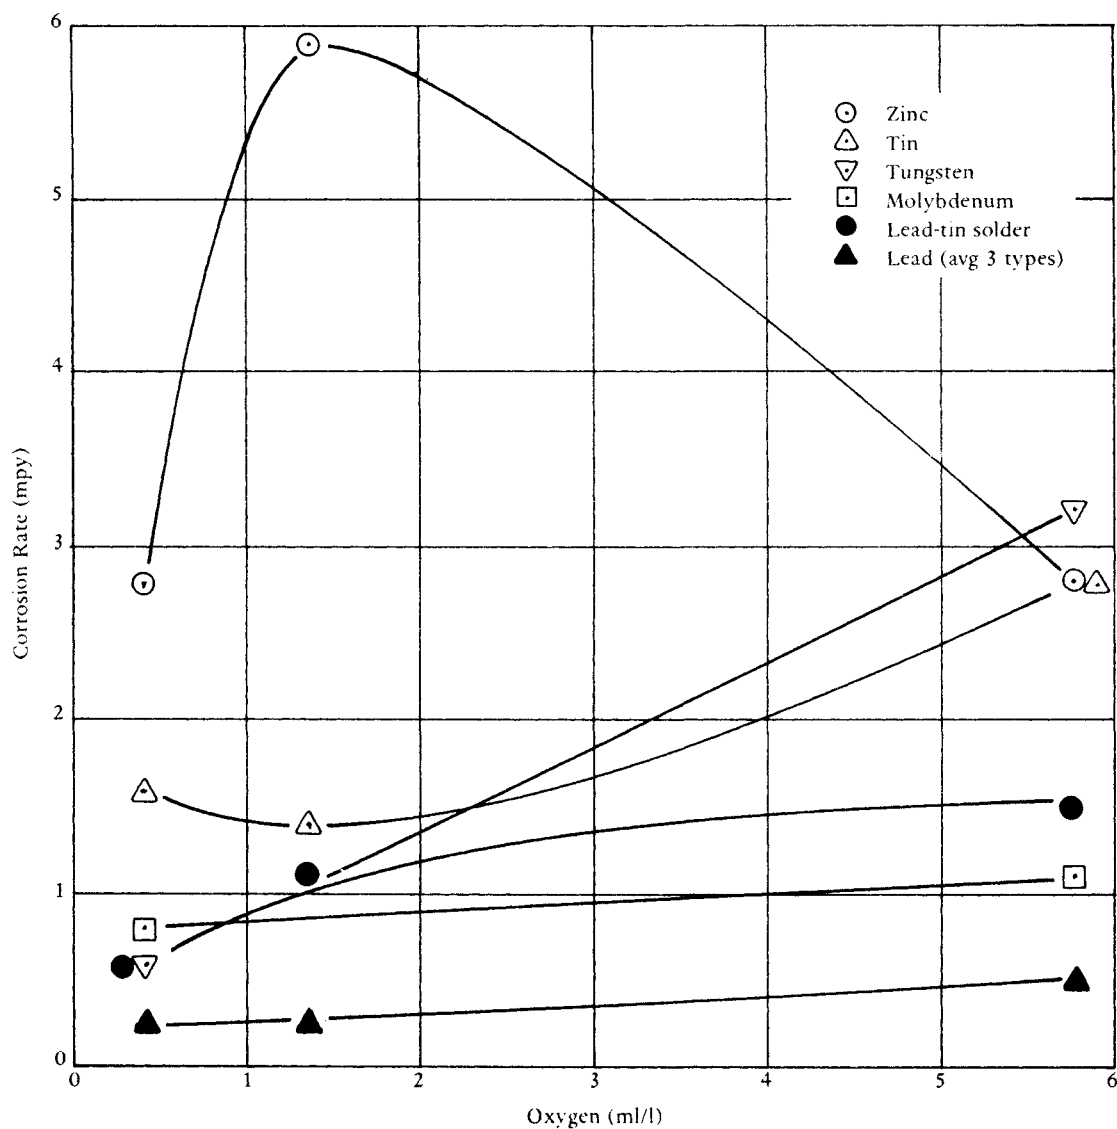
Figure 22. Effect of concentration of oxygen in seawater on the corrosion of miscellaneous alloys after 1 year of exposure.
