CORROSION FAILURES

**THEORY, CASE STUDIES,
AND SOLUTIONS**

K. ELAYAPERUMAL

V. S. RAJA

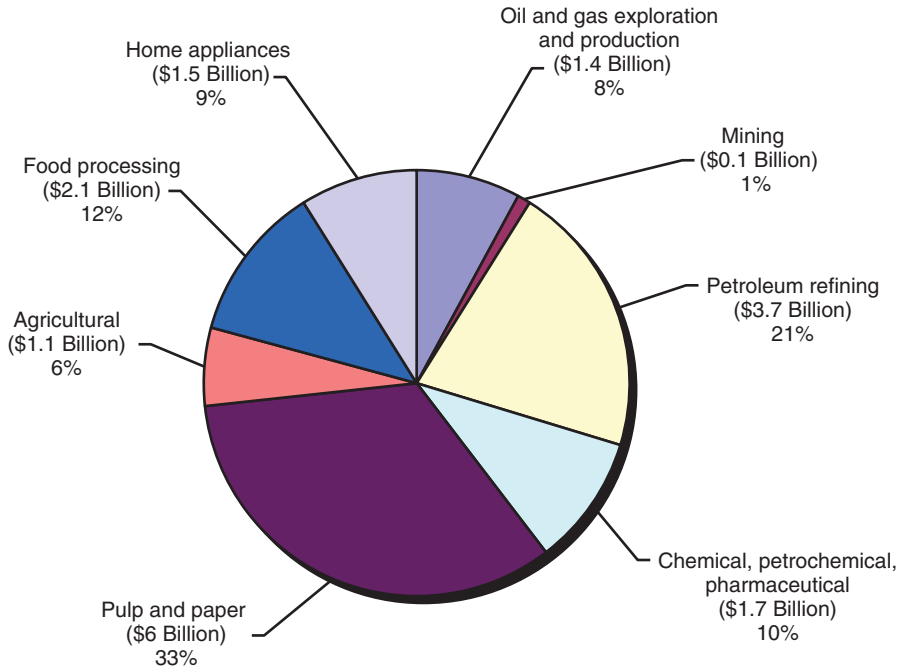
Figure 1.1 Annual cost of corrosion in the production and manufacturing category in US (\$17.6 Billion). Koch et al. (2002) (courtesy Federal Highway Administration, USA.)

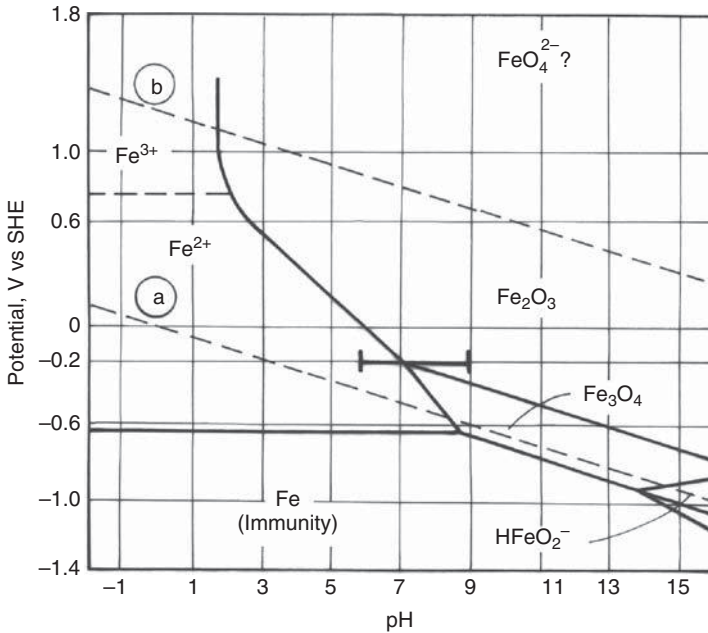
Figure 2.3 Potential-pH diagram (Pourbaix) for iron in water at 25 °C (77 °F). A decrease in pH from 9 to 6 at potential of -0.2 V, which shifts iron from a region of stability to one of active corrosion, is indicated by the solid bar (Pourbaix 1966) (Courtesy CEBELCOR).

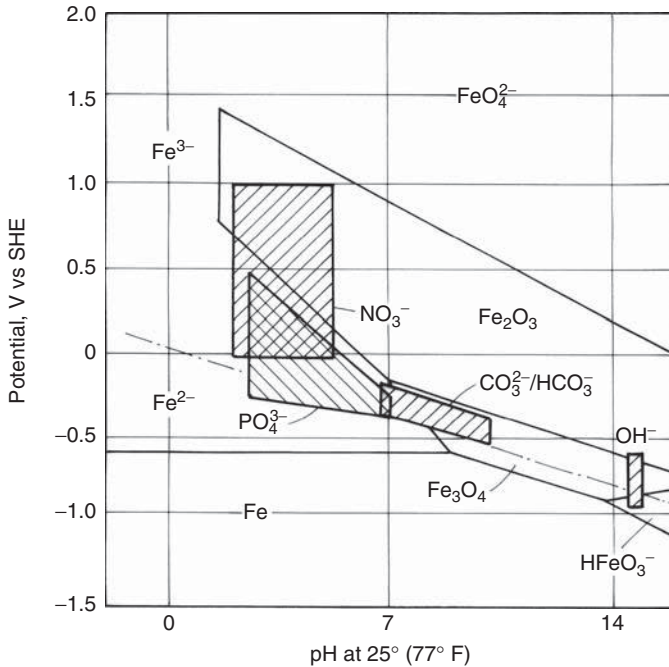
Figure 2.4 Relationship between pH-potential conditions for severe cracking susceptibility of carbon steel in various environments and the stability regions for solid and dissolved species on the Pourbaix diagram. Note that severe susceptibility is encountered where a protective film (phosphate, carbonate, magnetite, and so on) is thermodynamically stable, but if ruptured, a soluble species (Fe^{2+} , HFeO_3^-) is metastable (Jones 1987). (Reprinted with permission of ASM International. All rights reserved www.asminternational.org).

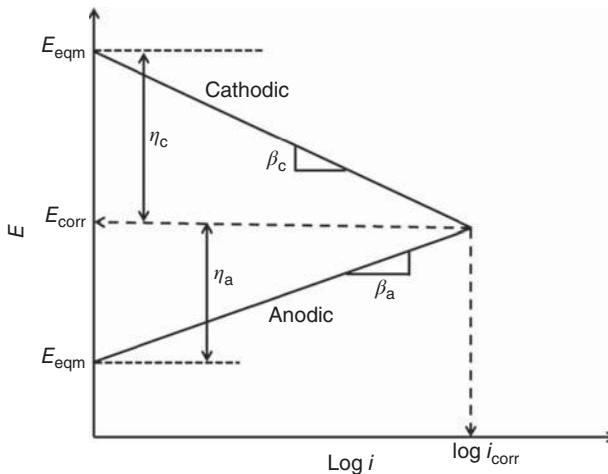
Figure 2.6 Evans diagram illustrates various kinetic parameters that control corrosion rates.

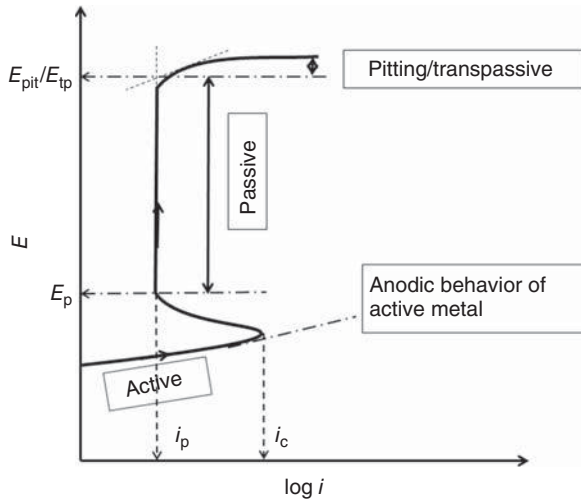
Figure 2.7 Schematic of anodic polarization of a metal exhibiting active-passive-transpassive (pitting) regions. See the text for the parameters shown in the diagram.

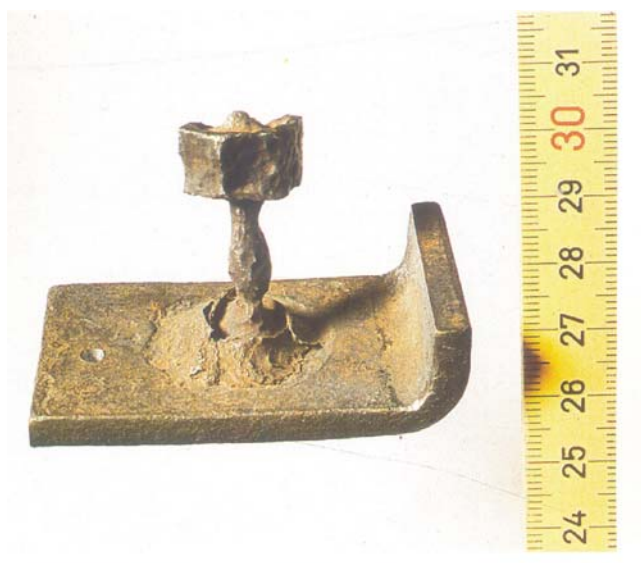
Figure 3.1 Galvanic corrosion attack of carbon steel bolt in contact with 12% Cr steel (AISI 410) stainless steel plate in hydrocarbons contaminated with traces of salts. This is ray lamp of a distillation column. (Source: During (1988). Reproduced with permission of Elsevier.).

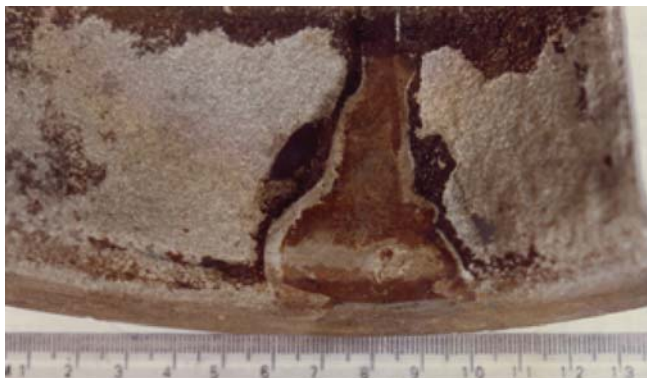
Figure 3.2 Severe microgalvanic attack on smaller areas of the weld seam (type 304L SS) by large areas of the parent metal (super austenitic stainless steel) in an organic solvent containing sulfuric acid as a carrier medium. (Courtesy: Elayaperumal, in “Corrosion Failures in Process Industries in India: Statistical Analysis and Case Studies” in Special Supplement 2009, Corrosion Reviews Special Issue: India, England: Freund Publications, 2009, p 57, case study 8.)

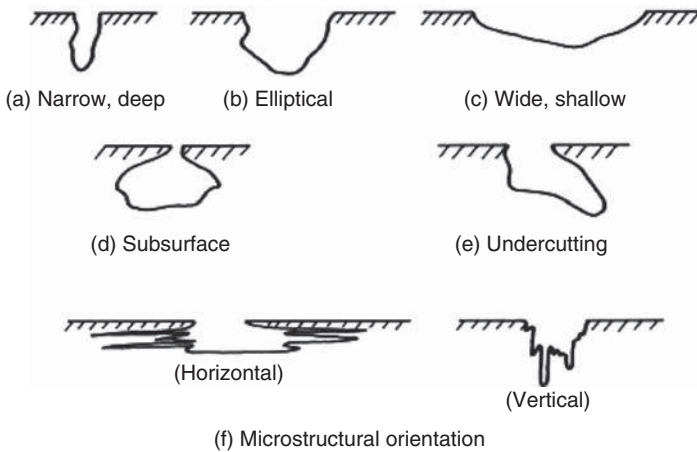
Figure 3.4 Possible variations in the pit morphology, seen through sample cross-section, are shown. (Reprinted with permission from ASTM G46. Copyright ASTM International, 100 Barr Harbor Drive, West Conshohocken, PA 19428.)

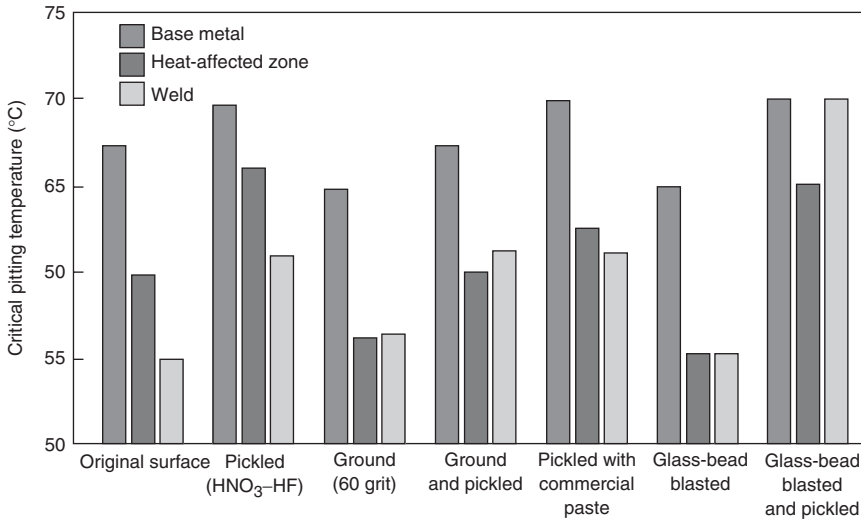
Figure 3.5 Role of the surface condition on pitting is exemplified in this diagram. Pickling of stainless steel increases the critical pitting temperature in FeCl₃ in the base metal, heat-affected zone, and welds areas. Mechanical cleaning treatments that are performed without a subsequent pickling treatment decrease the critical pitting temperature. (Reprinted with permission of ASM International. All rights reserved www.asminternational.org.)

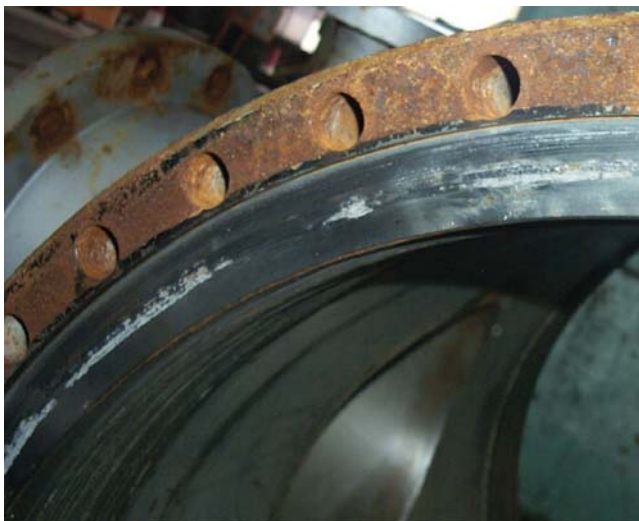
Figure 3.6 Photograph of a part of heat-exchanger sheet affected by crevice corrosion. The carbon steel shell was weld-cladded with SAF 2507 alloy. Note, only the gasket area of the shell suffered from attack; shell side was exposed to seawater. (Source: Raja (2008). Reproduced with permission of Narosa Publishing House.)

1. Occurs only when a metal passivates (note: this depends on alloy as well as the environment)
2. Crevice deposits must exhibit restricted flow of the electrolyte (If crevice gap is enhanced differential aeration does not occur and crevice corrosion will not be initiated)
3. The growth of crevice causes a drop in pH and a rise in chloride level and so the growth becomes autocatalytic. That means, crevice once stabilized will continue to grow even if the differential aeration ceases to operate
4. Crevice corrosion is more severe than pitting corrosion. A typical crevice attack under a gasket is shown in Figure 3.6. It is clear that the attack occurred at the metal-gasket interface.

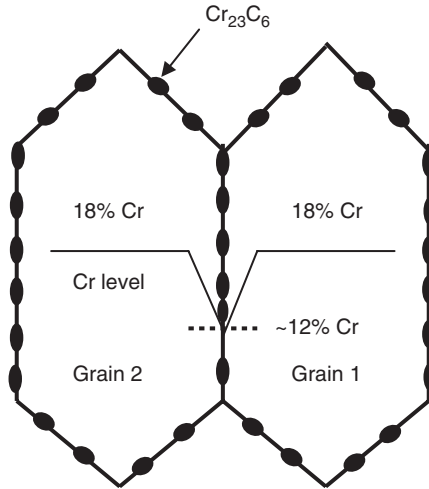
Figure 3.7 Schematic diagram showing Cr_{23}C_6 precipitations and chromium depletion at grain boundaries.

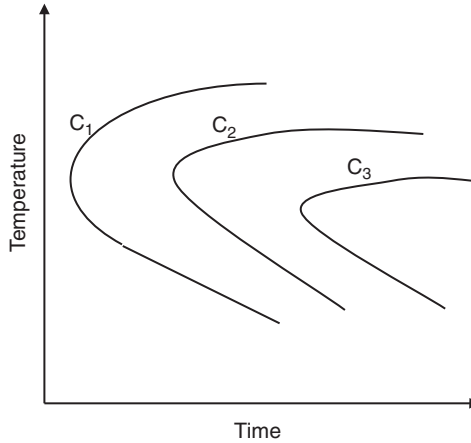
Figure 3.9 Schematic of Time–temperature–sensitization diagram showing shift in the nose of the curves towards right with decreasing carbon content. The carbon content decreases in the order $C_1 > C_2 > C_3$.

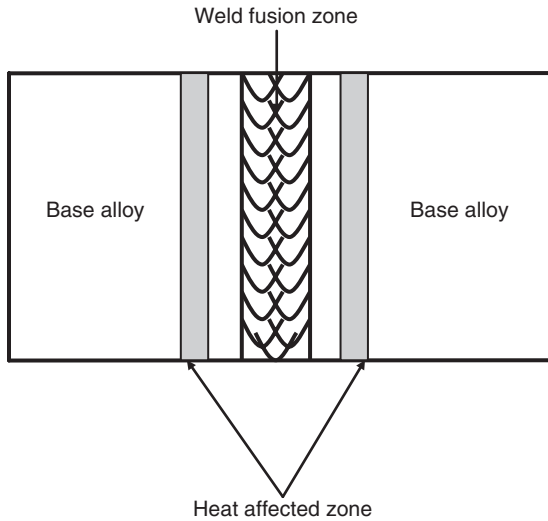
Figure 3.10 Schematic of weldment showing weld-fusion zone, heat-affected zone, and base alloy. The long strip region of the base alloy located away on both the sides of the weld fusion zone, as well as lying parallel to it, suffers IGC.

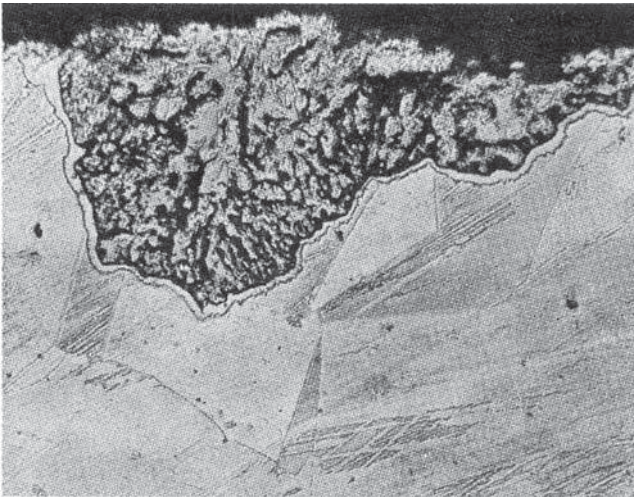
Figure 3.11 Etched cross-section through dezincification plug (Source: Verink and Heidersbach (1972). Reprinted with permission from STP 516- Localised Corrosion- Cause for Metal Failure Copyright ASTM International.).

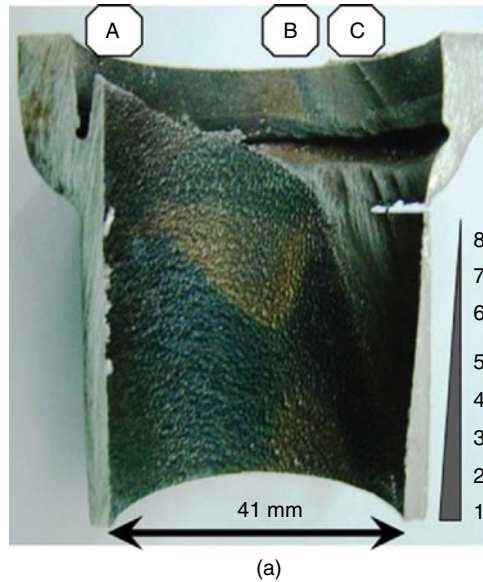
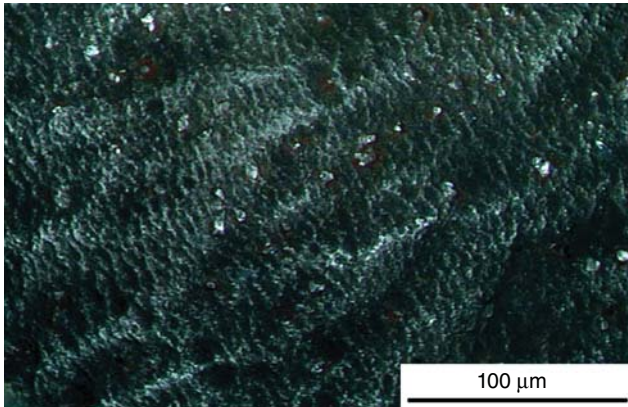
Figure 3.13 (a) Heavy thickness reduction near the socket weld (at location 8) and lower thickness reduction as seen at a distance 40 mm away from the socket weld (location 1) due to flow-induced corrosion is shown. (b) Characteristic features (Tiger Strips) of flow-induced corrosion seen at high magnification is shown (Source: Kain et al.(2011). Reprinted with permission from Elsevier.).

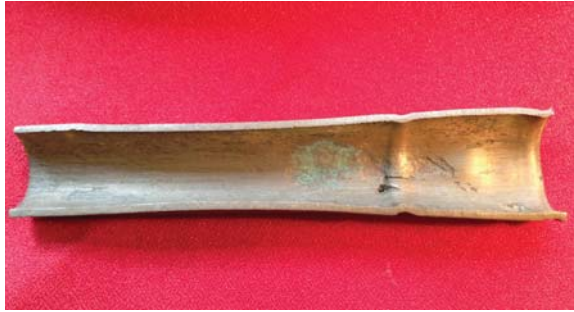
Inlet-end corrosion and impingement attack are two variations of erosion corrosion, which are location-specific and are widely reported. Inlet-end erosion usually observed at the inlet ends of condenser and heat exchanger tubes is a typical example of the turbulence effect (Figure 3.14a). Similarly, “impingement” attack occurs when fluid strikes metal surface head-on, like shell side fluid striking the tube outside surfaces in a shell and tube heat exchanger.

Figure 3.14 (a) 90Cu10Ni heat exchanger tube using seawater leaked within four months of operation due to erosion corrosion (b) Type 316 SS agitator blades of a reactor employing sulfonic acid rotating at a tangential velocity of 8.54 m/s failed within a few months.

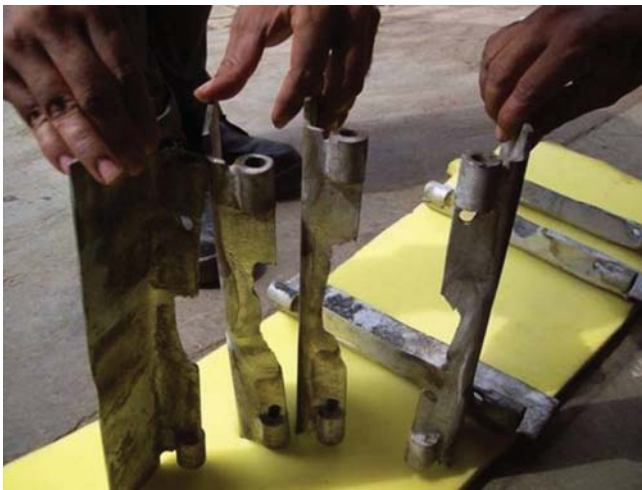
(b)

1. Pipelines, particularly bends, elbows, and tees, heat exchanger tubes particularly the inlet positions, reaction vessels, distillation columns, pump casings, valve bodies and stems, etc. where the metal (the equipment) is static and the fluid moves
2. Pump impellers, blowers. Propellers, centrifuges, reaction vessel agitators (Figure 3.14b), etc. where the metal also moves

3.8.2.2 Characteristics of Erosion Corrosion Attack This phenomenon is characterized by the appearance of grooves, waves, and valleys (Figure 3.14) that have a directional pattern along the flow direction of the corroding fluid.

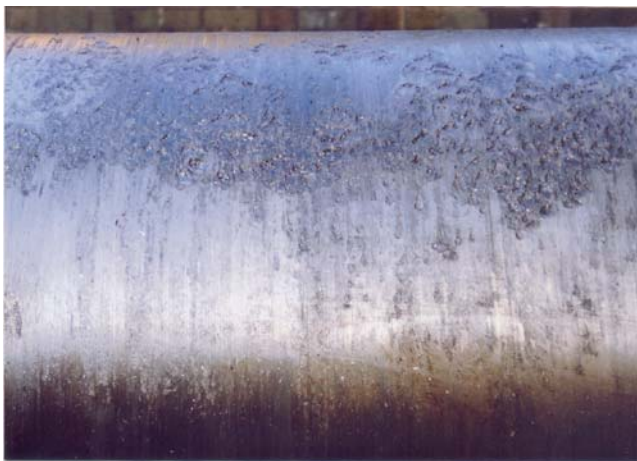
Figure 3.15 Cavitation damage appearing as bright pits on a damaged propeller shaft of a ship. The alloy is beta brass.

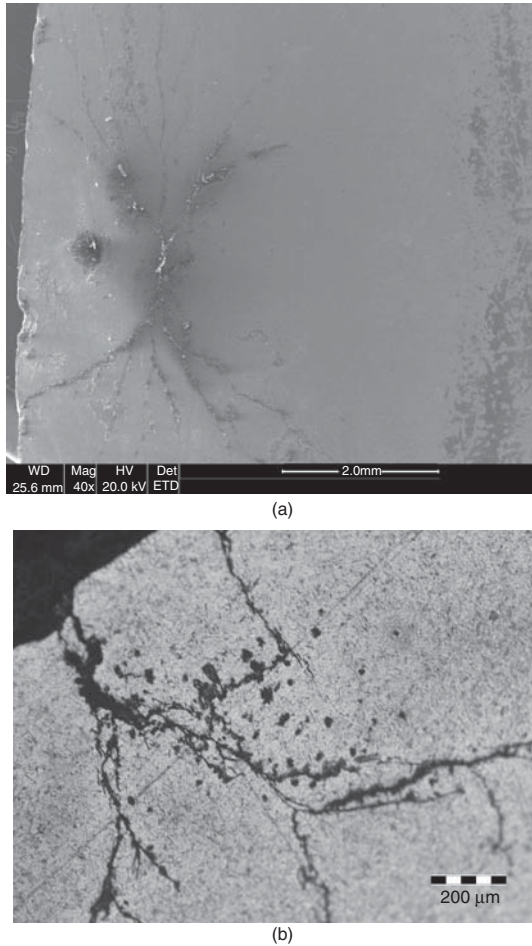
Figure 3.16 (a) Stress corrosion cracks of type 304 L SS tube of a high-pressure heater of a boiler of a thermal power plant. The cracking occurred under a deposit. Note the SS tube was free from any corrosion except on the cracked region. (b) The cross-sectional image of the cracked area of the tube showed branching cracks, typical of stress corrosion cracking. (Source: Raja (2008). Reproduced with permission of Narosa Publishing House.).

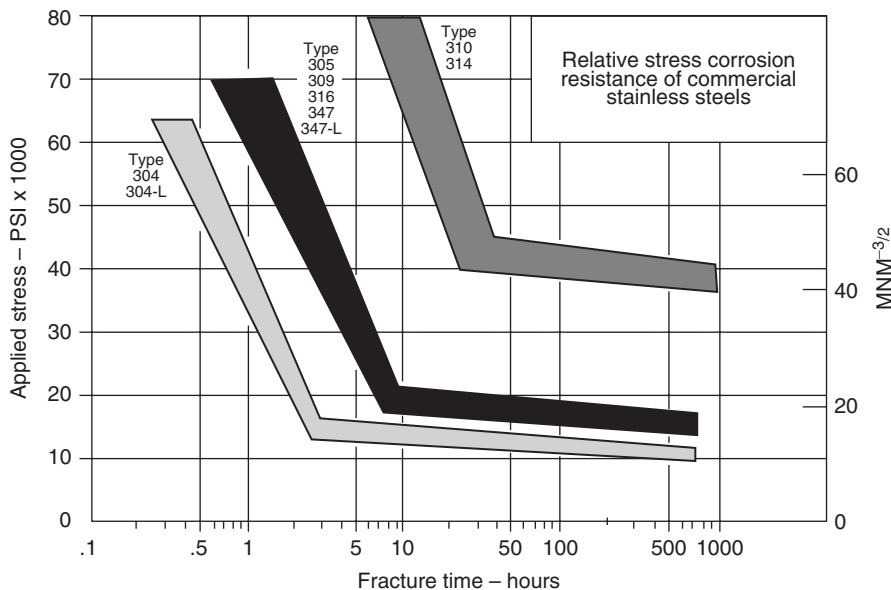
Figure 3.18 Composite curves illustrating the relative stress corrosion cracking resistance for commercial stainless steels in boiling magnesium chloride. (© NACE International 1960.)

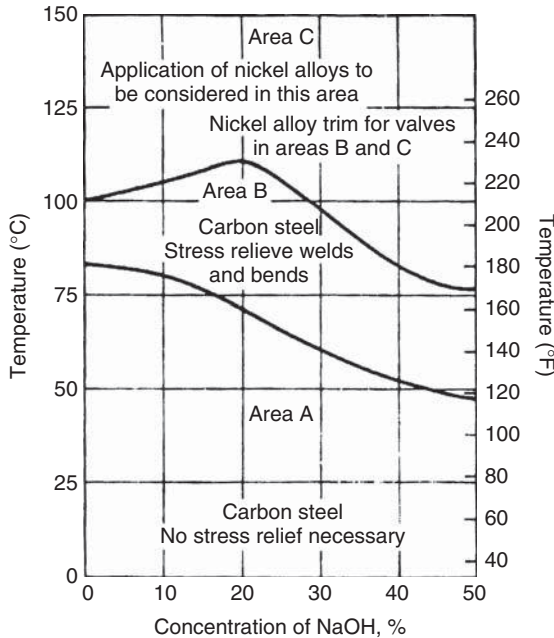
Figure 3.19 Carbon steels: Temperature and concentration limits for stress-corrosion cracking in NaOH. (© NACE International 1974.)

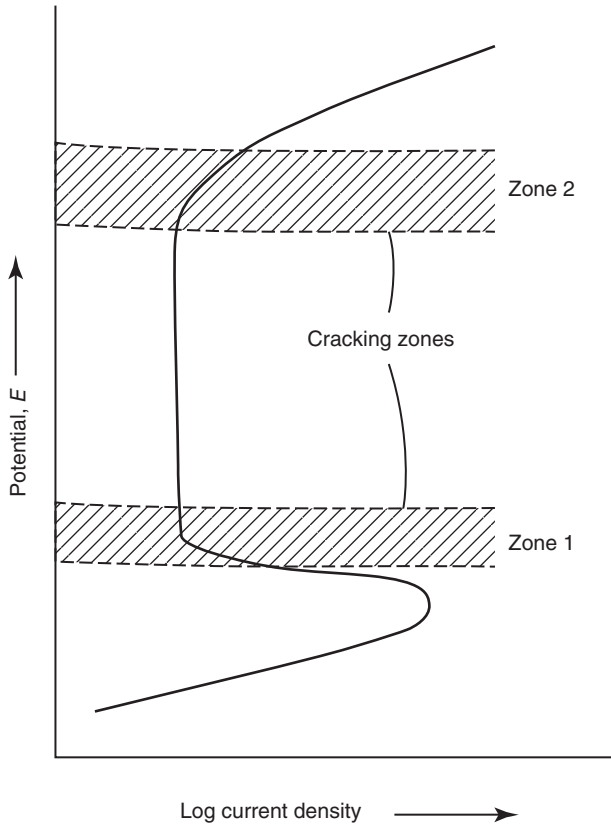
Figure 3.20 Stress corrosion cracking susceptible areas with respect to anodic polarization curve exhibiting active-passive-transpassive transition.

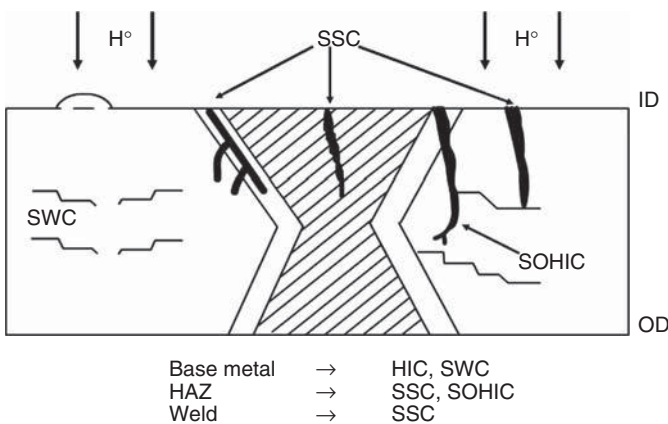
Figure 3.21 Forms of hydrogen damage in H_2S service. See the text for the explanations of the abbreviations. (Source: Elboujdaini (2011). Reprinted with permission from John Wiley & Sons, Inc.)

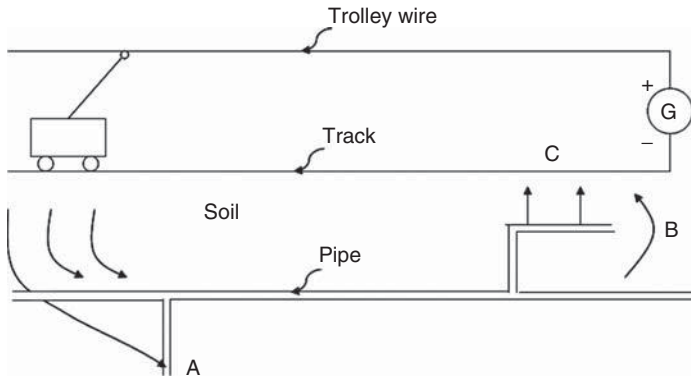
Figure 3.24 Stray-current corrosion of buried pipe (Source: Revie W and Uhlig (2008). Reprinted with permission of Wiley.).

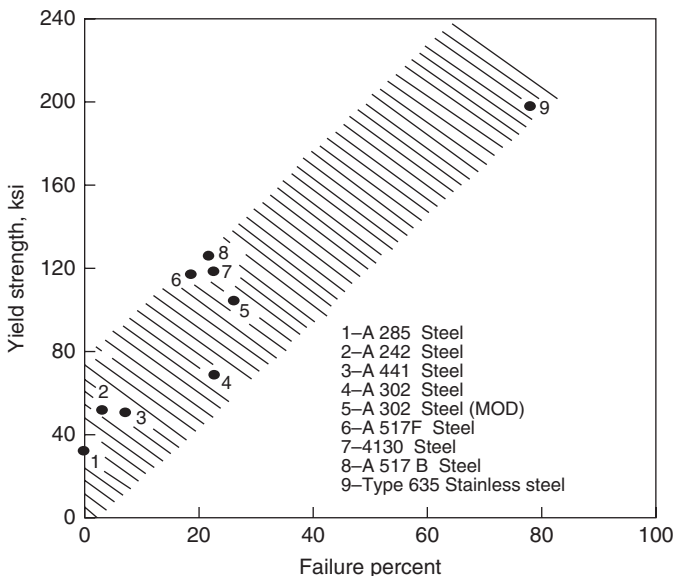
Figure 4.1 Relation of fracture frequency to yield strength (© NACE International 1969).

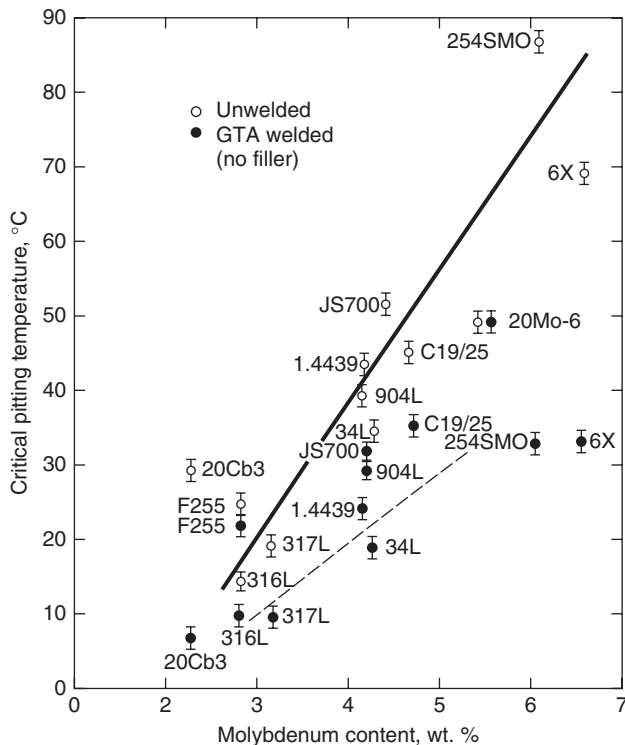
Figure 4.2 Variation of the critical pitting temperature (determined from ferric chloride solution) with the molybdenum content of various stainless steels. (Source: Garner 1985, Welding Journal, Vol 62, No. 1.)

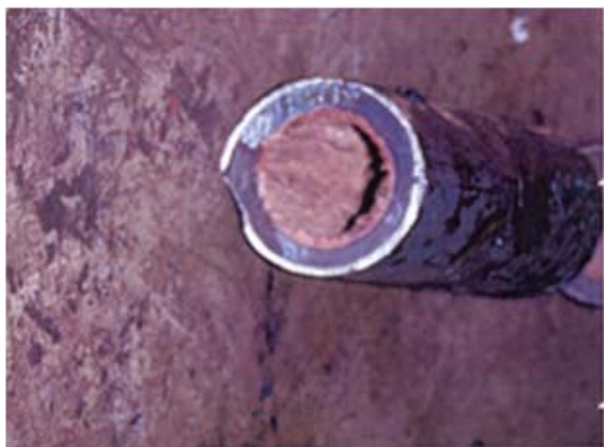
Case 1 Heavy corrosion and scaling in Monel-400 bromine preheater.

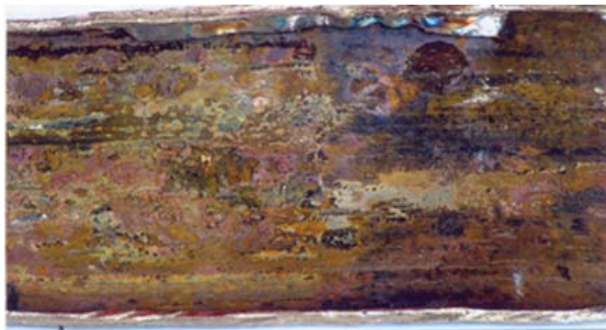
Case 3 Hot-wall effect corrosion by sea water on cupro-nickel cooler tube in an oil refinery. (Courtesy: Elayaperumal, in “Corrosion Failures in Process Industries in India: Statistical Analysis and Case Studies” in Special Supplement 2009, Corrosion Reviews Special Issue: India, England: Freund Publications, 2009, p 52, case study 3.)

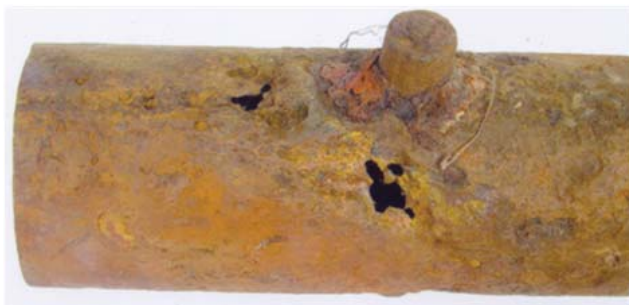
Case 4 Corrosion by fuel-ash deposit in a package boiler tube.

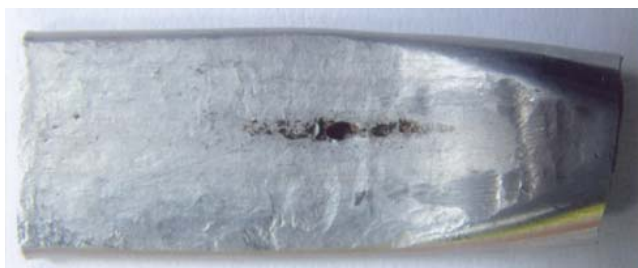
Case 6 Crevice corrosion in an off-shore platform stainless steel instrumentation tube. (Courtesy: Elayaperumal, in “Corrosion Failures in Process Industries in India: Statistical Analysis and Case Studies” in Special Supplement 2009, Corrosion Reviews Special Issue: India, England: Freund Publications, 2009, p 55, case study 6.)

SERVICE	Instrumentation tube in an off-shore platform producing oil and gas. Contains produced gas under pressure at ambient temperature
PROBLEM	Minor leak after 5 years of operation under one of the support clamps
MATERIAL	TYPE 316 L STAINLESS STEEL 3/8" OD × 0.065" WT seamless as per A268
OBSERVATIONS	Highly localized corrosion on the outside surface of the tube below the tight fit plastic support clamp. No general corrosion elsewhere due to the overall marine atmosphere. No corrosion on the inside surface
DIAGNOSIS	CREVICE CORROSION under the tight fit plastic support clamp
REMEDY	Keep the plastic support clamps under loose fit so that free air and moisture flow during winds are ensured

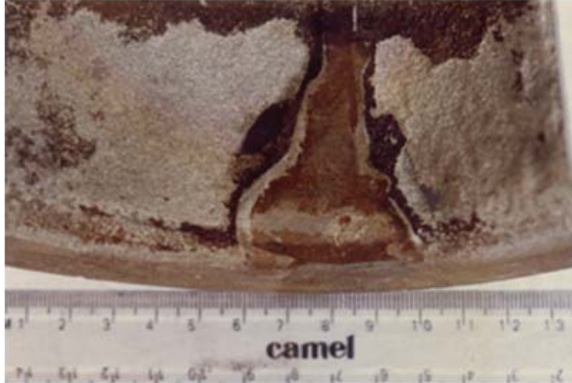
Case 8 Galvanic corrosion on parent metal 304 stainless steel in contact with weld metal 316 stainless steel in an organic chemical plant.

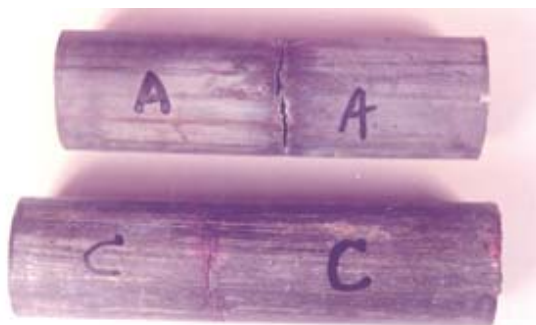
Case 9 Caustic stress corrosion cracking in stainless steel digester pre-heater in a pulp and paper plant.

SERVICE	Vertical shell-and-tube heat exchanger. Shell side: steam. Tube side: digester caustic liquor heated to 170°C and fed to the digester
PROBLEM	Leakage within 7 months of operation. Four identical ones behaved in the same way
MATERIAL	TYPE 316 L STAINLESS STEEL seamless tubes of size 32 mm OD × 1.50 mm WT, 5.0 m long
OBSERVATIONS	<ol style="list-style-type: none"> 1. Circumferential cracks somewhere in the middle portion between two baffle positions 2. Some tubes had bends in the middle 3. Multiple cracks initiated on the ID side, digester liquor side, trans-granular and branched during propagation
DIAGNOSIS	TRANS-GRANULAR STRESS CORROSION CRACKING BY CAUSTIC on the stress areas between the baffles
REMEDY	Replace 316L SS with 316 SS with highest possible yield strength and wall thickness. Redesign the baffle position and numbers so that stress on the tubes is minimized

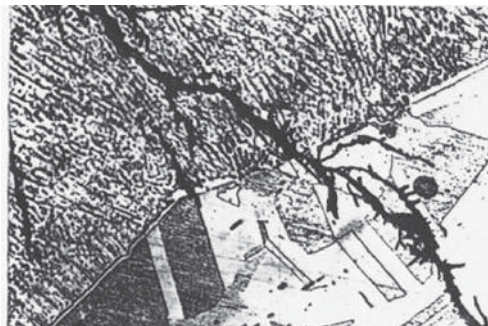
Case 10 Transgranular stress corrosion cracking by polythionic acid in a stainless steel esterification column in an organic chemical plant, microstructure across weld and parent metal, (200X).

SERVICE	Shell of a vertical column in which esterification takes place with alcohol as a reactant. Has been in operation for few years
PROBLEM	After one of the yearly maintenance operations while hydro testing heavy leakage occurred in several places of the shell near various weld joints
MATERIAL	316 L STAINLESS STEEL
OBSERVATIONS	Dye-penetrant test revealed multiple cracks on the inside surface on the weld regions both in the weld and parent metals. Metallographic test showed the cracks to be branched trans-granular
DIAGNOSIS	STRESS CORROSION CRACKING by POLYTHIONIC ACID which forms only during shutdown periods. Sulphur was a sudden impurity in the alcohol. It forms sulfide. The latter reacts with moisture and air during shutdown to produce PTA which induces SCC
REMEDY	Alkaline wash of equipments just before shutdown prior to exposure to air and moisture. Inert purging and/or blanketing for short shutdown periods

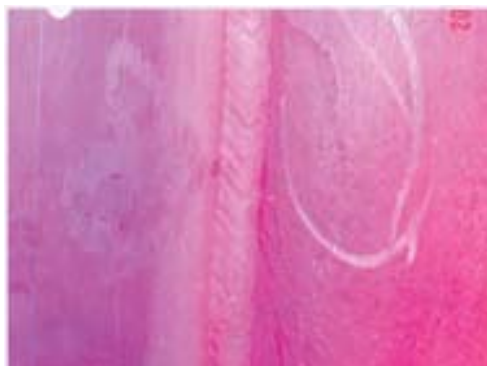
Case 11 Corrosion under insulation. Stress corrosion cracking of stainless steel half pipe limpet coil of a stirred reactor in an organic chemical plant.

SERVICE	Limpet coil welded to the outside surface of a reactor used for both heating and cooling purposes
PROBLEM	Leaks occurred in the limpet coils within 1 year of service
MATERIAL	TYPE 304 STAINLESS STEEL
OBSERVATIONS	<ol style="list-style-type: none"> 1. Dye-penetrant test showed multiple cracks on the coil near the weld joints 2. Metallography showed the cracks to be transgranular and branched 3. The mineral wool insulation covering the limpet coil was wet with high chlorides
DIAGNOSIS	EXTERNAL STRESS CORROSION CRACKING (ESCC) by chloride from a specific lot of re-used insulation
REMEDY	<ol style="list-style-type: none"> 1. Always use fresh insulation whenever necessity comes for replacement 2. Use minimum heat input for welding the half pipe to the reactor 3. Consider duplex stainless steel as an alternative and better material of construction for the coil

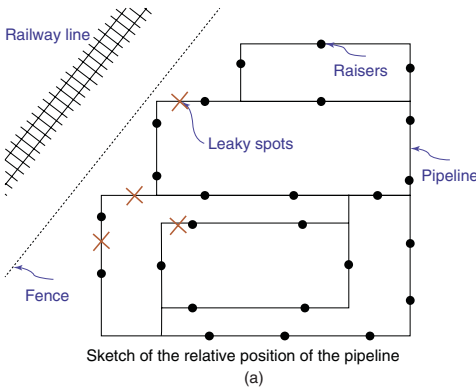
Case 12 (a) Sketch of underground firewater lines in an organic chemical plant showing positions (X marks) where leaks have occurred. (b) A leaky spot as seen on the outside surface of the underground fire water line pipe.

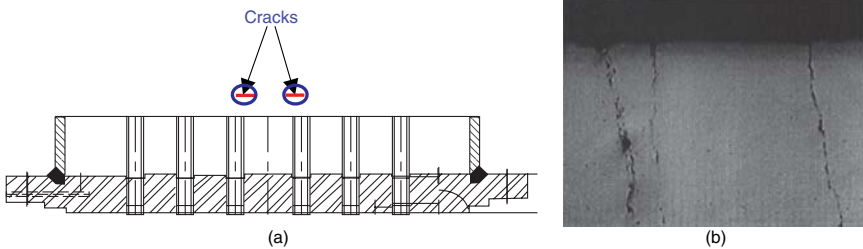
Case 13 (a) Longitudinal sketch of the bottom portion of tubes and bottom tube-sheet showing the location of the circumferential cracks in alcohol vapor super-heater. (b) Microstructure of the longitudinal cross section of the inside surface of a failed tube of the alcohol vapor super heater showing multiple cracks initiating on localized pits, (50X).

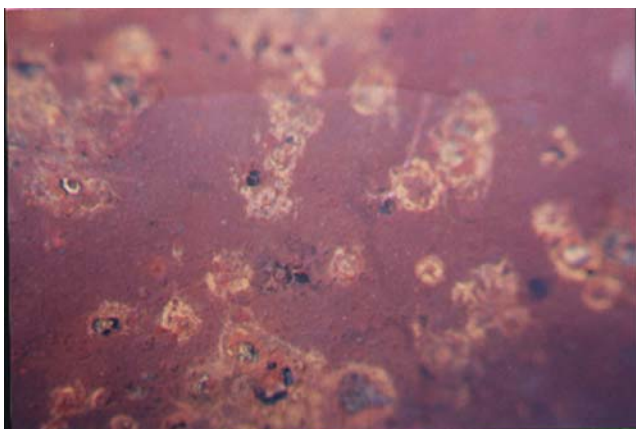
Case 14 Close-up view of the pits on the outside surface of one of the affected package boiler tubes.

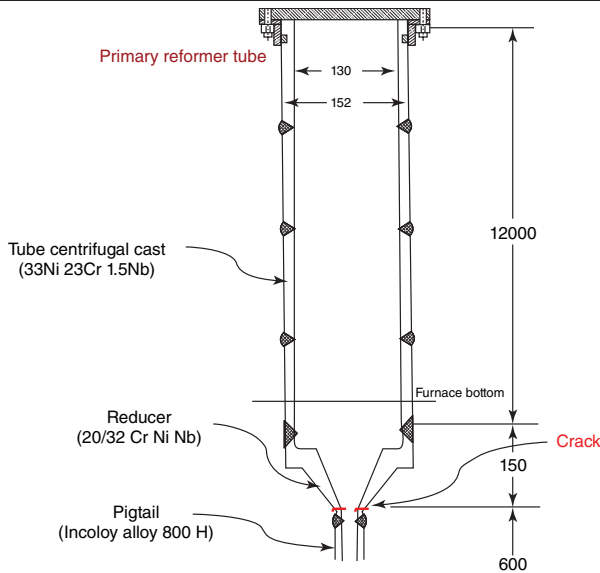
Case 15 Cross section of a reformer tube showing crack at the reducer at the bottom.

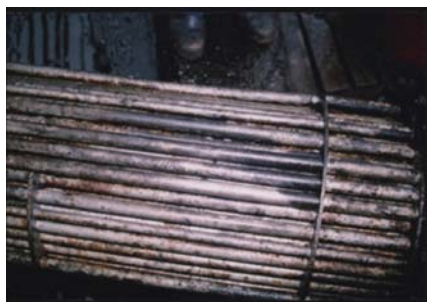
Case 21 (a) Bottom row tubes in an amine kettle re-boiler of an organic chemical plant. (b) Closer view of the external tubes with amine sludge.

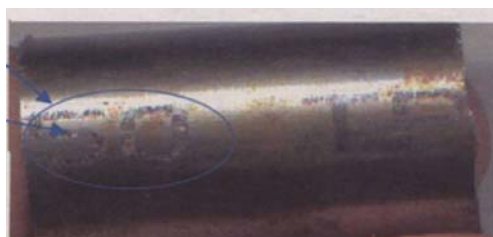
Case 23 (a) Inside surface of 430SS high temperature generator tube showing corrosion rust patches. (b) Outside surface of 430SS high temperature generator tube showing leaked areas.

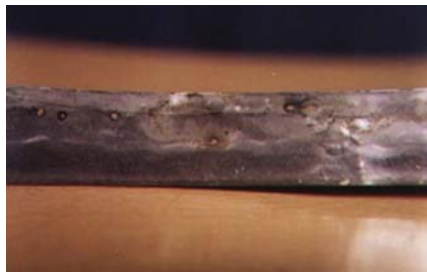
Case 24 (a) Gasket groove surface showing localized corrosion marks. (b) 304SS asbestos gasket envelope showing through and through corrosion pits.

REMEDY	Use only corrosion-resistant nonabsorbing gaskets like “SS 316 Spiral Wound PTFE filled gasket” and not any lower quality absorbing type gaskets

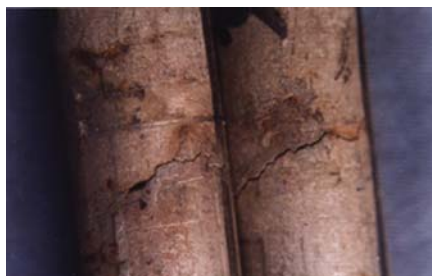
Case 25 (a) Outside surface of SS 304 cooler tubes showing circumferential cracks. (b) Optical micrograph of the longitudinal section of the tube showing carburation on the inside surface to a great depth (100X).

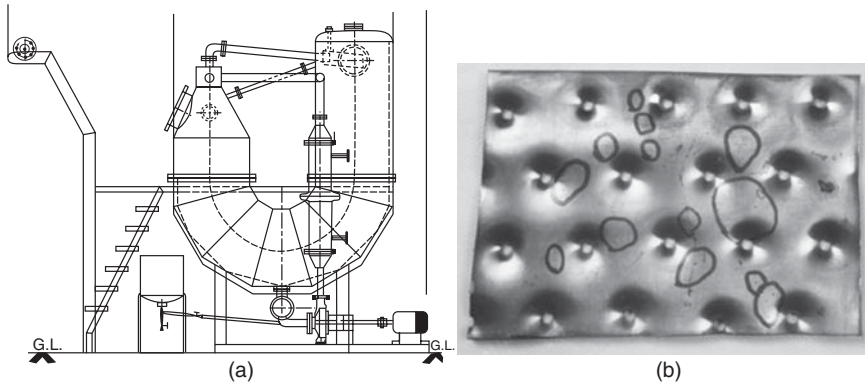
Case 27 (a) Elevation drawing of the U shape jet dyeing machine. (b) Localized sharp pitting corrosion marks on the inside surface of the perforated basket of jet dyeing machine.

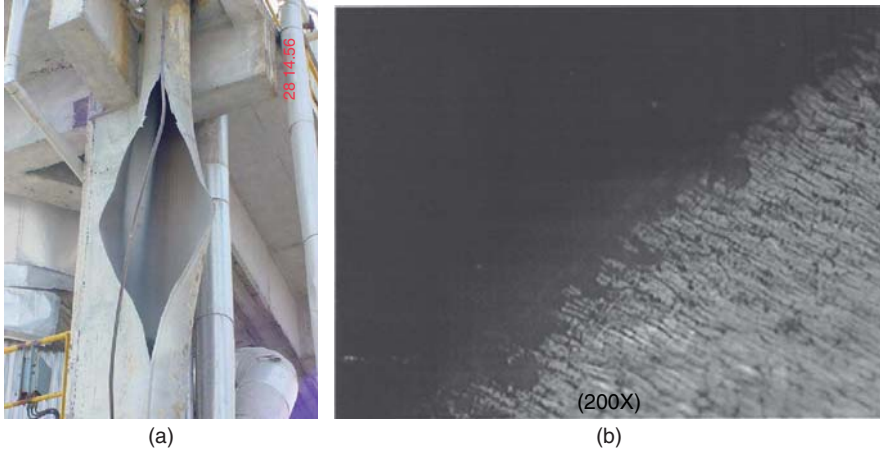
Case 29 (a) The burst 316L SS welded pipe on location. (b) Optical micrograph of the longitudinal cross section across the split surface of the pipe showing crevice corrosion (200X).

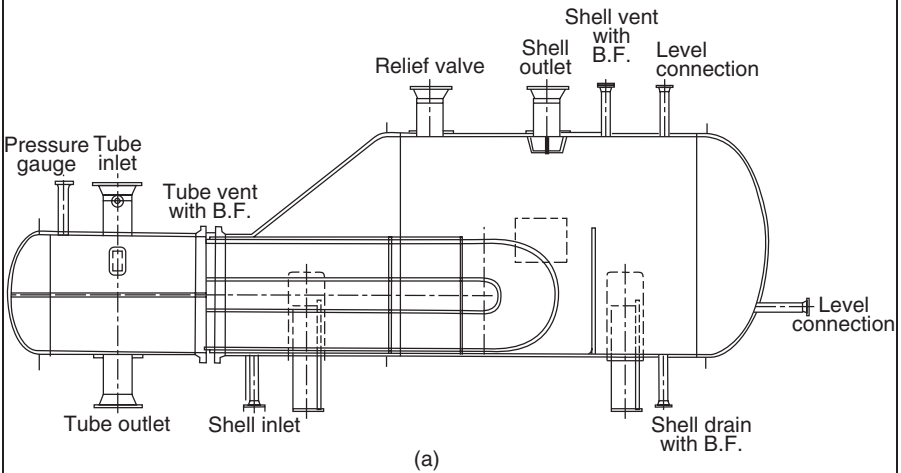
Case 30 (a) Elevation drawing of the kettle type heat exchanger. (b) Cross section of the tube bundle showing the plugged leaky tubes. (c) The outside surface of an affected tube showing corrosion patches. (d) The outside surface of a second affected tube showing corrosion patches.

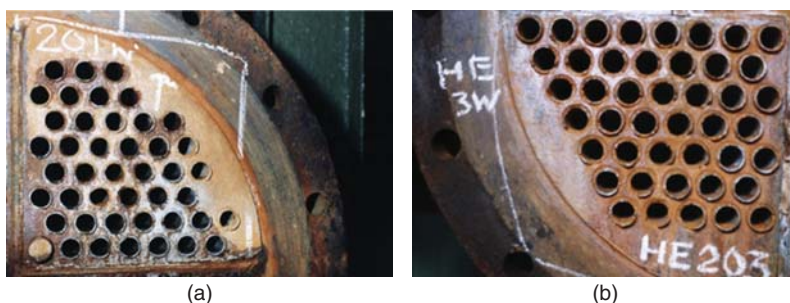
Case 35 (a) Inlet end erosion corrosion of carbon steel tubes in an acid cooler, first pass. (b) Inlet end erosion corrosion of carbon steel tubes in an acid cooler, second pass.

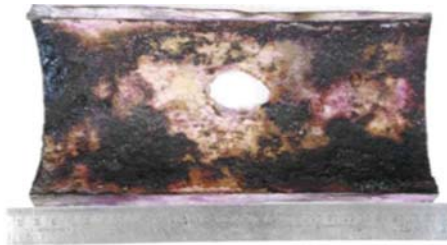
Case 37 (a) Sketch of the flow diagram of EDC through preheater, vaporizer and furnace. (b) Photograph of the inside surface of the radiant coil at a leaked area.

REMEDY	Avoid carryover of liquid EDC along with moisture to the pyrolysis furnace, by ensuring efficient operation of preheater and vaporizer

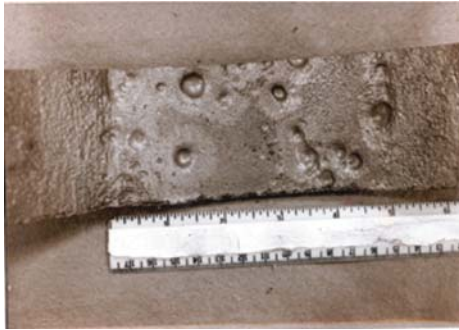
Case 38 Pitting corrosion due to dissolved oxygen in carbon steel boiler tube.

SERVICE	Waste heat boiler. Fuel: exhaust gas from burning of bagasse of a sugar mill along the outside surface of the tubes
PROBLEM	Leakage in the first, lower banks of convection tubes. No leakage in the second upper banks
MATERIAL	Boiler quality carbon steel
OBSERVATIONS	<ul style="list-style-type: none"> • General rusting, small size corrosion pits throughout and deep and wide pits in localized places on the inside surface • Outside surface free from corrosion • DM water without effective deaeration (either thermal or chemical) is used as boiler feed water. The dissolved oxygen content was 9–10 ppm as against the specified maximum of 0.005 ppm • The chemical oxygen scavenger sodium sulfite was only about 8 ppm as against required 71 ppm to scavenge 9 ppm of dissolved oxygen
DIAGNOSIS	CORROSION PITTING BY DISSOLVED OXYGEN in the feed water. Thermal deaeration was not practiced. Chemical deaeration was not sufficient and effective

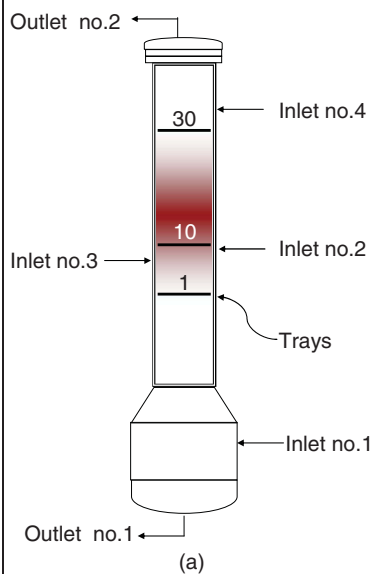
Case 44 (a) Schematic of the absorption column indicating the corroded region in the middle. (b) A typical corroded tray.

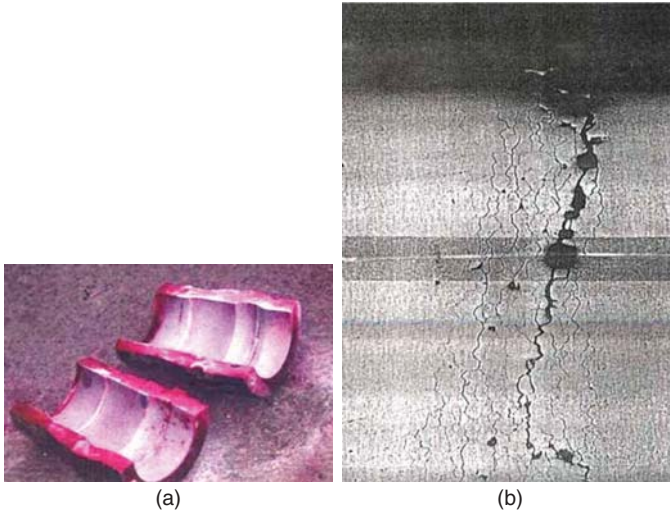
Case 45 (a) Dye penetrant test indications on the heat affected zones of the weld. (b) Intergranular corrosion and cracking initiated on the outside surface in the weld heat affected zone (200X).

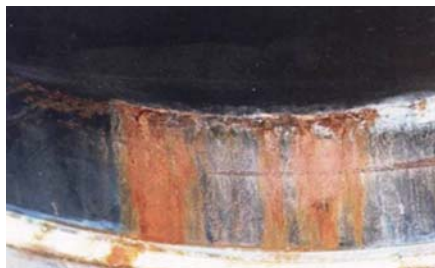
Case 47 (a) Preferential corrosion on the weld line in a Monel clad carbon steel vessel. (b) Corrosion on isolated points on shell course weld in Monel clad carbon steel vessel.

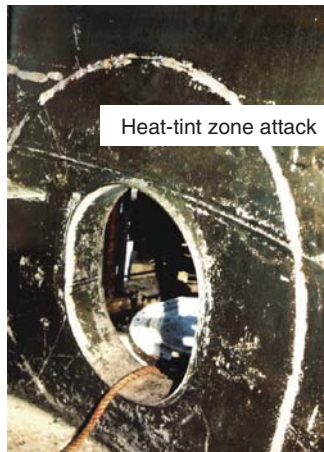
Case 58 (a) Corrosion of Monel vessel by acidic chloride water at liquid vapor interface.
 (b) Corrosion of Monel vessel by acidic chloride water on weld line and nearby places.
 (c) Corrosion of Monel vessel by acidic chloride water at weld heat tint zones.

CASE STUDY 58 Continued	
SERVICE	<p>Washing rubber crumbs with live steam to remove chemicals associated with crumbs. Recycle water is added to the tank</p> <p>pH: 2–4, chloride: large quantity, temperature: 91–98°C, pressure: 0.2 kg/cm²g</p>
PROBLEM	<p>After 5 years of operation, with periodic and frequent shutdowns, unusual corrosion/erosion patches noticed on the inside surface</p>
MATERIAL	<p>Shell: Monel 400 (ASME SB 127). 5 mm thick plate, 4.5 M Ø, 8.5 M height</p> <p>Impeller blades: 304 L SS</p>
OBSERVATIONS	<ul style="list-style-type: none"> • Several corrosion indications throughout the inside surface, more near weld areas, near water-mark lines and on heat-tinted locations corresponding to outside welds and tag welds • Impeller blades had many branched cracks
DIAGNOSIS	<ul style="list-style-type: none"> • Corrosion by acidic wash water in the presence of dissolved oxygen during shutdown periods in which the water was not drained. (Monel is resistant to acidic chloride solution, only in the absence of dissolved oxygen) • STRESS CORROSION CRACKING by chloride of impeller blades of 304 L SS

REMEDY	<ul style="list-style-type: none"> • Drain wash water during shutdown, wash the vessel with fresh water, and keep the vessel dry • Replace 304L SS with 316 SS/duplex SS for the impeller blades

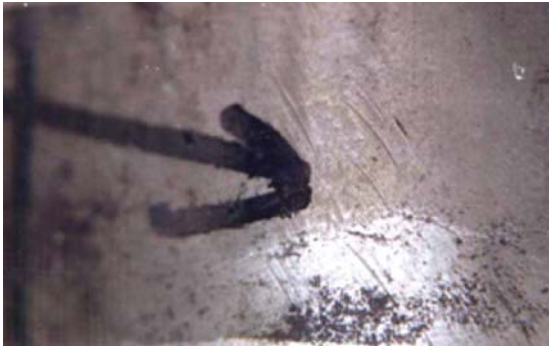
Case 61 (a) Cracks as seen on the external, outside, surface of overhead pipeline of 304SS in an oil refinery. (b) External stress corrosion cracking (ESCC) due to chloride corrosion under insulation (CUI) on 304 SS pipe in an oil refinery 500X.

SERVICE	12" NB 40 Sch. Pipe (4.36 mm WT). Pipeline from regenerator to overhead condenser transferring H ₂ S-rich acid gas (80% H ₂ S) at a pressure of 1 kg/cm ² and at a temperature of 110°C
PROBLEM	After 10 years of service, leaking occurred during hydro-testing
MATERIAL	304 SS, welded pipe
OBSERVATIONS	<ul style="list-style-type: none"> • Cracks initiated on localized pits on the outside surface below a simple support • Fine multiple cracks
DIAGNOSIS	<ul style="list-style-type: none"> • External chloride stress corrosion cracking due to sudden wetting of insulation material containing 7 ppm chloride
REMEDY	<ul style="list-style-type: none"> • Ensure that insulations are free from chloride and that they are kept dry throughout by proper overlapping of external protective cladding

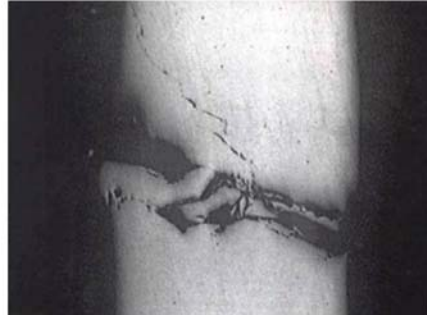
Case 62 (a) Transverse cracks as seen on the outside surface of 304L SS tubes little away from the expanded ends. (b) Chloride stress corrosion cracking initiated on the inside surface of compressor inter-stage cooler tubes of 304L SS(50X). (c) A fully grown stress corrosion crack, from inside to outside, of compressor interstage cooler tube of 304L SS(50X).

CASE STUDY 62 Continued	
PROBLEM	Leakage of tubes within 9 months of service pH of cooling water has gone down to 4.5 from 7.5
MATERIAL	Type 304L SS Seamless tubes as per ASTM A-213, 19.05 mm OD × 1.24 mm WT × 5500 mm long and 431 Nos. Two pass design
OBSERVATIONS	<ul style="list-style-type: none"> ● 56 tubes on the outer rows of top half (tube-side entry) have leaked ● Sharp transverse cracks on positions just after the tube sheet inner edge on the gas inlet side ● Branched transgranular cracks initiated on the inside surface of the tubes (gas side) ● The in-coming compressed gas contains moisture from the spray cooler upstream ● Instead of the specified DM water for spray cooling purpose, cooling water with 250–350 ppm chloride has been used frequently whenever DM water shortage arises ● There has been frequent noticeable vibrations in the cooler
DIAGNOSIS	<ul style="list-style-type: none"> ● Chloride stress corrosion cracking initiated on the inside surface of the tubes on stressed portions near the tube-expansion ends at the high temperature regions

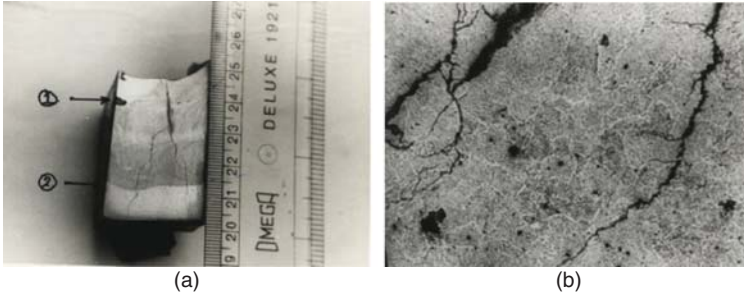
Case 63 (a) Cross section of crack across nozzle, weld and shell. (b) Caustic intergranular stress corrosion cracking in carbon steel shell plate (100X).

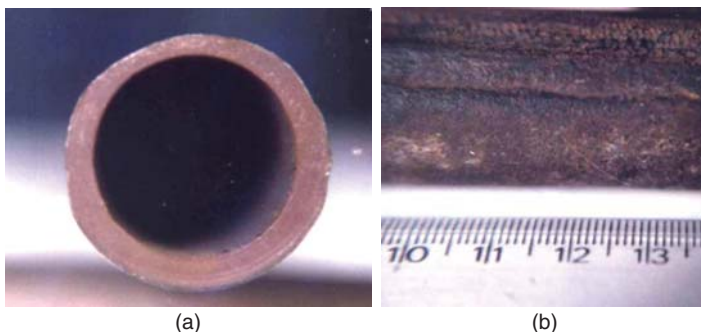
Case 64 (a) Cross section of a steam generator tube showing thickness reduction on the outside surface. (b) Close view of the corrosive attack on the outside surface.

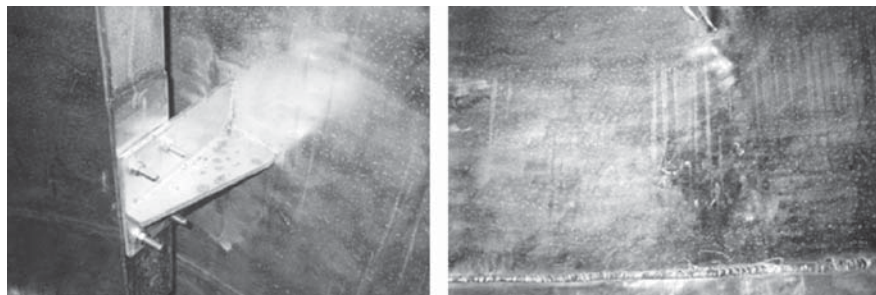
Case 68 (a) Corrosion pits on a baffle support bracket and nearby areas on the shell. (b) Corrosion pits on the shell above the weld line.

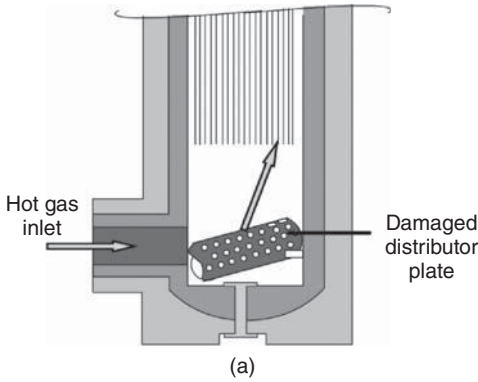
Case 69 (a) Schematic of the bottom portion of waste heat boiler. (b) Schematic of the concentric steam generator tube assembly with the bottom closure cap. (c) Photograph of damaged gas distributor. (d) Affected steam generator tube bundle with closure end caps at the bottom ends. (e) Steam generator tubes with blisters on the closure end caps.
