CORROSION FAILURES

**THEORY, CASE STUDIES,
AND SOLUTIONS**

K. ELAYAPERUMAL

V. S. RAJA

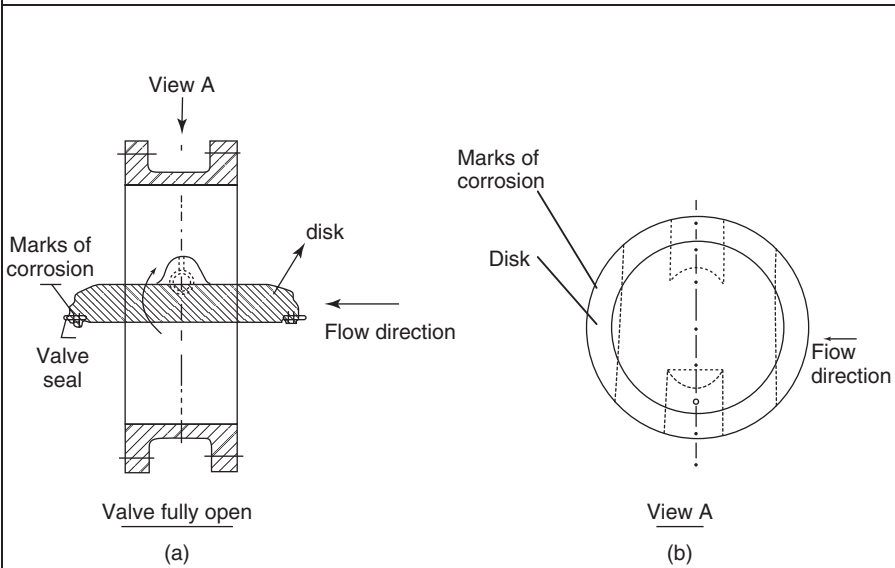
Case 72 (a) Sketch of the condenser inlet valve. Longitudinal section with valve fully open. (b) Sketch of the cross section of the valve disc indicating the damage locations.

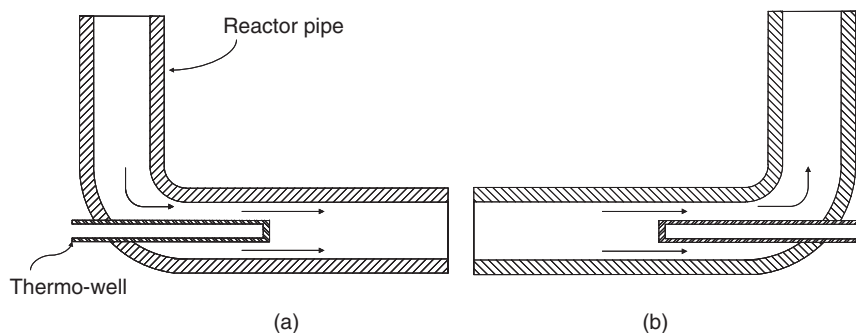
Case 76 (a) Sketch of the orientation of un-affected thermo-well with respect to flow of process fluid. (b) Sketch of the orientation of affected thermo-well with respect to flow of process fluid.

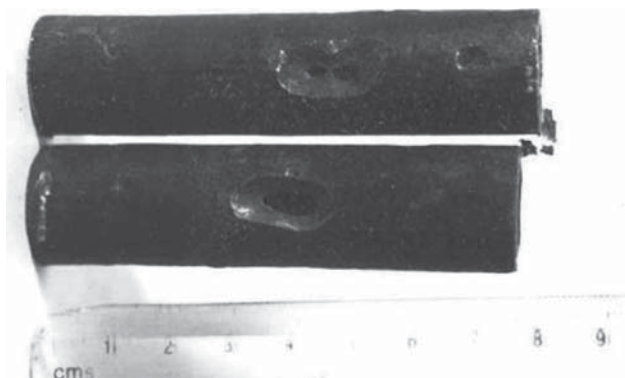
Case 78 Corrosion under sludge by sulfuric acid on carbon steel tubes.

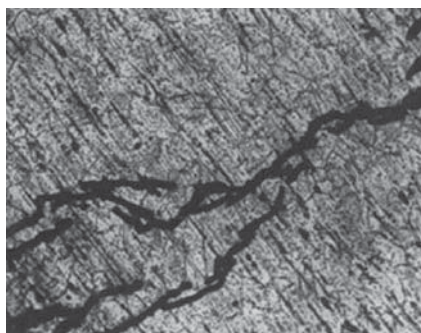
Case 80 (a) Initiation of caustic stress corrosion cracking in 316SS autoclave shell (50X).
(b) Propagation of caustic stress corrosion cracking in 316SS autoclave shell, 100X.
