New Cathodic Protection Installations

Kenneth C. Clear and Sivaraman Venugopalan
Kenneth C. Clear, Inc.
Boston, Virginia 22713

New Cathodic Protection Installations
June 1993

Project Summary

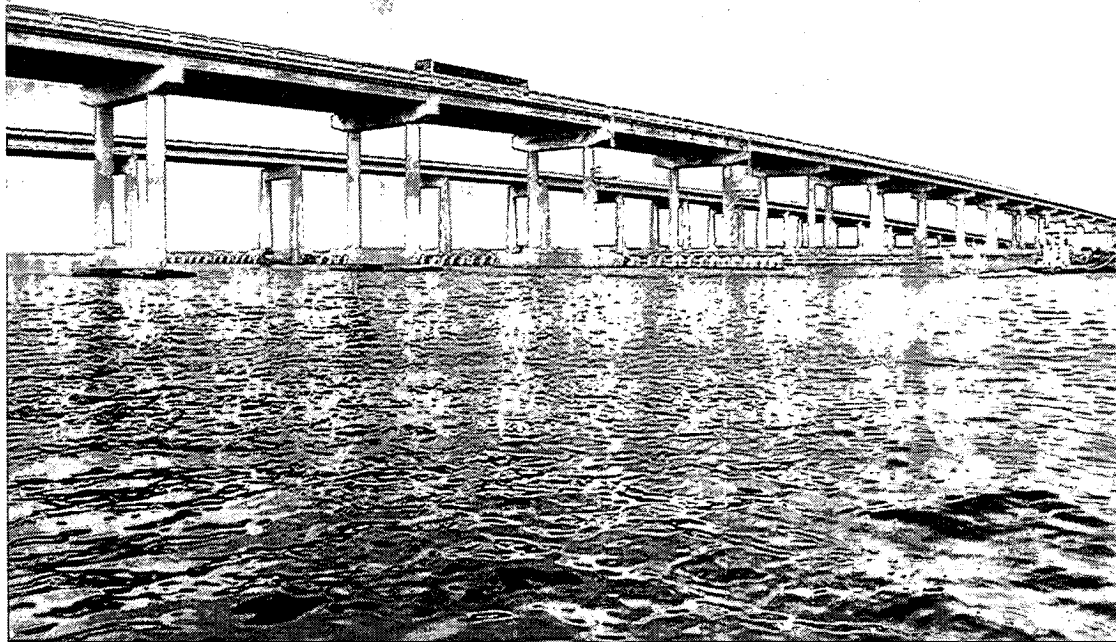
Figure 1. Installation and Activation of Anode

Overall View of the Structure

Sandblasting
in Progress

Installation of Anode in Progress

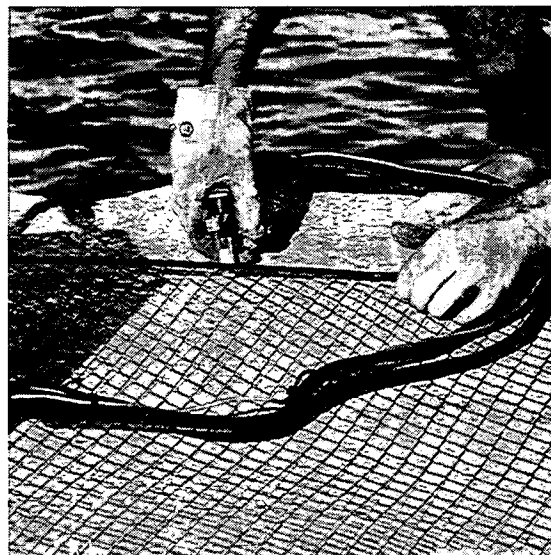
Figure 1. (cont'd) Installation and Activation of Anode

Current Distributer Bar
Resistant Spot Welded
to the Anode Mesh

Post-tensioning
Duct and New Steel
in Place

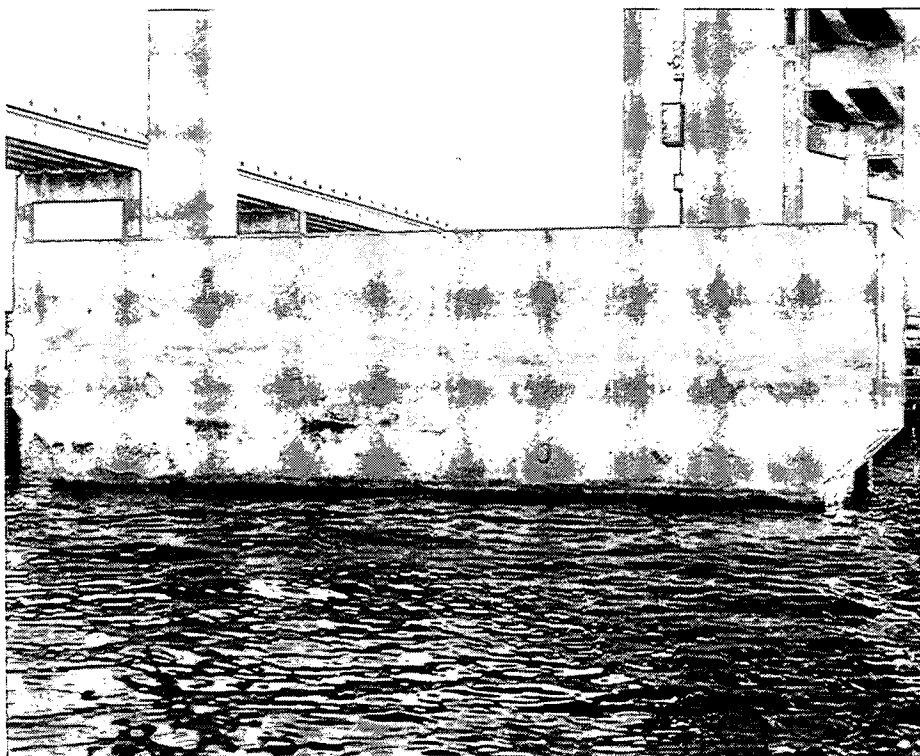
Completed Cathodic Protection System and the Structural Jacket

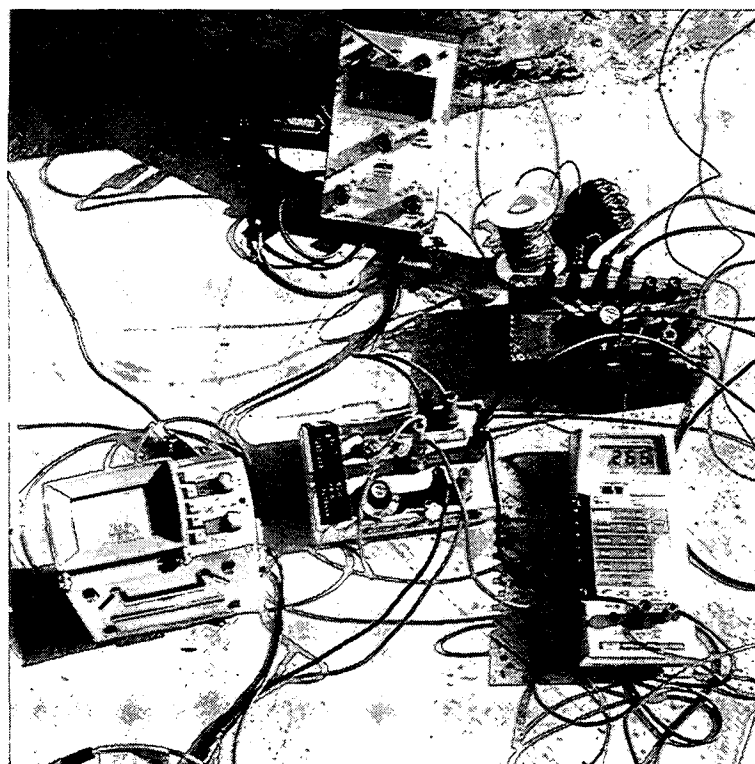
Figure 1.(cont'd) Installation and Activation of Anode

Activation in Progress

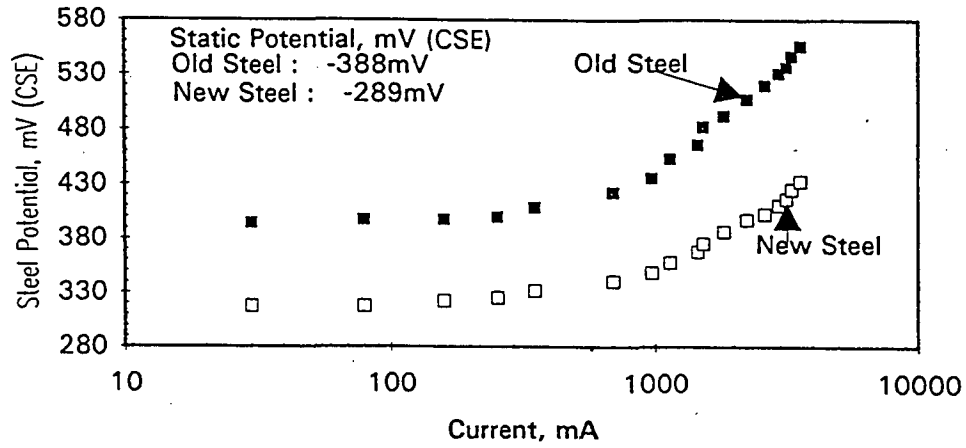
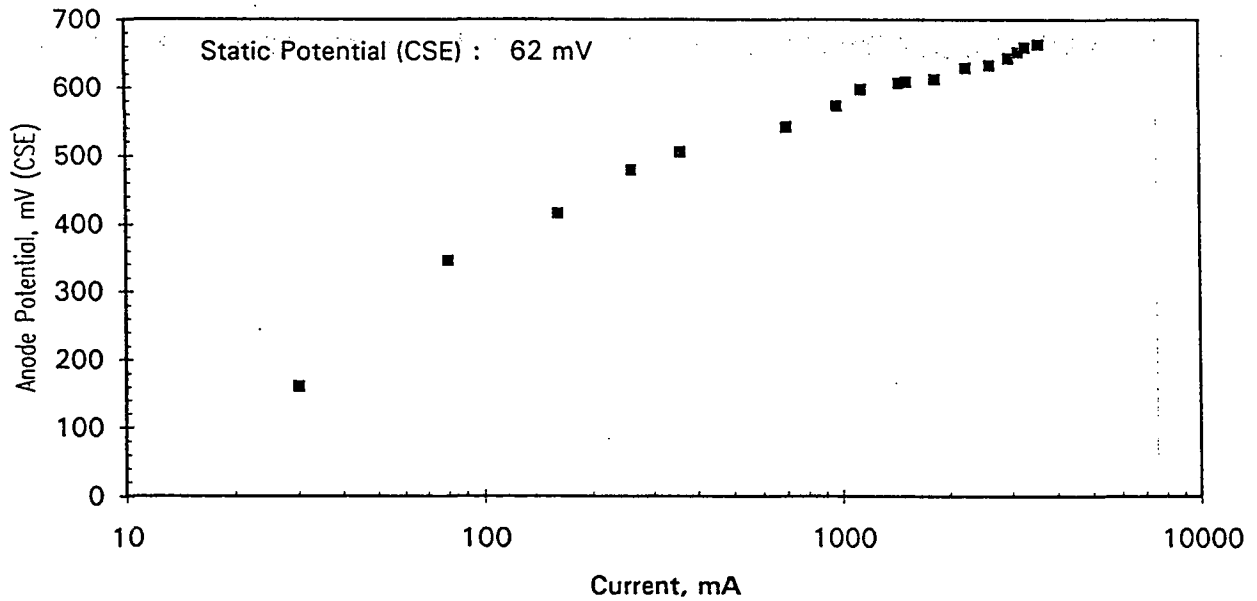
Figure 2. E-log I Plot for Steel and Anode

E - LOG I of the Elgard 300 Mesh Anode
Gandy Bridge, Tampa, Florida

Static Potential (CSE) : 62 mV

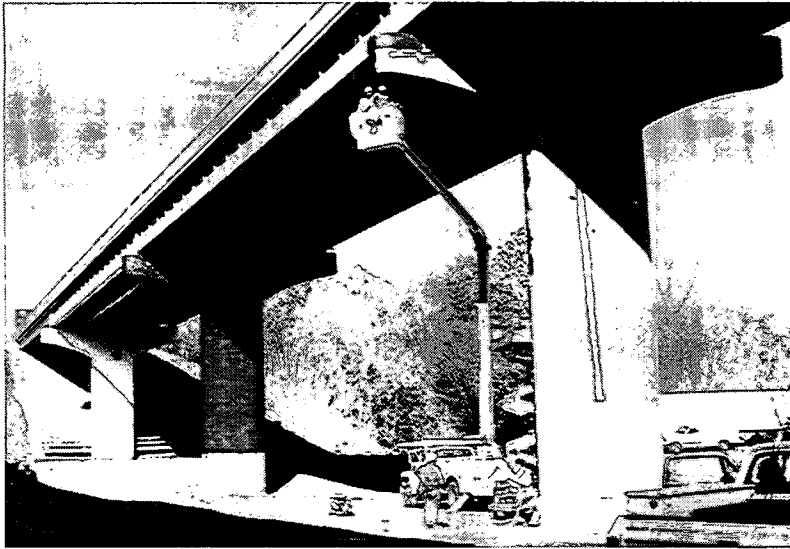
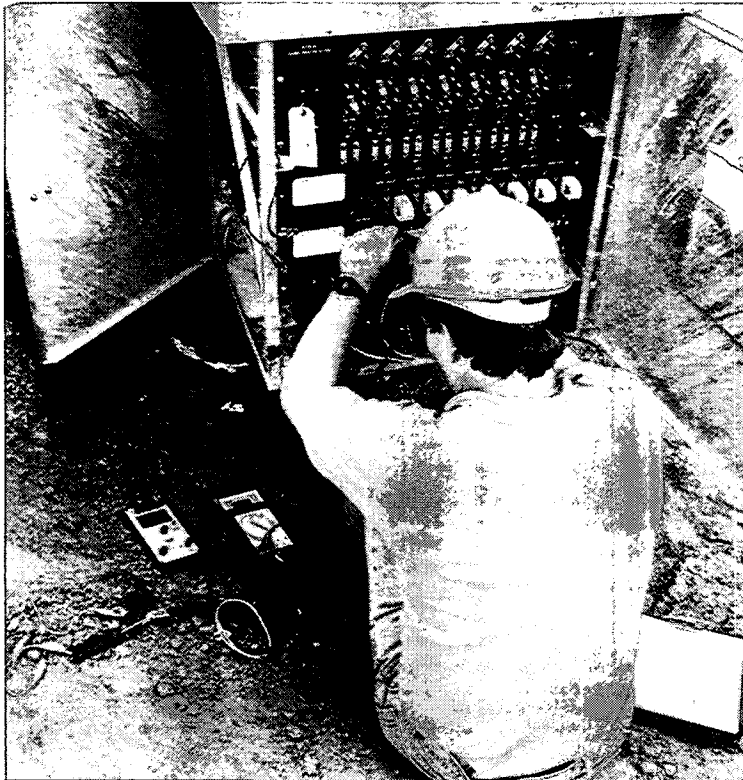
Figure 1. (cont'd) Installation and Activation of Anode

Steps in Anode
Installation

Activation in
Progress

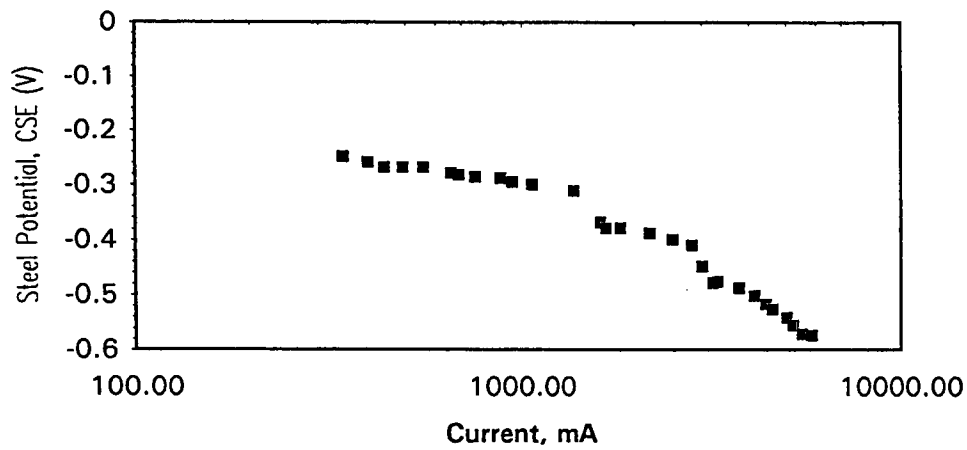
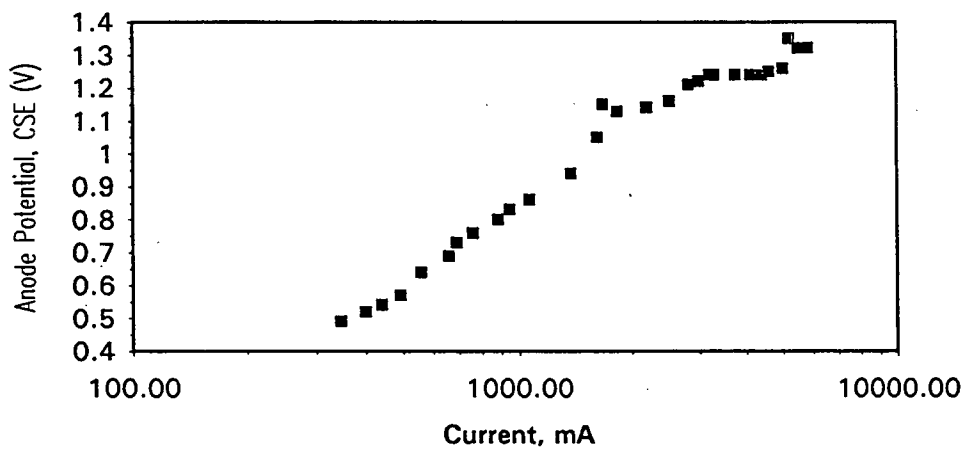
Figure 2. Anode and Steel Polarization Curves

The E-log I test was performed on pier 6 and anode and steel polarization curves were obtained. The rectifier was operated in an auto mode in conjunction with taps and the current control knob to better adjust the current output. Care was taken to ensure that the current was continuously increased even when the tap setting had to be changed to the next higher level. At each current level, the anode and the steel were allowed to polarize for two minutes before measuring the instant-off potential. There were two embedded half-cells per zone, of which, one was used for measuring the potential of steel and the other for measuring the potential of the anode. The potential of the anode was measured between the embedded half-cell and the anode and of the steel between the embedded half-cell and the rebar. The instant-off potential was measured by manually switching off the rectifier. Figure 2 shows the anode and the steel polarization curves. The protection current for pier 6 is about 1.9 A. The corresponding concrete, anode, and steel densities are 1.63, 1.63, and 2.63 mA/ft² respectively. The rebar showed about 120 mV of

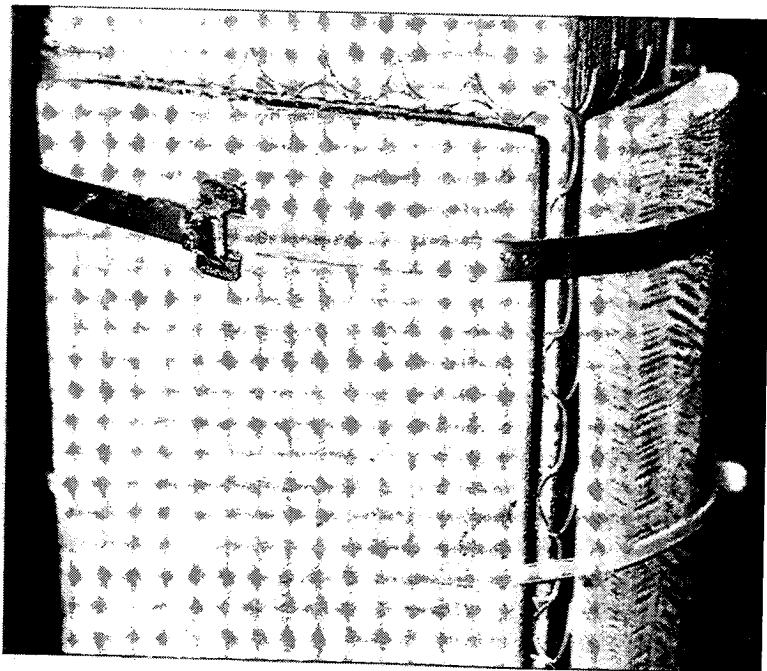
Close Up of Perforated
Zinc Sheet Anode

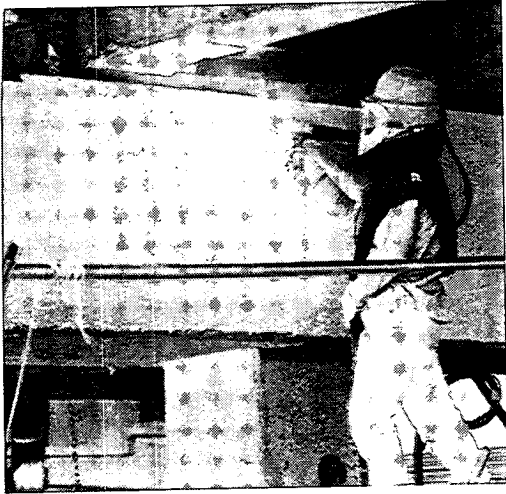
Arc-Sprayed Zinc Anode

The Arc-Sprayed Zinc System: All the delaminated and surrounding unsound concrete was removed and left unpatched. The exposed steel was abrasive blasted to remove mill scale, rust, oil and/or other foreign material such that a near white metal appearance was obtained. All the concrete surface designated to be metallized was thoroughly sandblasted and pieces of duct tape, about 1 in², were applied to the sandblasted concrete surface to permit measurement of the applied coating thickness. Prior to metallizing, the concrete surface was air blasted to remove any sand residue and dust from the sandblasting operation. Metallizing was first started on the exposed cleaned rebars and then on the concrete surface. Metallizing was done using pure zinc (99.9 percent) in the wire form of 1/8 in. standard size. The wire was melted by the heat of the electric arc and sprayed through the nozzle by compressed air. Metallizing was done in several passes to achieve a minimum coating thickness of 15 mil. Thickness coupons were removed via the duct tape and the thickness was measured using a digital micrometer in the field. Where thickness was less than 15 mil, additional passes were made to achieve that thickness.

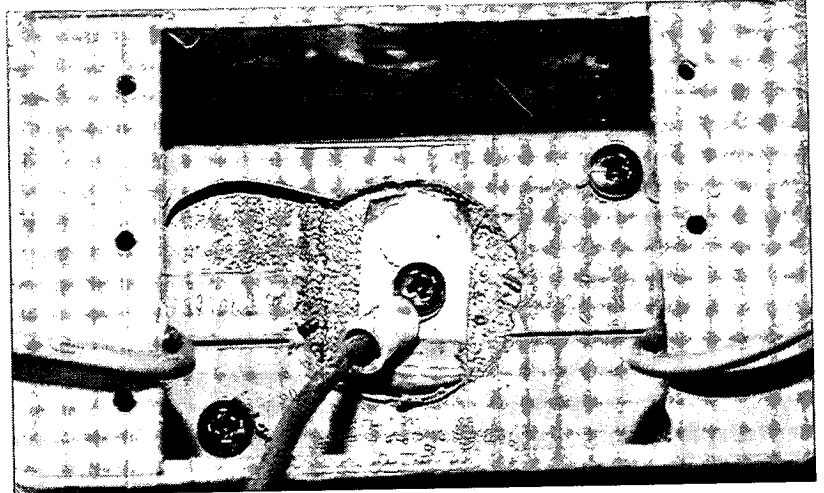
Connection to Arc-Sprayed Zinc Anode
for Monitoring

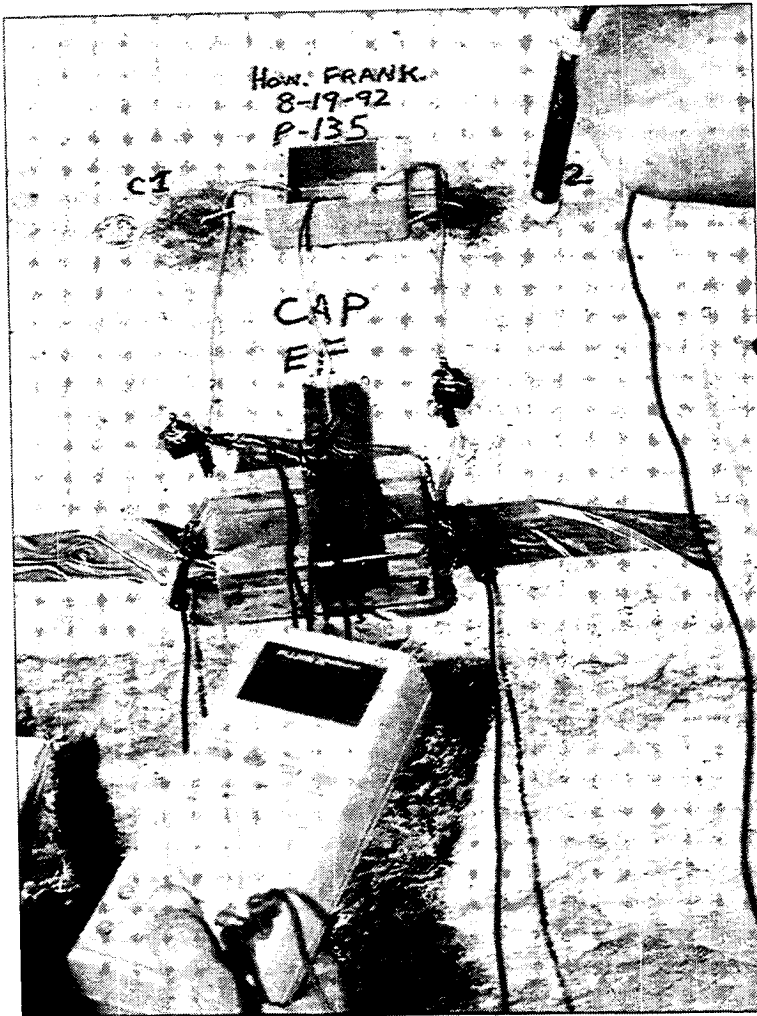
Activation and Data
Collection in Progress

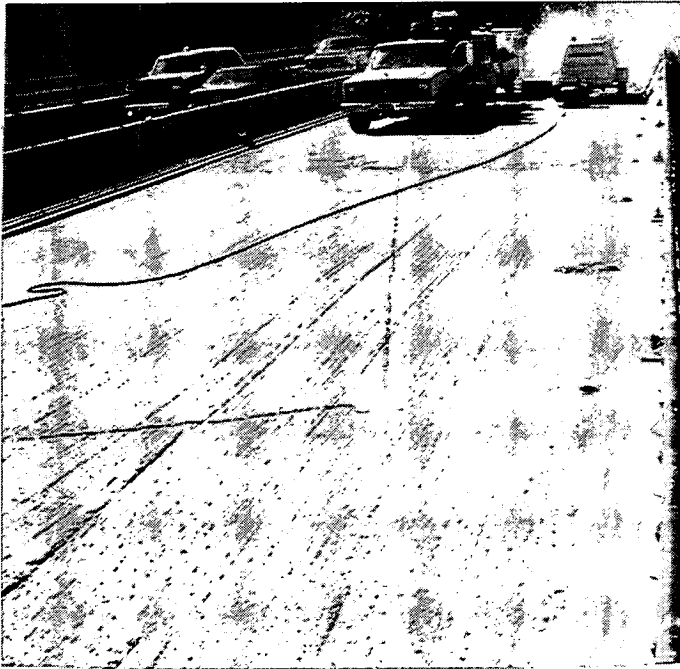
Figure 1. Surface Preparation and Anode Installation

Scarified Deck Being Sandblasted   Anode Installation in Progress

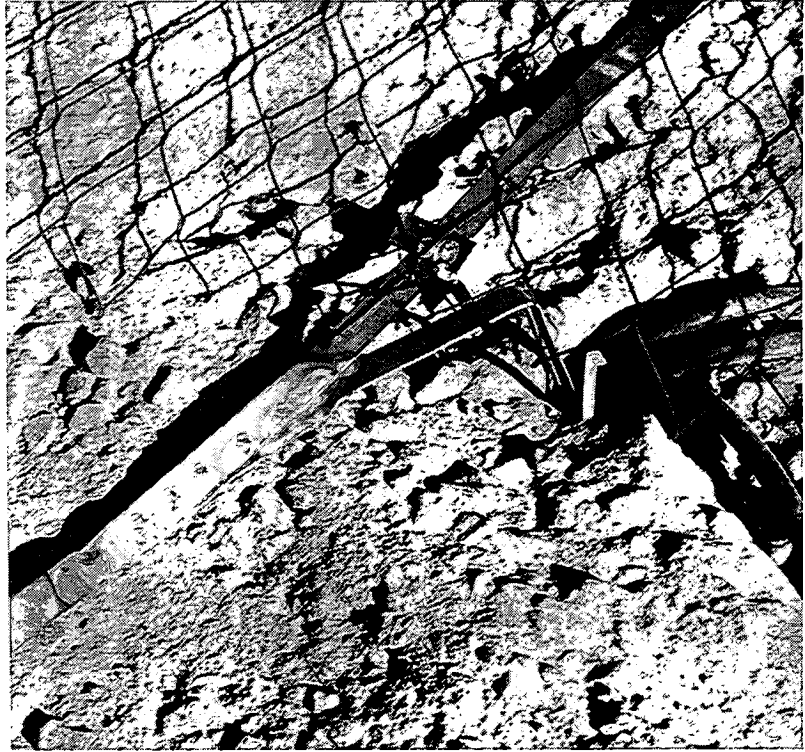
Special Anode Connector Welded in Place

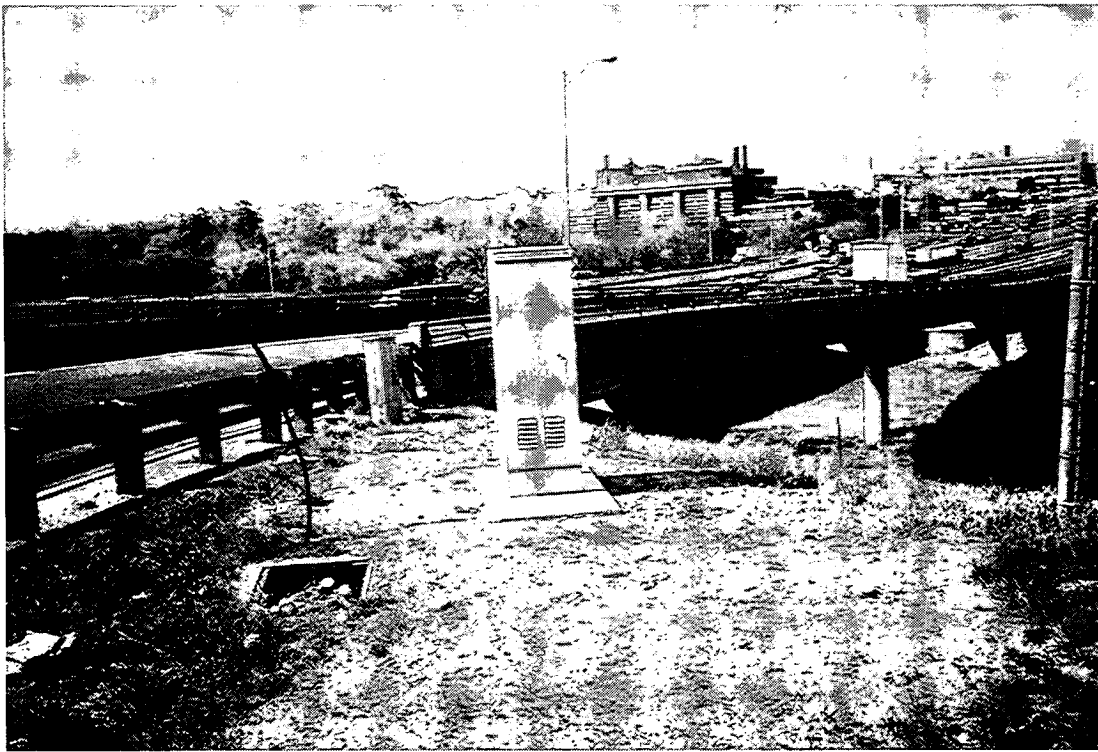
Overall View of the Structure

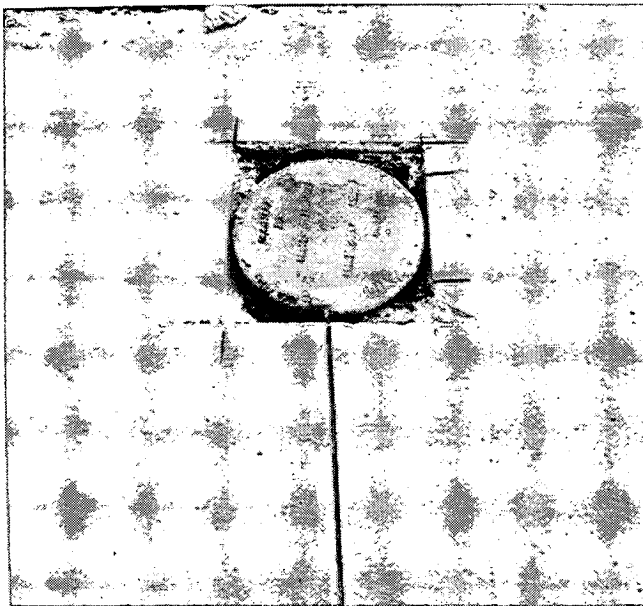
Installation of Pancake Anode

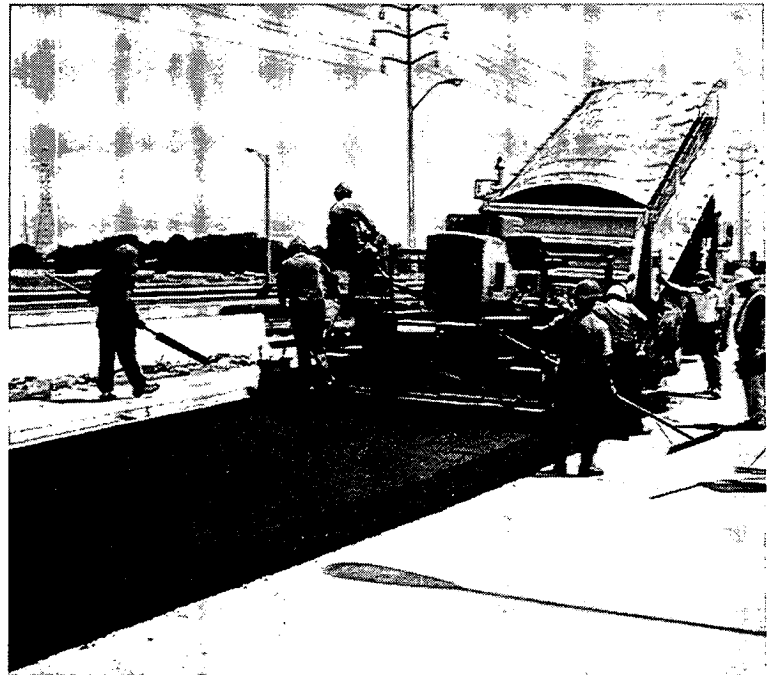
Placement of Coke Asphalt Mix

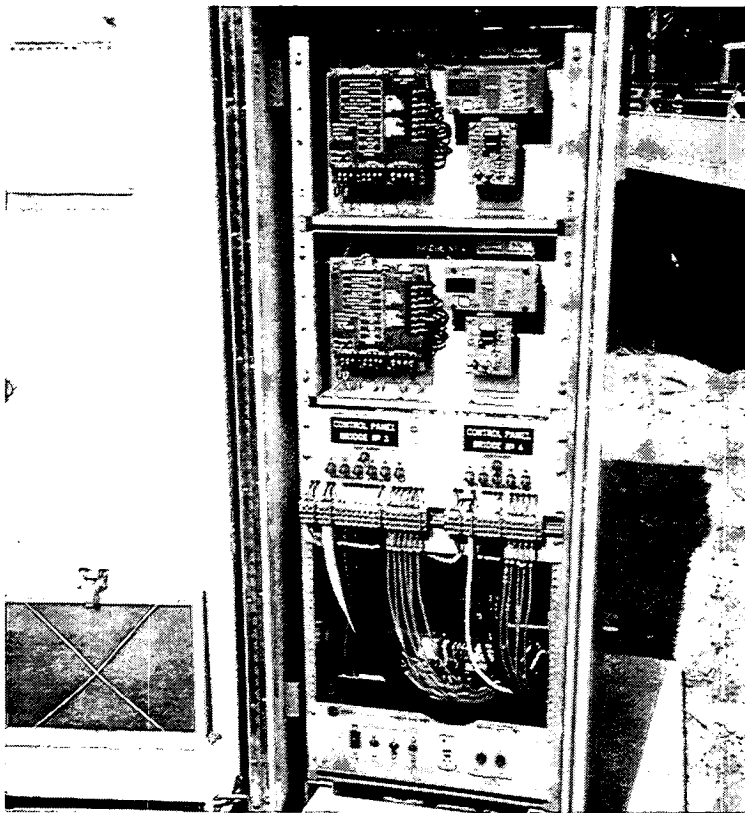
Front View of the Rectifier

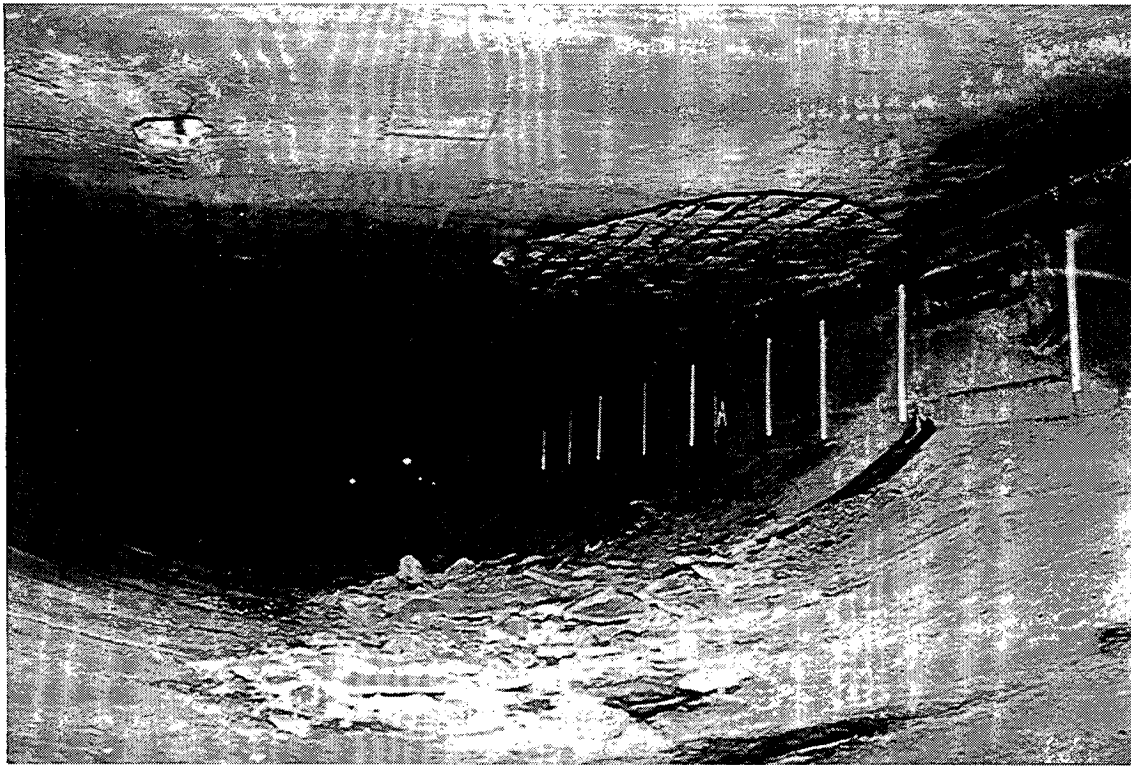
Overall View of the Roadway Underside

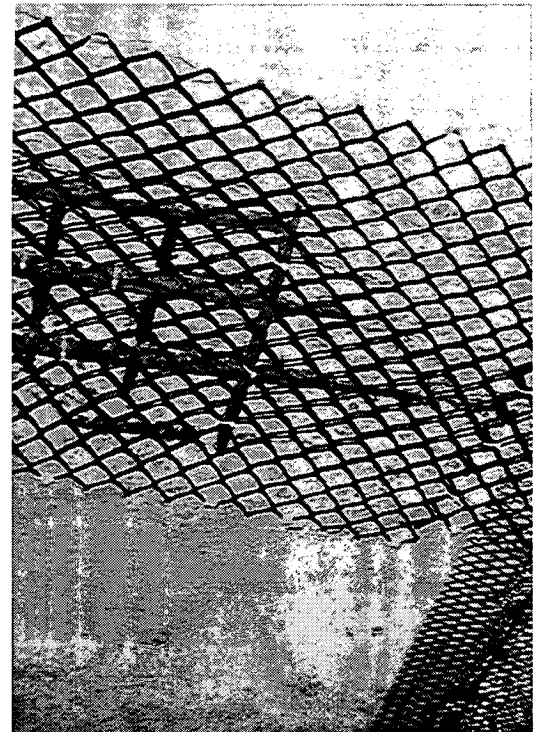
Plastic Mesh to Electrically
Isolate Anode and Steel

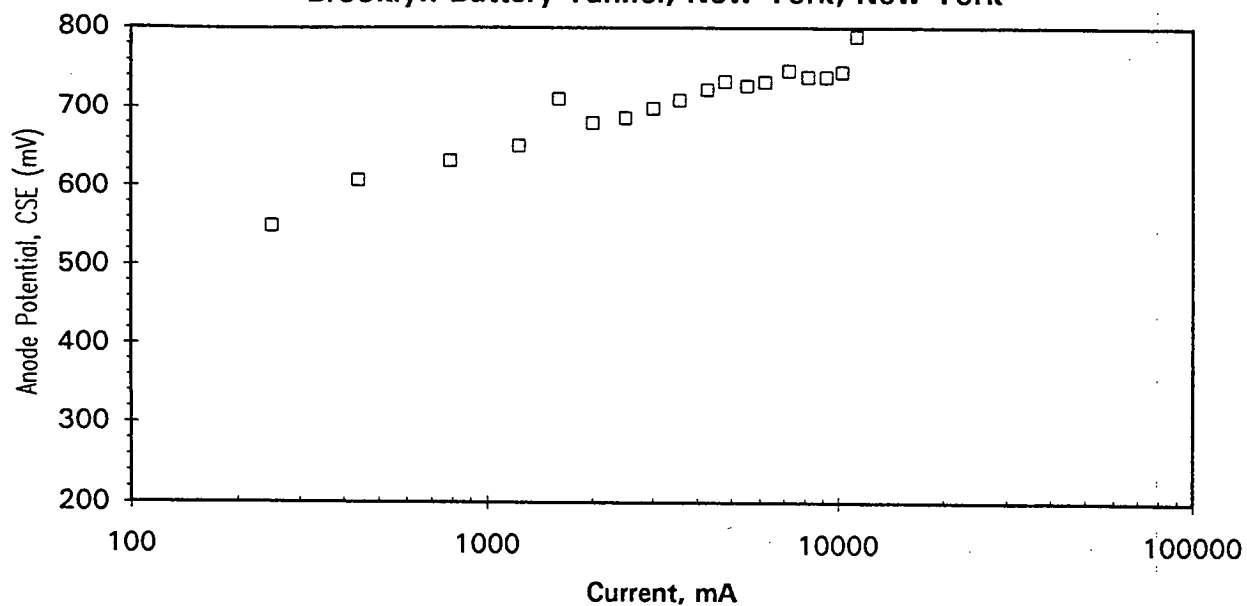
Figure 2.   E-Log I of Anode and Top and Bottom Steel

E - LOG I of the Elgard Mesh Anode
Brooklyn Battery Tunnel, New York, New York

E - LOG I of the Bottom Steel
Brooklyn Battery Tunnel, New York, New York

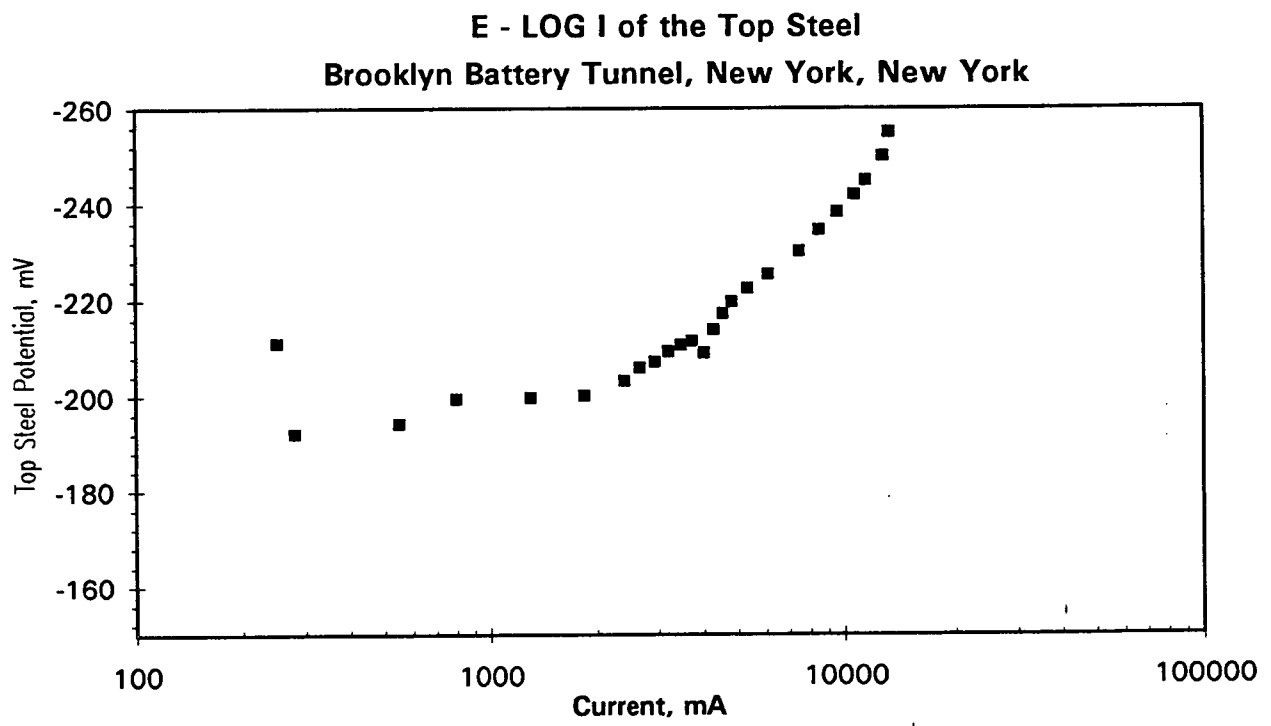
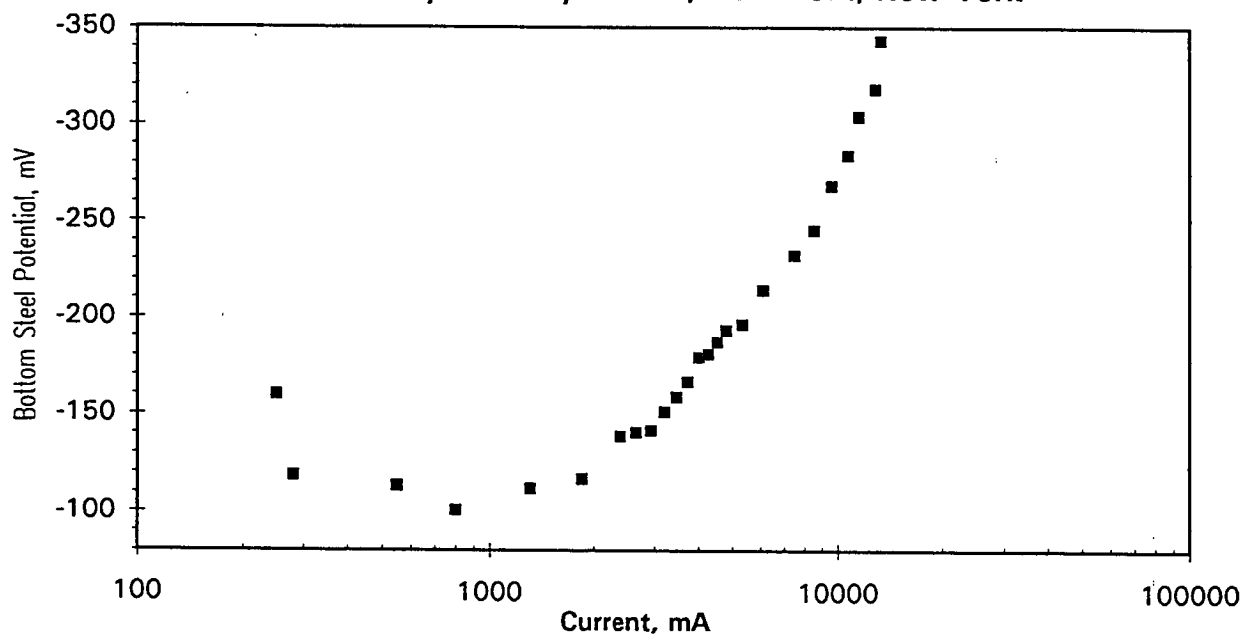
The polarization curves of both the top and bottom steel showed an abnormal trend at lower current levels (i.e., the potential shifted more positive with the increase in cathodic current). However, the normal trend (i.e., the potential shift to more negative potential with the increase in cathodic current) was observed at higher current levels. The reason for this behavior is not known. The polarization curve for the top and bottom steel had three distinct regions as shown in Figure 2 and the start of the third region was identified as the protection level. The current

corresponding to this level of protection was about 8 amperes and a current density of 3.0 mA/ft² of concrete surface area.

Figure 2 also gives the polarization curve for the mesh anode. The anode potential seemed to stabilize at higher current levels and operated at 740 mV at the identified protection level. The corresponding current density on the anode was 10.00 mA/ft² which was only 50 percent of the anode current discharge capacity.

A conservative analysis of the E-Log I plot yielded a protection current of 8 A as described. A more rigorous analysis of the E-Log I plot indicated a protection current in the range of 5 A.
