NALCO

Corrosion in the Petroleum Industry

TABLE OF CONTENTS

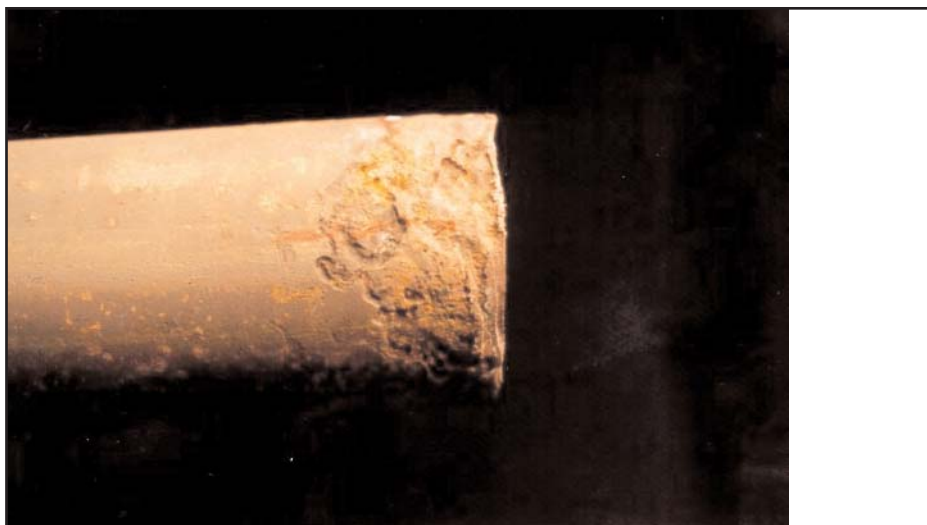
Figure I-1: Uniform Corrosion

Carbon dioxide (CO_2) is absorbed in brines and can cause severe corrosive attack of steel. The corrosion rates of CO_2 can theoretically be from 1,000 to 10,000 mils per year, if not stopped by corrosion products or inhibitors. Uniform corrosion takes the form of hills and valleys with very little area that is not attacked (Figure I-1).

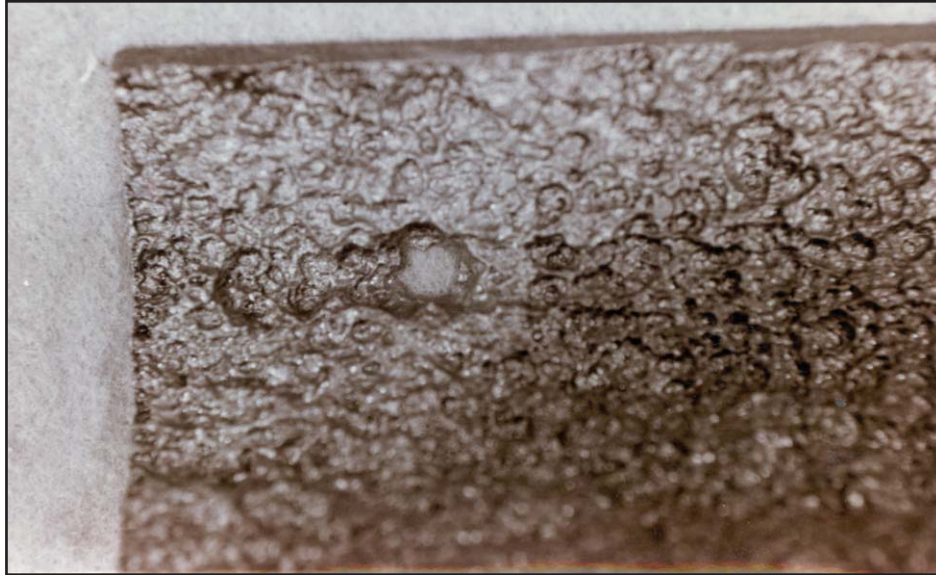
Figure I-3: Uniform Corrosion with Numerous Pits

Another form of CO₂ corrosion takes the form of numerous pits (Figure I-3).

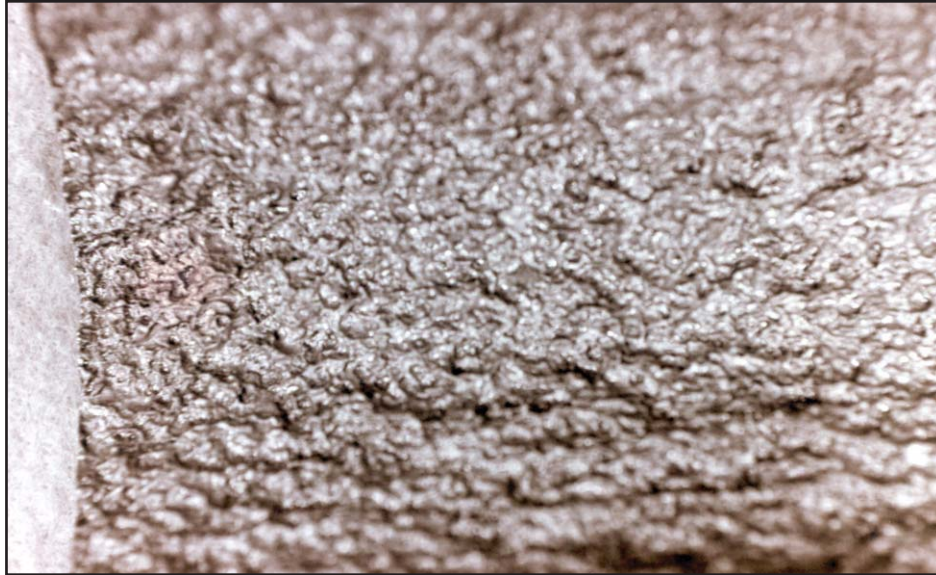
Figure I-5: Uniform Corrosion Showing Hills and Valleys

Figure I-4 and Figure I-5 show additional examples of uniform corrosion, leaving a distinctive hill and valley texture.

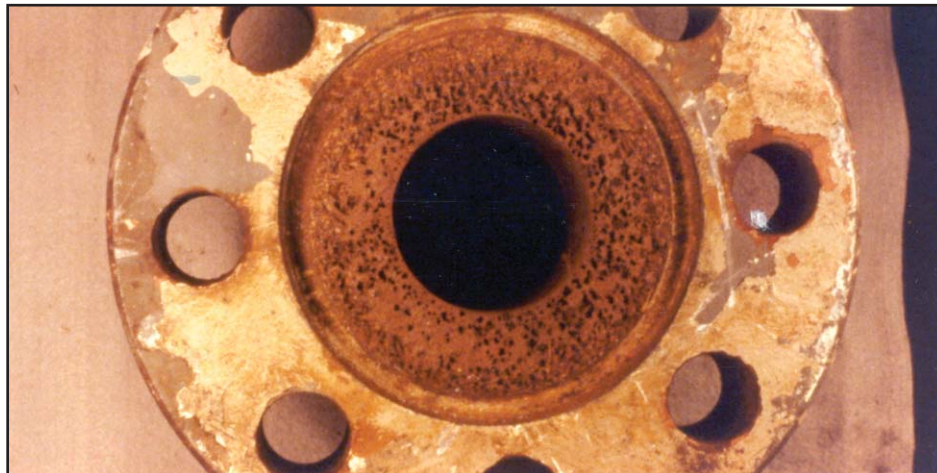
Figure I-7: CO₂ Attack — Honeycomb Pattern

Another form of CO₂ attack has been observed on exposed faces of high-pressure wells, taking the form of an intricate honeycomb (Figure I-6 and Figure I-7).

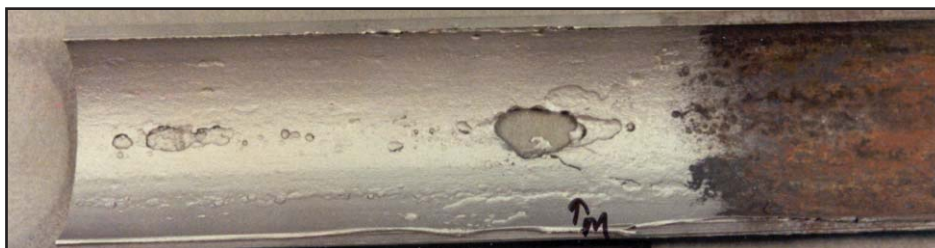
Figure I-10: Tubing Perforated by CO_2 Corrosion

A piece of downhole tubing that perforated within two years of operation is shown in Figure I-10 and Figure I-11.

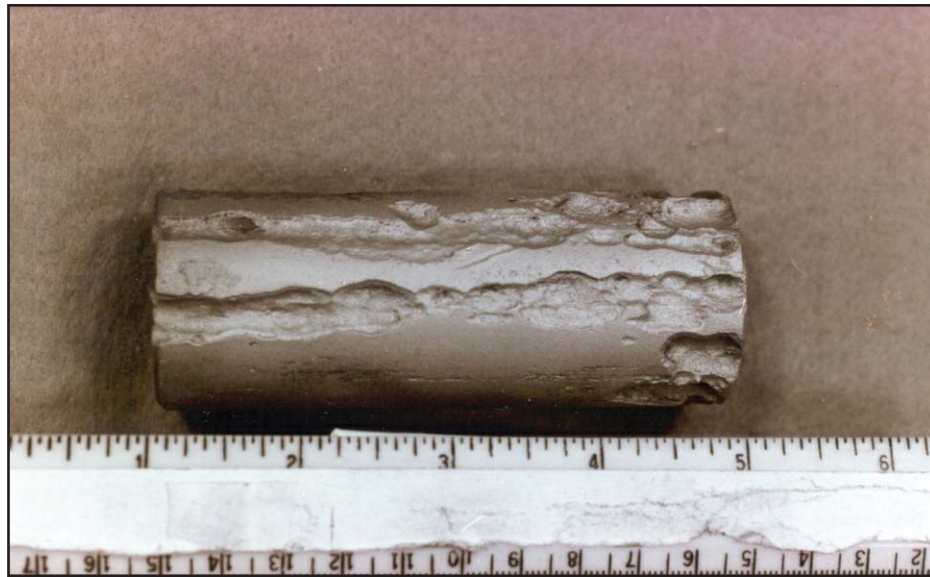
Figure I-13: Sucker Rod Connector with Wormhole

In the wormhole attack, individual CO₂ pits are interconnected and form a wormhole appearance, with segments very similar to the segmentation pattern on a worm. A sucker rod connector had a typical wormhole (Figure I-13).

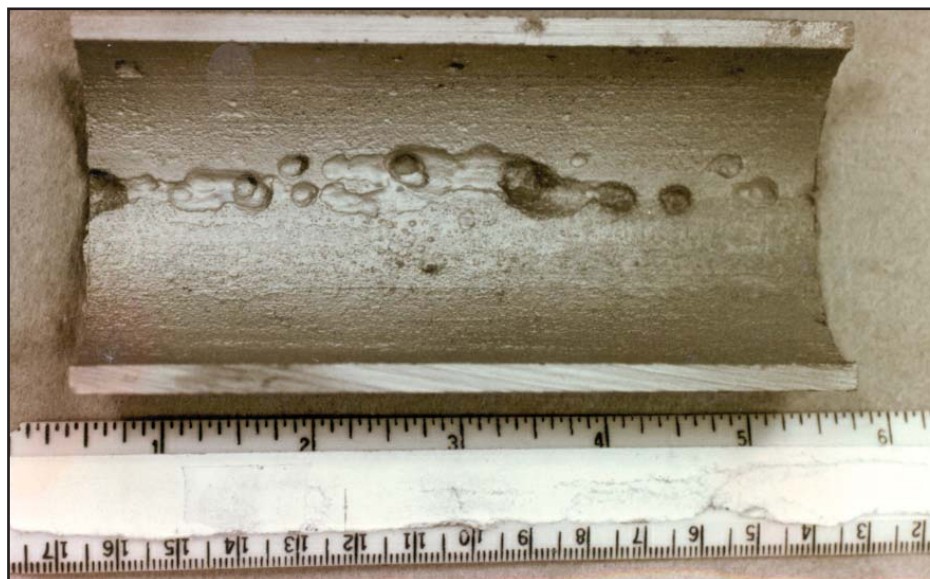
Figure I-14: Tubing with Wormhole Attack

Tubing with wormhole attack can be seen in Figure I-14, with a close-up view in Figure I-15.

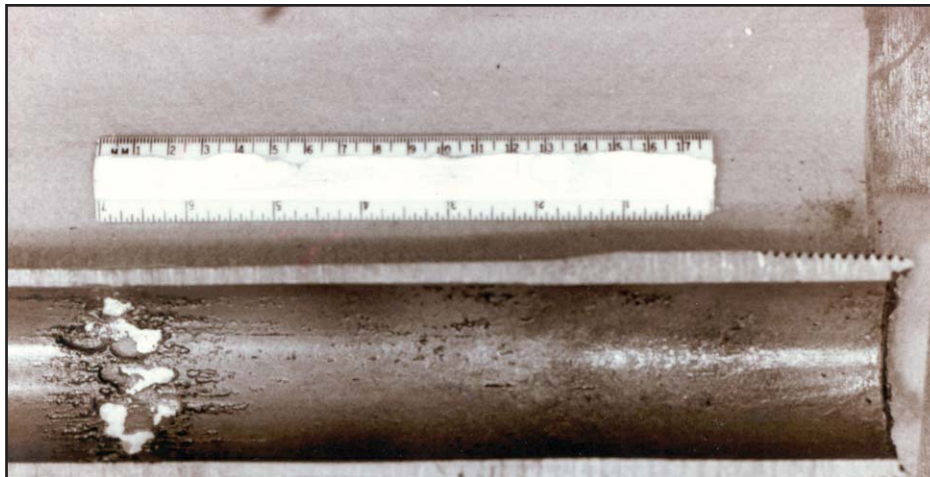
Figure I-17: Ringworm Corrosion

Another form of corrosion observed in the oilpatch is named ringworm corrosion (Figure I-17).

Ringworm corrosion is a metallurgical effect caused by the making of the upset. In fabricating the upset, a zone is created 4 to 6 inches from the upset shoulder, wherein carbon particles have been spheroidized. These spheroidal-shaped particles accelerate corrosion in mildly corrosive or even non-corrosive environments. This is a galvanic effect. If one observes numerous through-the-wall penetrations in tubing 4 to 6 inches from the upset shoulders such as in Figure I-18, ringworm corrosion is suspected.

The treatment for ringworm corrosion is to normalize the steel after making the upset. Normalizing redissolves the carbide particles eliminating the zone created by making the upset.

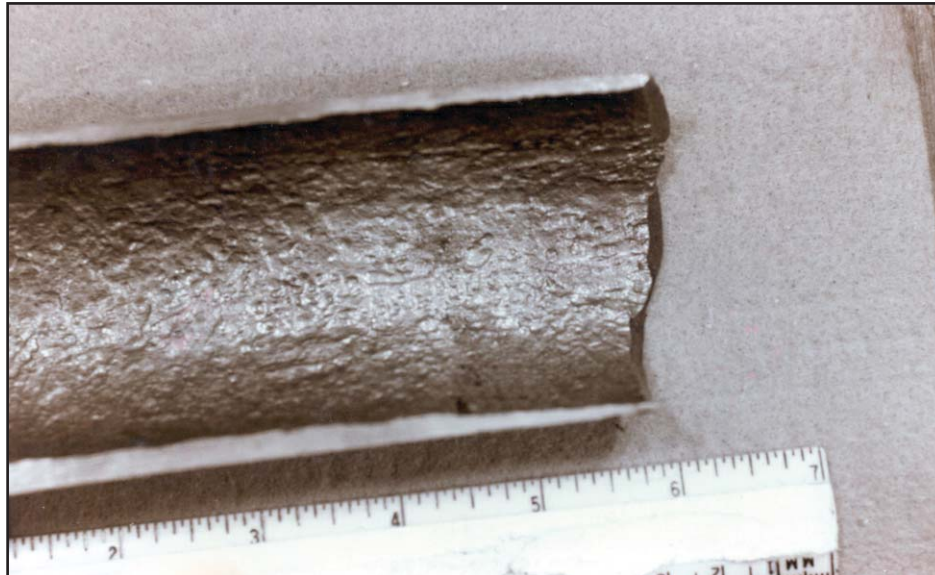
Figure I-19: Parted Tubing by Ringworm Attack

Ringworm can cause tubing parting (Figure I-19).

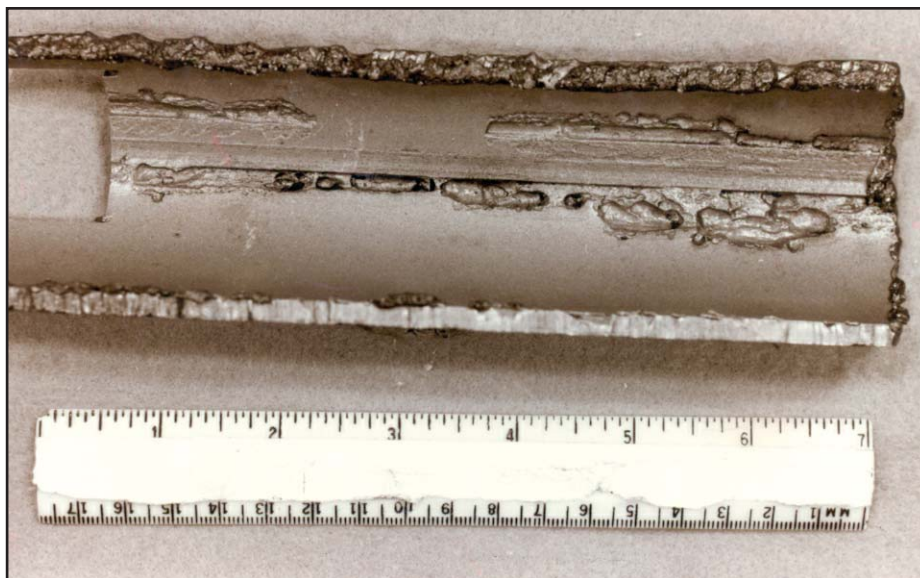
Figure I-21: Heat-affected Zone Corrosion

Another form of galvanically accelerated corrosion is called heat-affected zone corrosion (Figure I-21).

Heat-affected zone corrosion is found in elbows, reducers, and flowline tees. These are typically field welds, where there are no means of negating the effect of welding by post weld heat treatments. The fix for heat-affected zone corrosion is to normalize the steel after welding, which can be done on tubing, but may not be possible on field welds.

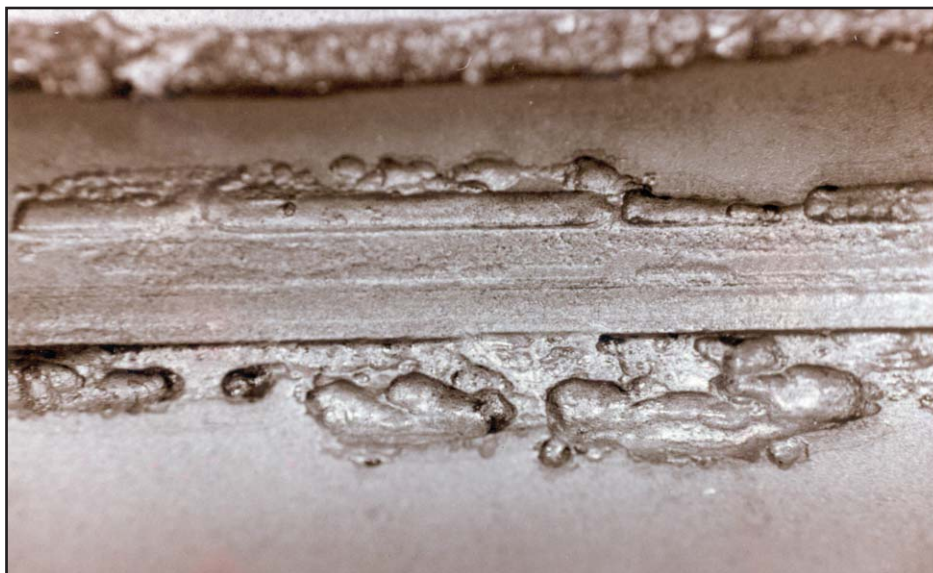
Figure I-22: HAZ as Typified by Deep Corrosion Along Weld Seam

Heat-affected zone corrosion or HAZ attack is typified by deep corrosion along the weld seam. Figure I-22 shows a typical example and Figure I-23 illustrates a close-up view.

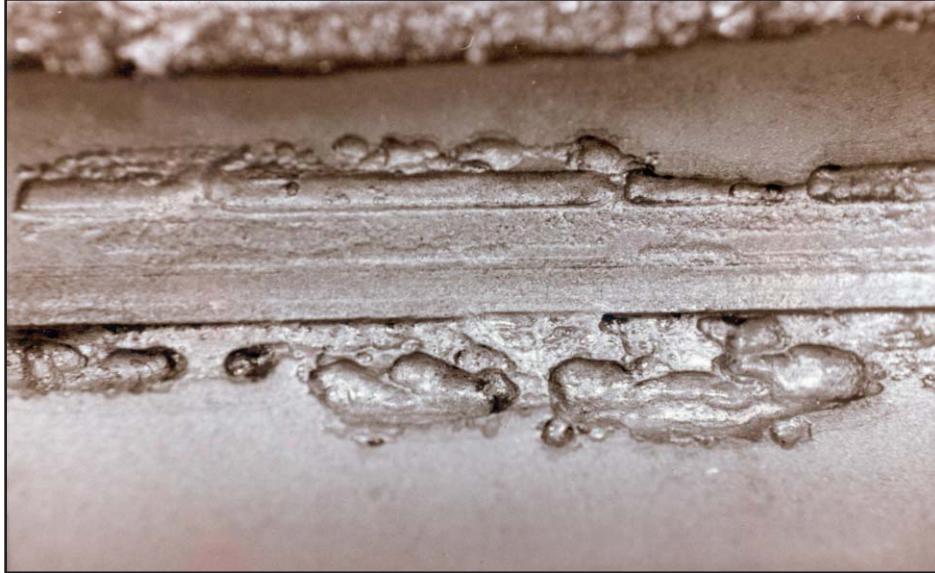
Figure I-23: Close-up of Figure I-22

The weld seam is relatively unharmed, although the zone right next to the weld is deeply corroded. This can be seen in a photomicrograph through the weld and heat-affected zone. The heat-affected zone is darker than the weld (Figure I-24).

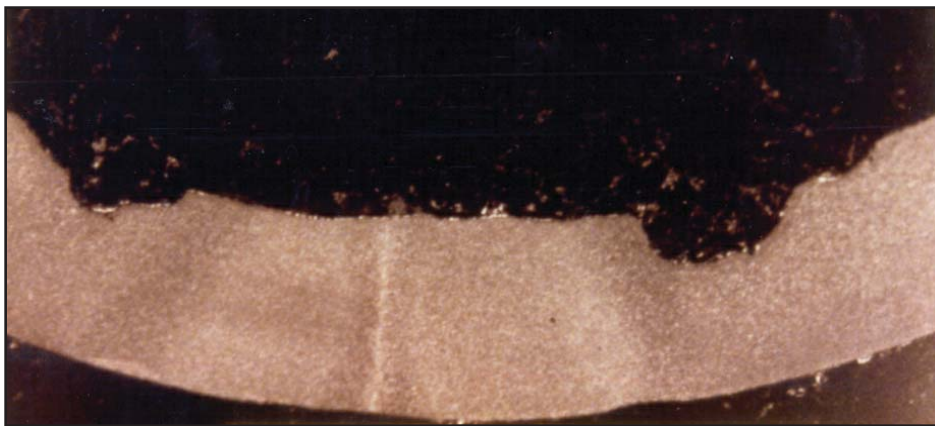
Figure I-24: Photomicrograph of HAZ Attack

The HAZ corrosion mechanism is similar to ringworm corrosion. During welding, a zone is created wherein carbon particles accumulate and precipitate to form nodules. These nodules in mildly corrosive environments form a galvanic cell. The weld itself can preferentially corrode at times (Figure I-25).

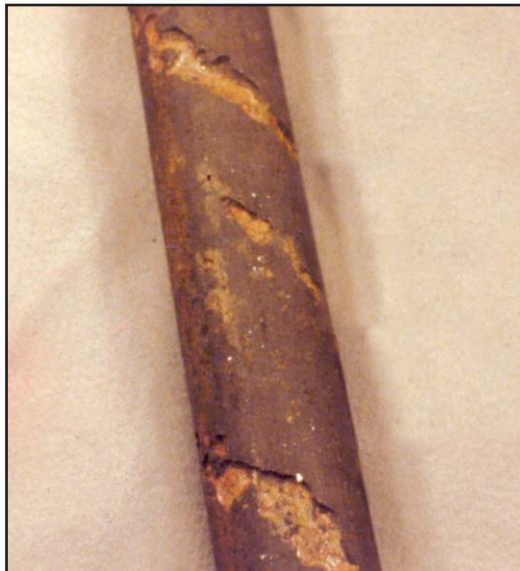
Figure I-26: Corrosion Resulting from Rolled-in Inclusions

An unusual form of metallurgical attack on the outside of tubing is shown in Figure I-26 and I-27, and is attributed to rolled-in inclusions.

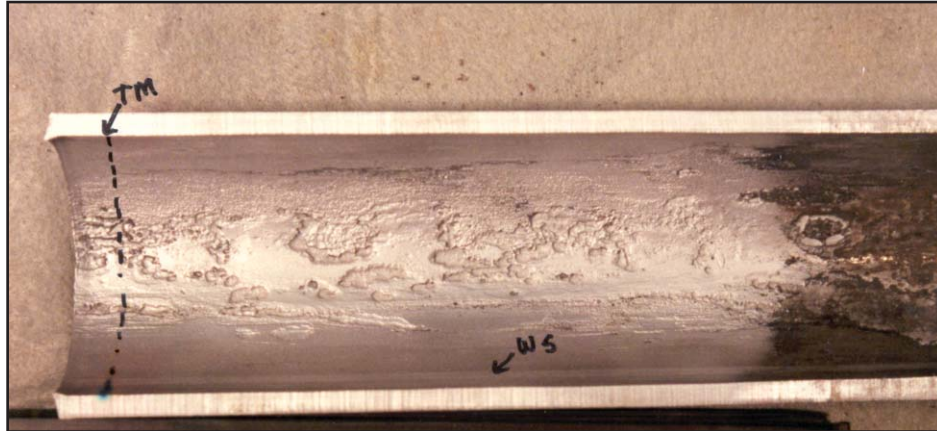
Figure I-29: Mesa Attack on Tubing

Tubing that has undergone mesa attack can be seen in Figure I-29. Flat surfaces and deep gouges between the flat surfaces typify it (Figure I-30). Mesa corrosion can be controlled with inhibitor films to get greater protection on those surfaces where corrosion has occurred.

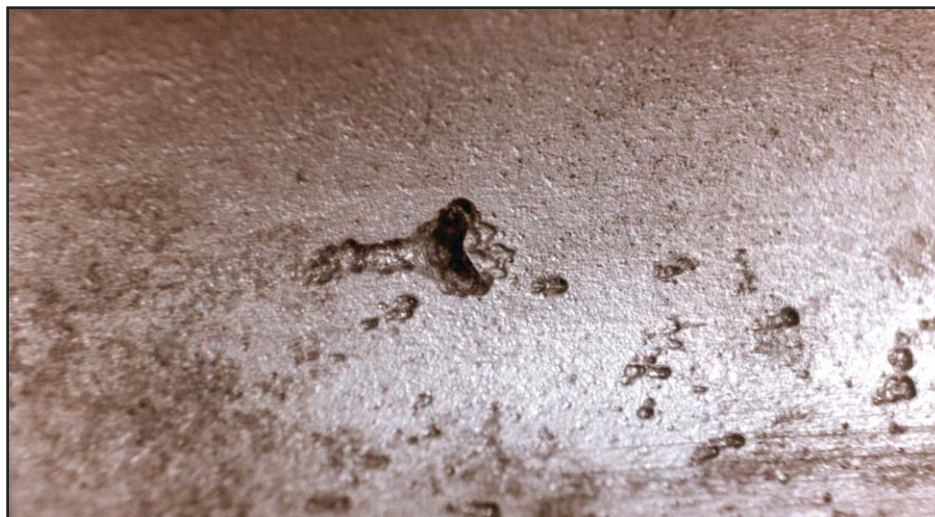
Figure I-33: Close-up View of Pit

A close-up view of the pit shows the typical tail. The tail is usually downstream of the flow, pointing opposite to the direction of flow. It is formed by the escaping or dripping of corrosion by-products out of the deep pit (Figure I-33).

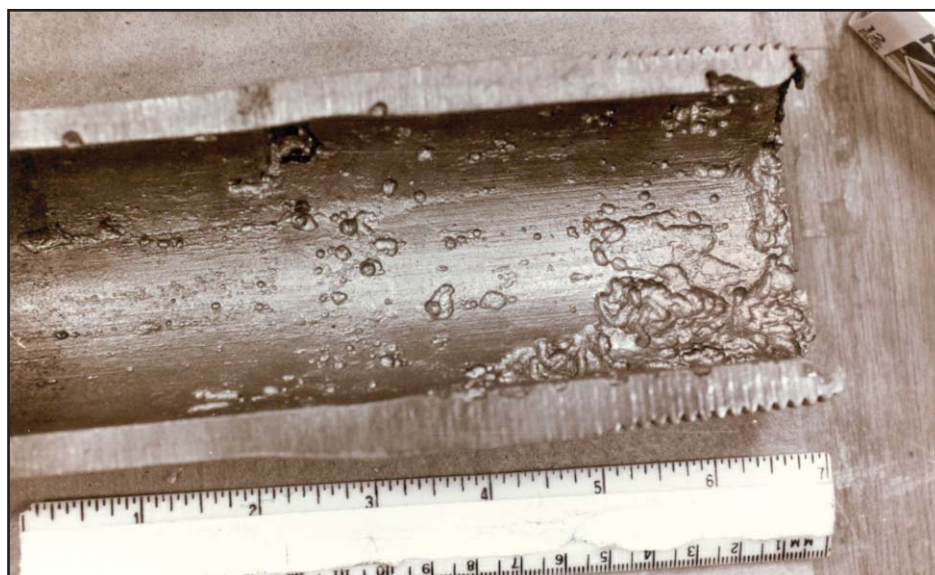
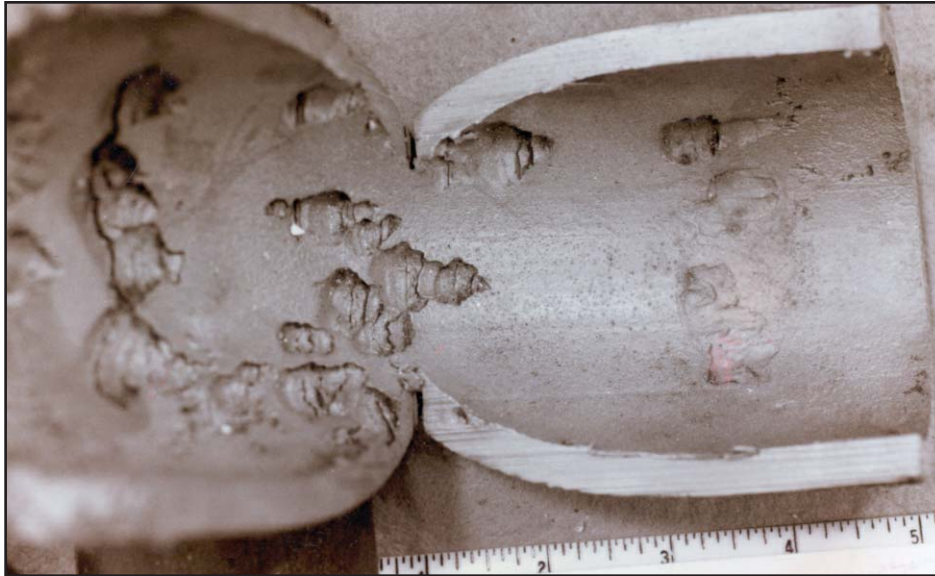
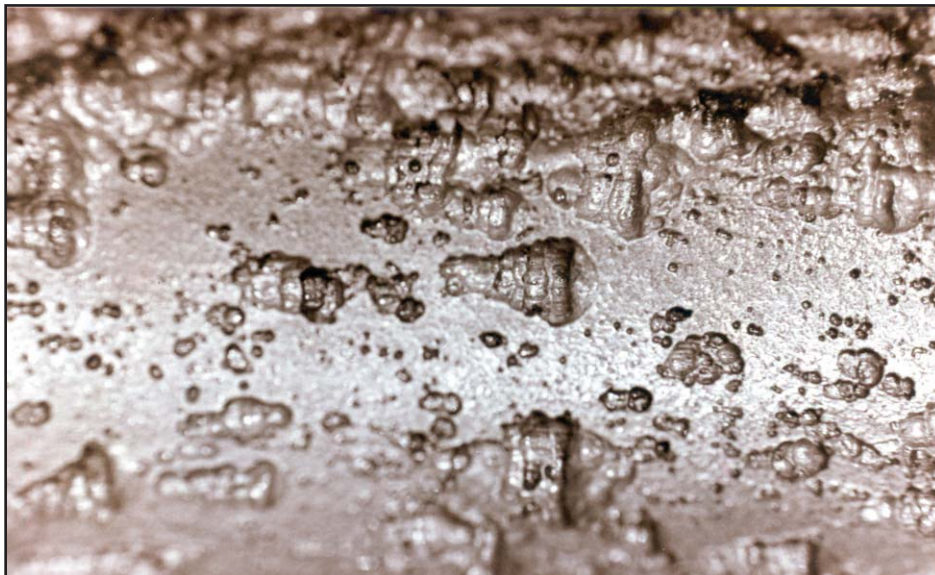
Other examples of the raindrop effect are shown in Figure I-34, Figure I-35, and Figure I-36. Use of corrosion inhibitor films might prevent the raindrop effect by preventing droplets from hanging up in the tubing. The most prevalent place for the raindrop effect has been relatively close to the Christmas tree head. However, the effect has also occurred at lower levels where the temperature is low enough to condense the moisture from the gas stream.

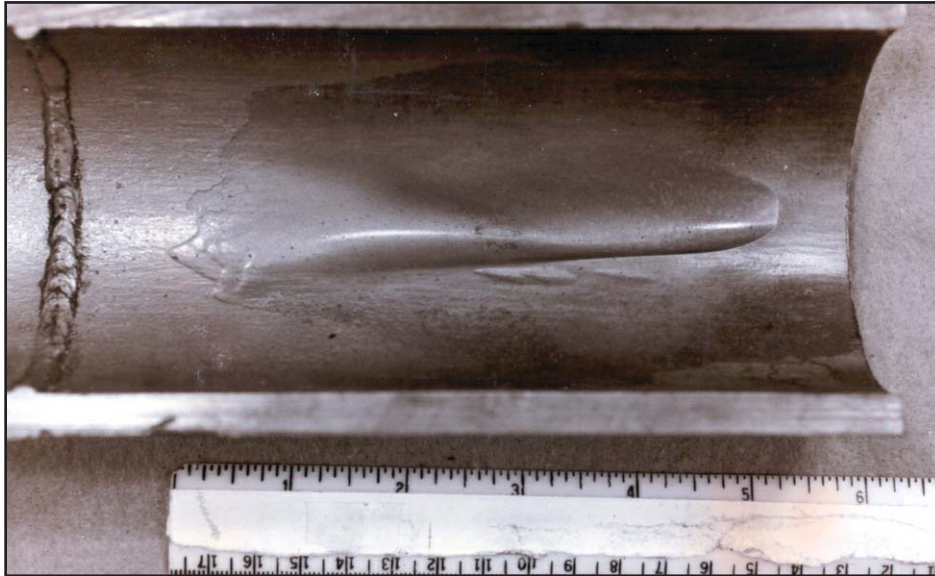
Figure I-37: Flow-Enhanced Corrosion

Another form of severe metal loss usually leading to rapid failures is flow-enhanced corrosion (Figure I-37).

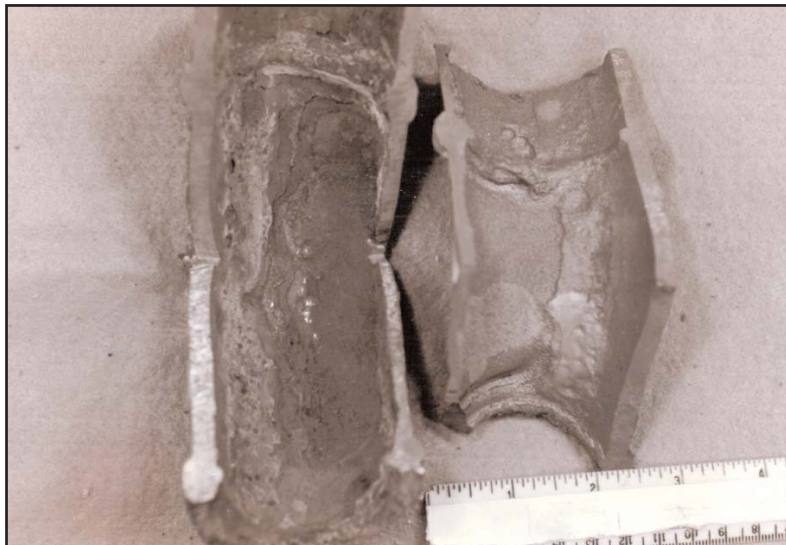
Figure I-38: Flow-Enhanced Corrosion in an Elbow

Flow-enhanced corrosion was at one time called erosion-corrosion. Flow-enhanced corrosion usually occurs when a change of direction in the flow of fluids occurs, such as near an elbow. Typically, the mechanism follows a deposition of a protective FeCO_3 film with rubbing off the film by the flow of fluids, and sometimes solids. After the protective coating is abraded off, a new surface is exposed which then immediately starts to corrode. The corrosion product is a softer surface, which is then eroded away, and the process continues until a failure occurs. The following illustrates an elbow taken from a flowline (Figure I-38).

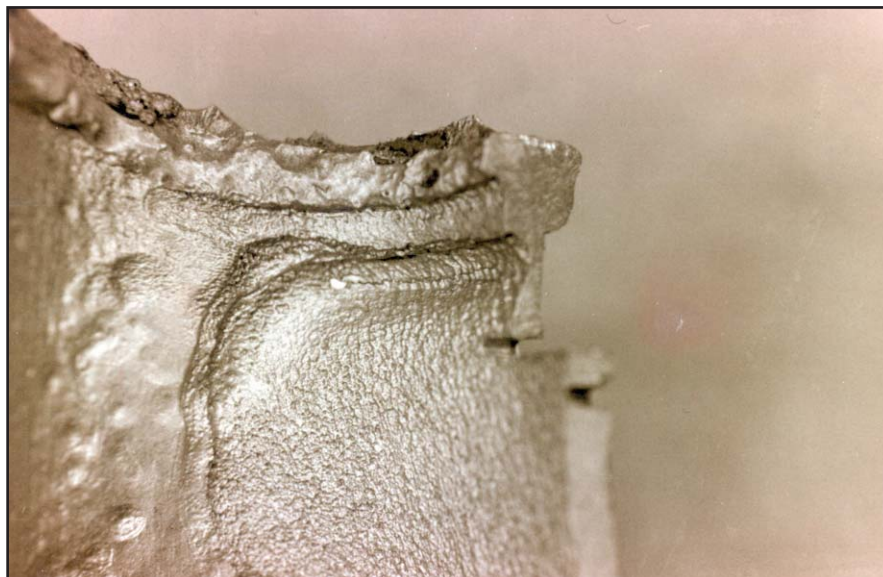
Figure I-40: Close-up Showing Penetration

Figure I-39, a close-up view after cleaning, shows the severe metal loss. Figure I-40 shows the through-the-wall penetration.

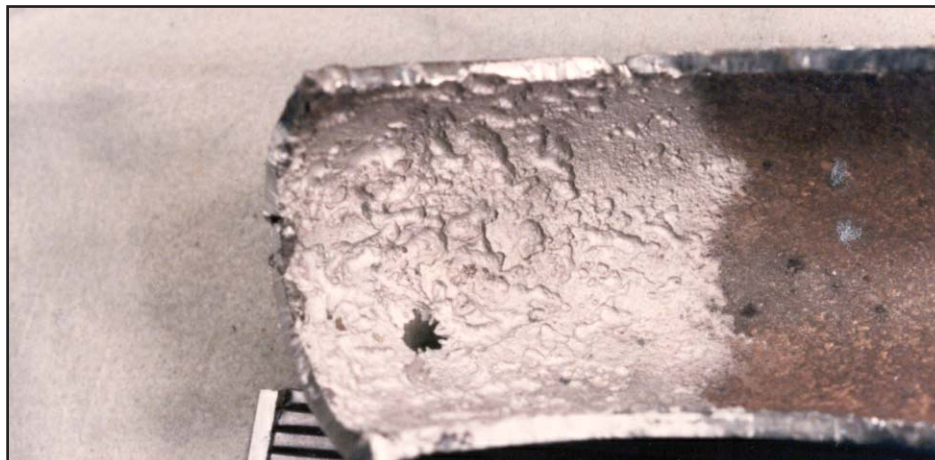
Figure I-43: Flow-Enhanced Corrosion in U-bend

Another example of this flow-enhanced corrosion is located at the top of a U-bend, as seen in this flowline (Figure I-43).

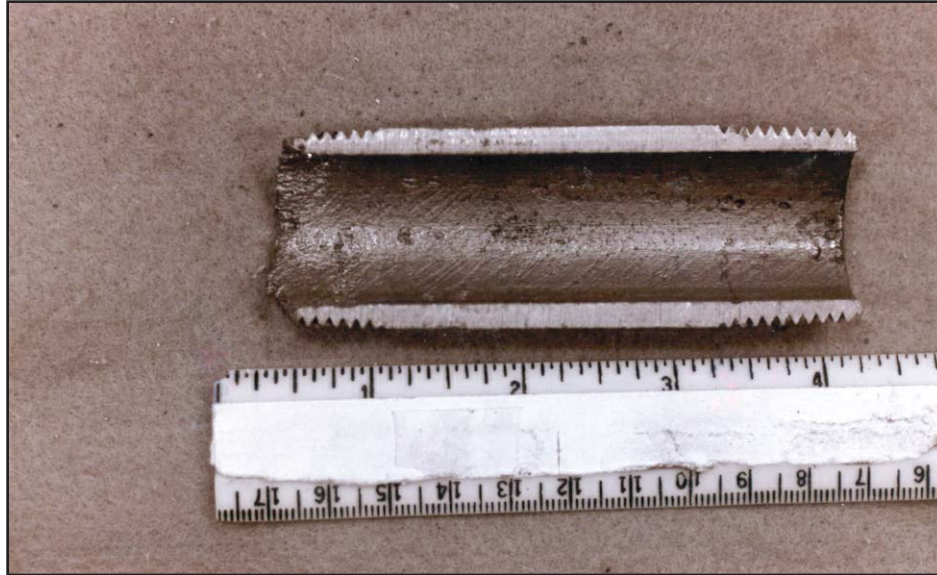
Figure I-45: Flow-Enhanced Corrosion at Nipple Joints

Another form of flow-enhanced corrosion is at nipple joints. Usually there is a gap when a threaded joint is made up, and at the gap, turbulence is generated and flow-enhanced corrosion can occur (Figure I-44 and Figure I-45).

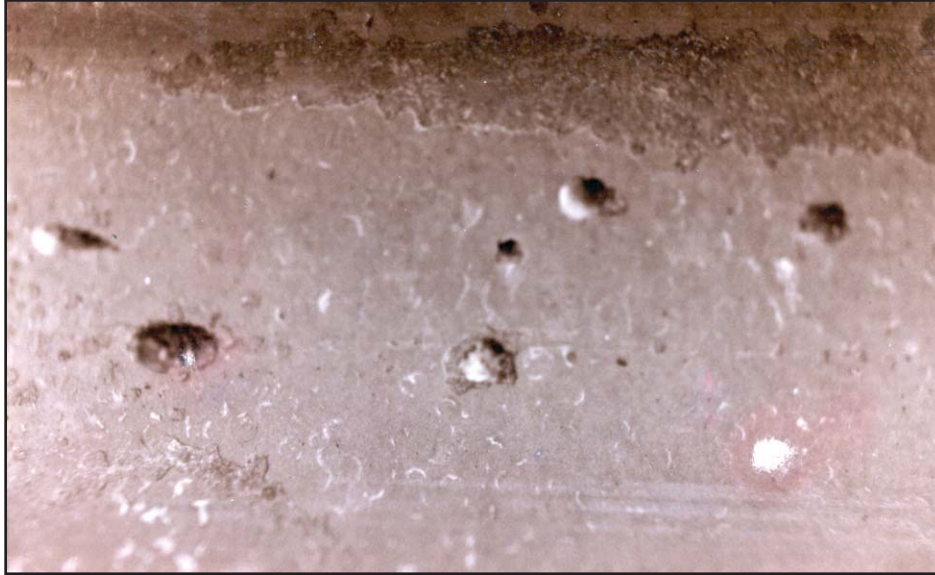
Figure I-49: A Pit Formed from a Pore in the Coating

Pores can sometimes cause an undercutting and pits in the base metal (Figure I-49).

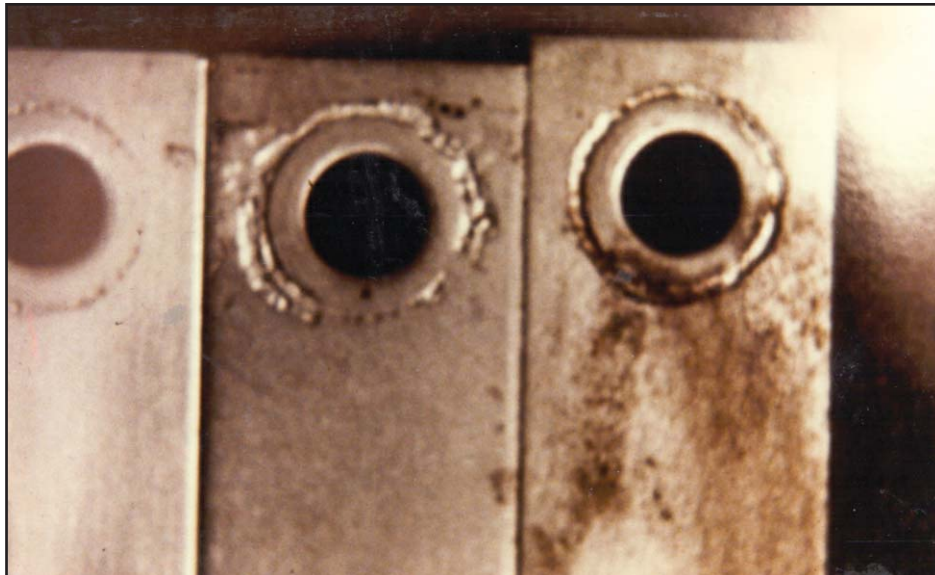
Figure I-50: Crevice Corrosion

Another form of attack is called crevice corrosion. Crevice corrosion usually occurs in metals with a good protective coating. However, at crevices, there are places where the protective coating does not get underneath, and severe localized corrosion can occur (Figure I-50 and Figure I-51).

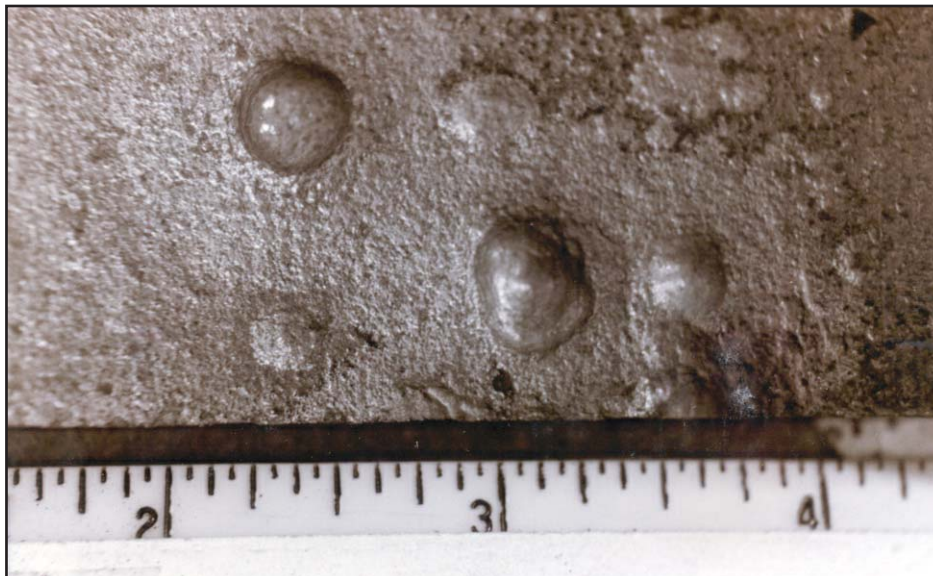
Figure II-3: Typical Pits

A close-up view shows the typical pits (Figure II-3).

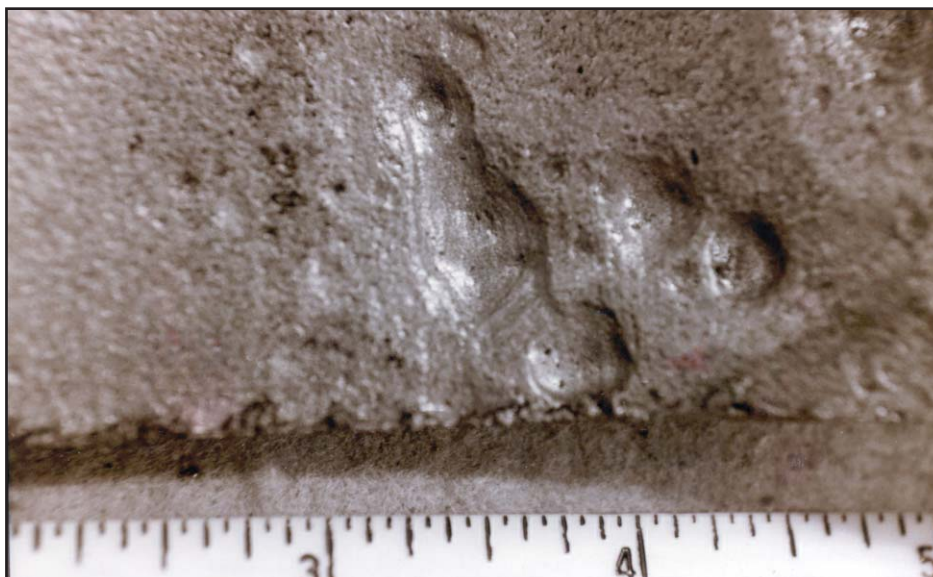
Figure II-4: Shallow Saucer-like Pits

On cleaning, the shallow saucer-like pits are seen (Figure II-4).

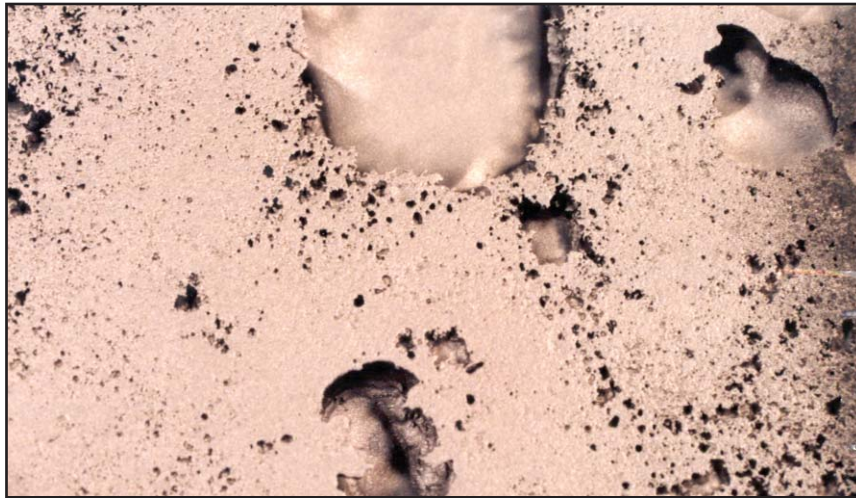
Figure VIII-4: Erosion-Corrosion — DEA Stripper Tower Wall

Metal loss was confined to a DEA impingement zone. Corrosion was attributed to carbon dioxide in the DEA (Figure VIII-4).

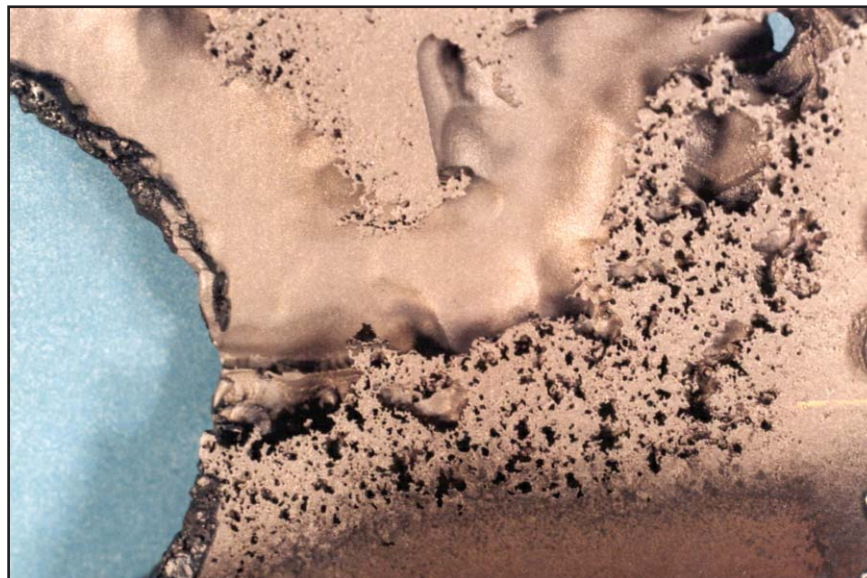
Figure VIII-5: Large Areas Eroded

Figure VIII-5 shows the large areas that were eroded, leaving a smooth surface.

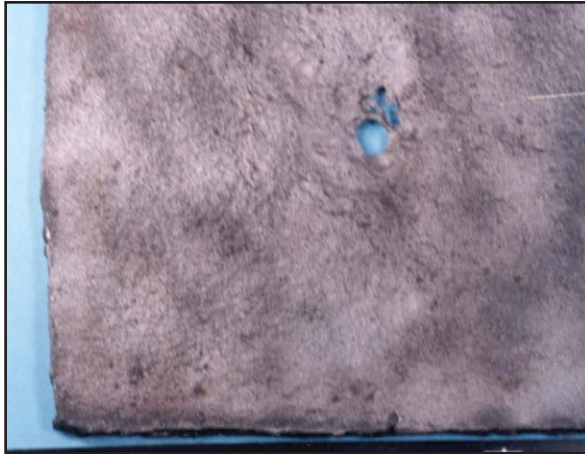
Figure VIII-6: Crude Storage Tank Failure Most Likely from Wet Oxygenated Soils

SRB's and iron oxidizing bacteria attack carbon steel storage tank bottom floor (Figure VIII-6).

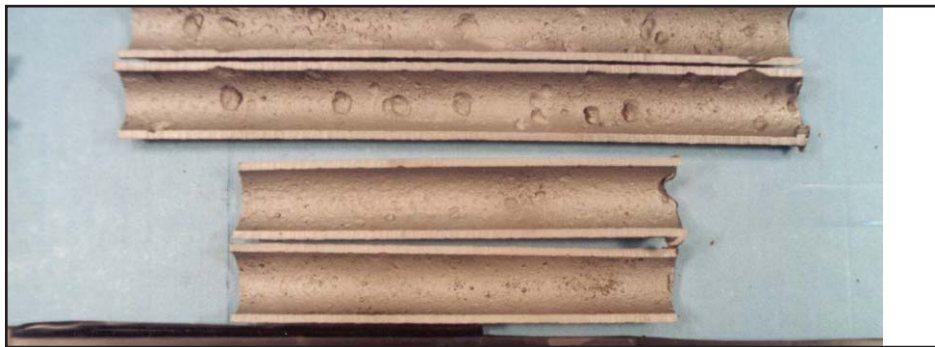
Figure VIII-7: Oxygen, H_2S , and CO_2 Corrosion

Figure VIII-7 shows an example of a carbon steel exchanger tube from a crude pre-heat train (tubeside: crude oil, shell side: hot naphthas).

- Pits were round with smooth side walls and etched bottoms.
- Corrosion by-products were iron oxides, iron sulfides, and iron carbonates, suggesting O_2 , H_2S , and CO_2 as the corrosive species.
- Internal deposits contained calcium, magnesium, chlorine, sodium, and silicon — probably from water in the crude.

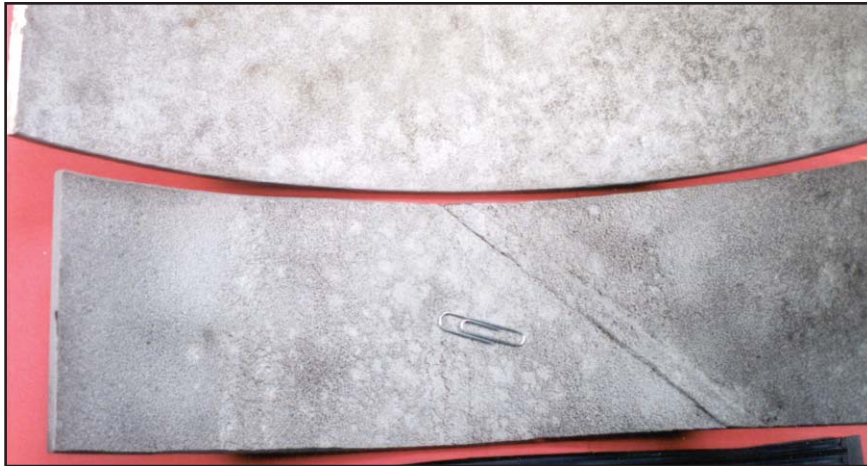
Figure VIII-8: Carbon Steel Product Pipeline Corrosion

Underdeposit etching was attributed to sulfur containing species and oxygenated fuel in transported fuels (Figure VIII-8 and Figure VIII-9).

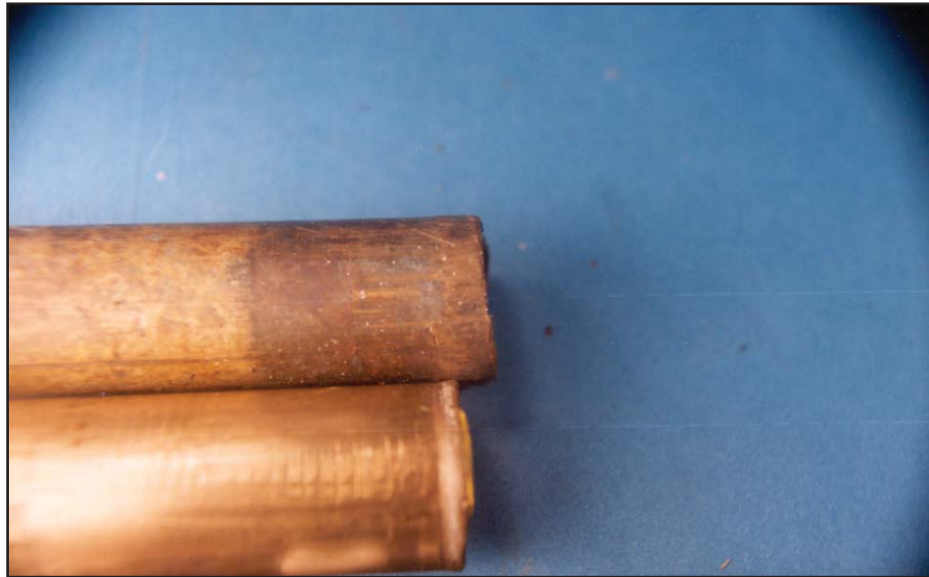
Figure VIII-10: Aluminum Brass Stress Cracking

Aluminum brass crude overhead heat exchanger tubes show signs of stress cracking (Figure VIII-10 and Figure VIII-11). There was no evidence of corrosion affecting the tubes. Therefore this was probably due to:

- Tubes overstressed during installation.
- Thermal stressing during hydrotest and operations.
- Operational stresses, such as water, hammering, and vibration.

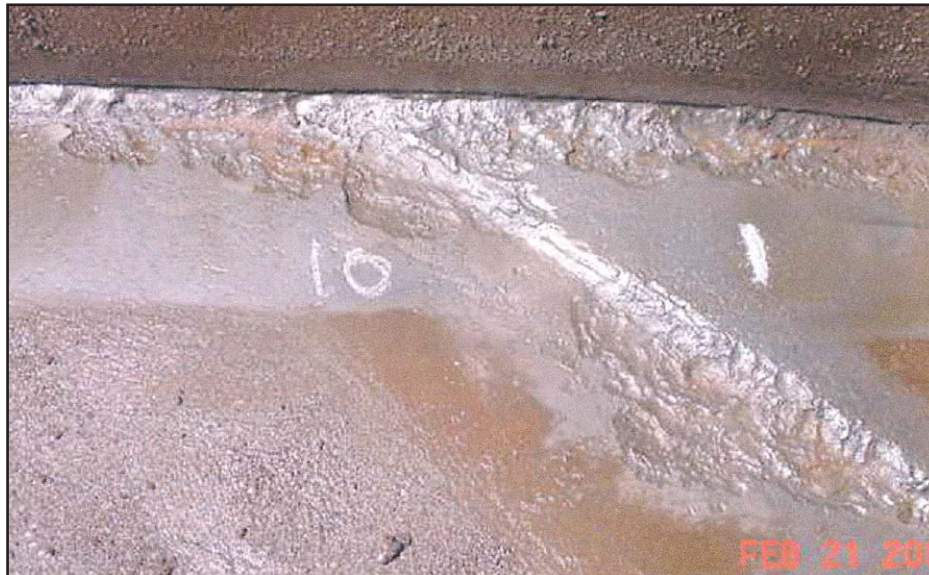
Figure VIII-12: UAN Corrosion — Carbon Steel Storage Tank

Figure VIII-12 and Figure VIII-13 shows an example of UAN corrosion. Note how the corrosion is more severe at the tank edges and along the plate boundaries.

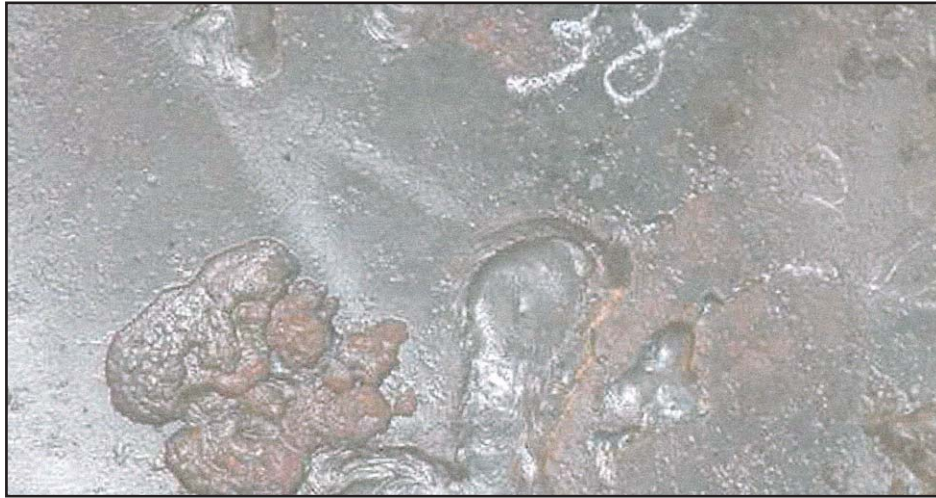
Figure VIII-14: UAN Corrosion on Carbon Steel Storage Tanks

Figure VIII-14 shows an example of corrosion on a carbon steel storage tank bottom from concentrated UAN

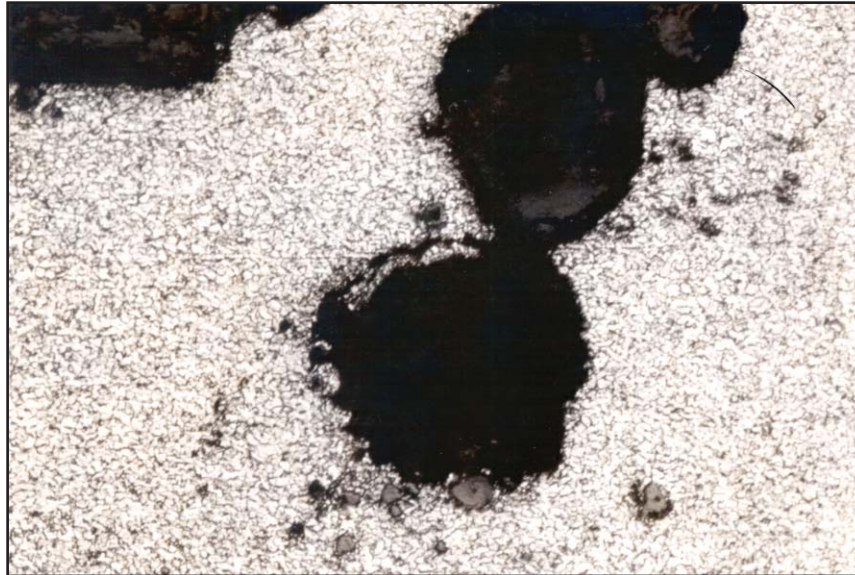
Figure VIII-17: Fuel Storage Tank Corrosion

Figure VIII-17 is a photomicrograph at 100X showing the cavernous pits, carbides, and manganese sulfide stringers.

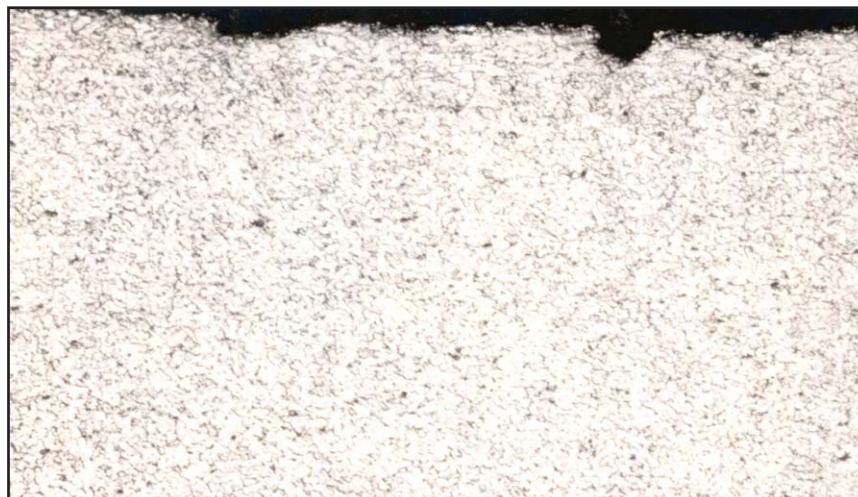
Figure VIII-18: Fuel Storage Tank Corrosion

Figure VIII-18 shows another section of the bottom of the fuel tank where corrosion had not occurred. Note the relative cleanliness as compared to figure VIII-17.

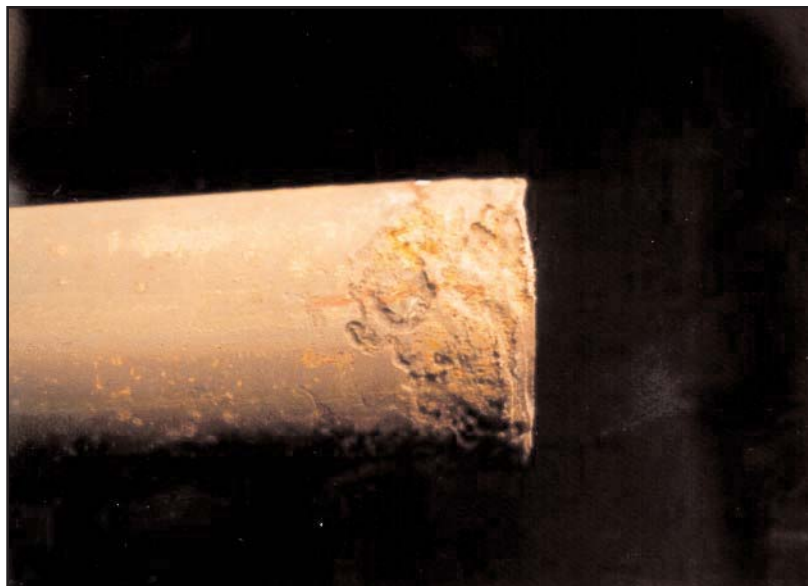
Deep, localized wastage occurred at the ends of several tubes at the bottom of a transfer line exchanger, causing two failures (Figure IX-1). Thick layers of deposits accumulated on the bottom tubesheet of this exchanger (Figures IX-2 and Figure IX-3). These deposits insulated the tubes and tubesheet, and prevented the rinsing away of caustic and other aggressive alkaline salts following steam generation. The alkaline salts concentrated to levels as high as the percent ranges to remove protective iron oxide layers and to attack the steel.

Figure IX-1: Localized Metal Loss at End of Tube that Contacted Bottom Tubesheet

Clean and maintain clean tubesheet surfaces. Alter the design and operation of the exchanger to prevent the formation and entrapment of a steam blanket. Since no corrosion occurred away from the tube ends, boiler water chemistry and treatment was proper and did not contribute to the corrosion.

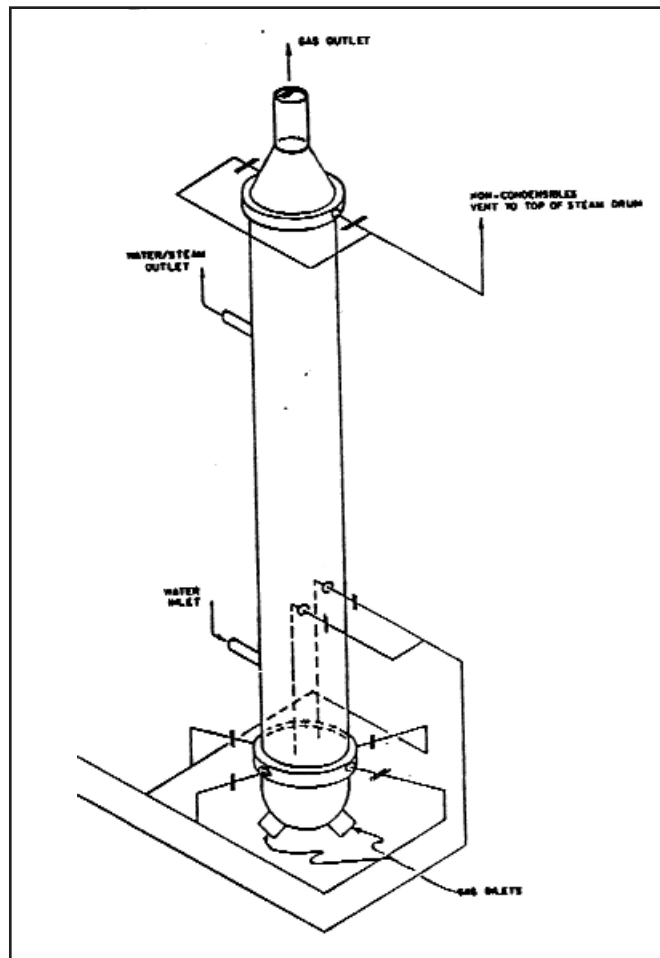
Figure IX-2: Transfer Line Exchanger

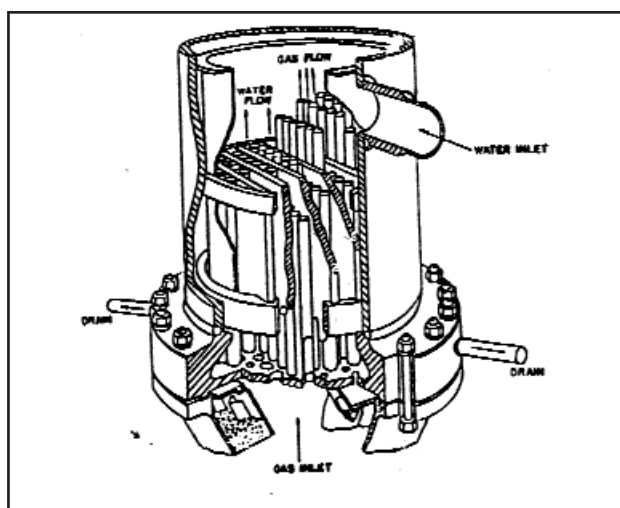
Figure IX-3: Tubesheet where Corrosion Occurred

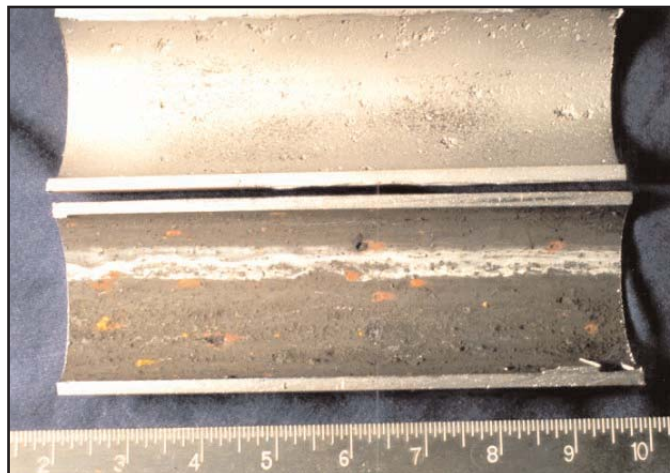
A tube section was removed from the generating bank for surveillance. The internal surface of the section was generally covered with thin, uniform layers of black iron oxides and deposits (Figure IX-5). The uniform layers were interrupted in scattered sites by mounds or tubercles of black iron oxide (Figure IX-6). The presence of iron oxide tubercles indicated that oxygen corrosion occurred at the tubercle sites, resulting from exposure to waters containing excessive concentrations of dissolved oxygen. Removing the layers and tubercles revealed a mostly smooth, unattacked internal surface that was interrupted by moderately deep depressions where the tubercles were present (Figure IX-7).

Figure IX-5: Bottom-half Section Showing Internal Surface Covered with Uniform Layer of Black Iron Oxide Interrupted by Scattered Iron Oxide Tubercles

Idle time oxygen corrosion may be controlled through use of proper lay-up practice. This may include inert gas (nitrogen) blanketing and the proper use of oxygen scavenging chemicals. Such chemicals may be fed to higher levels than used during boiler operation, and may require monitoring, replenishment and circulation. Oxygen corrosion during boiler operation requires proper feedwater deaeration and oxygen scavenging practice.
