NALCO

Corrosion in the Petroleum Industry

TABLE OF CONTENTS

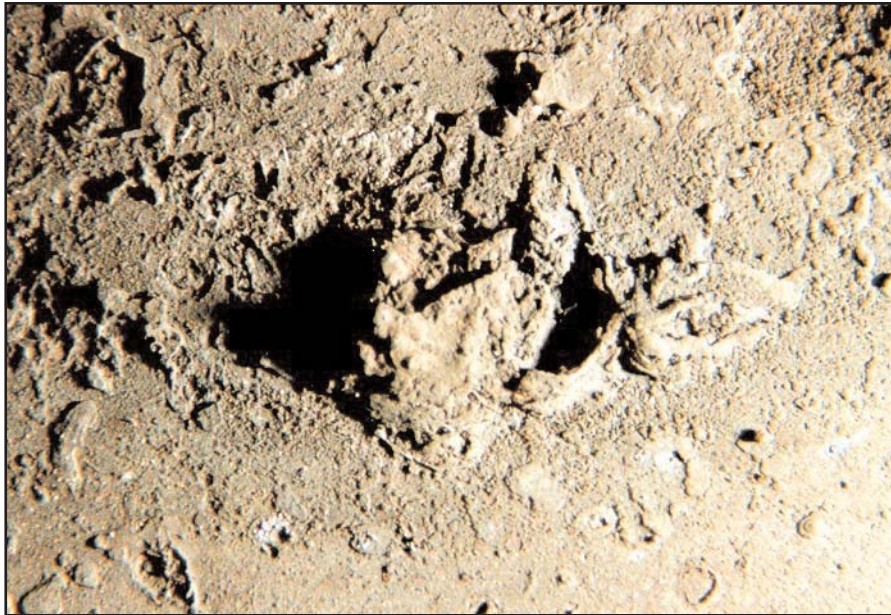
A tube section was removed from the generating bank for surveillance. The internal surface of the section was generally covered with thin, uniform layers of black iron oxides and deposits (Figure IX-5). The uniform layers were interrupted in scattered sites by mounds or tubercles of black iron oxide (Figure IX-6). The presence of iron oxide tubercles indicated that oxygen corrosion occurred at the tubercle sites, resulting from exposure to waters containing excessive concentrations of dissolved oxygen. Removing the layers and tubercles revealed a mostly smooth, unattacked internal surface that was interrupted by moderately deep depressions where the tubercles were present (Figure IX-7).

Figure IX-6: Iron Oxide Tubercle with No Flow Orientation

Idle time oxygen corrosion may be controlled through use of proper lay-up practice. This may include inert gas (nitrogen) blanketing and the proper use of oxygen scavenging chemicals. Such chemicals may be fed to higher levels than used during boiler operation, and may require monitoring, replenishment and circulation. Oxygen corrosion during boiler operation requires proper feedwater deaeration and oxygen scavenging practice.

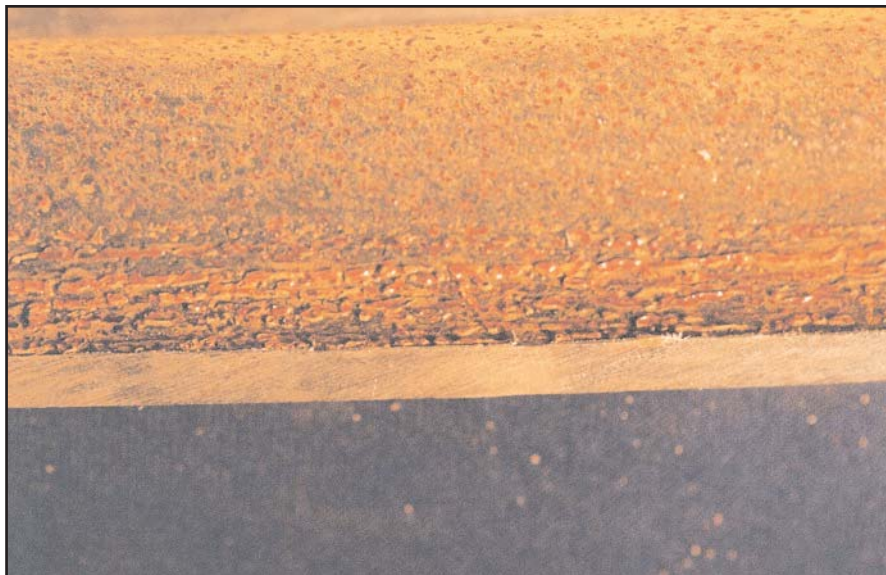
In some cases, idle time oxygen corrosion may be identified by the pattern and nature of iron oxide formation. Figure IX-8 shows the internal surface of a horizontally-oriented economizer tube that experienced shallow metal loss within narrow strips along the bottom. During idle periods the boiler was drained and a shallow pool of water remained along the tube bottom. Air leaked into the boiler and oxygenated the residual water to cause oxygen corrosion that produced orange-brown iron oxide corrosion products.

Figure IX-8: Localized Strip of Orange-brown Iron Oxide along bottom of Horizontal Tube

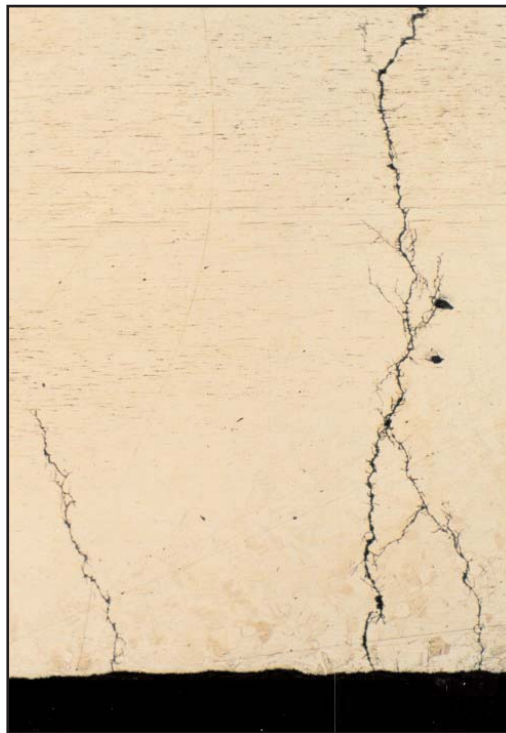
Metallographic cross-sections revealed that the cracks were transgranular, highly branched and penetrated from the internal surface outward (Figure IX-16). This revealed that the fissures and cracks formed due to stress corrosion cracking.

Figure IX-16: Metallographic Cross-section Revealing Branched, Transgranular Cracks Penetrating Outward from Internal Surface

The most probable corrodent responsible for stress corrosion cracking was determined to be chloride for several reasons.

- 1) The threshold concentration of chloride necessary to cause cracking may be quite low at the normal operating temperatures of the deaerator. Cracking may occur at chloride concentration as low as 20 ppm at 200°F (93°C).
- 2) Caustic stress corrosion cracking rarely occurs at metal temperatures below 300°F (149°C) and generally requires concentrations of caustic in the percent levels. It is improbable that either condition was met in this system.
- 3) The presence of depressions and oxide corrosion products on the internal surface would have formed due to corrosion by chloride. Caustic would not tend to cause such corrosion.

Since chloride stress corrosion cracking may occur at even low concentrations at normal operating temperatures, it is recommended that deaerators and water-wetted components throughout boilers should not be constructed of austenitic stainless steels. Aside from this recommendation, chloride stress corrosion cracking may be prevented only by ensuring that no chloride gets into the deaerator, which will be very difficult and expensive to accomplish.

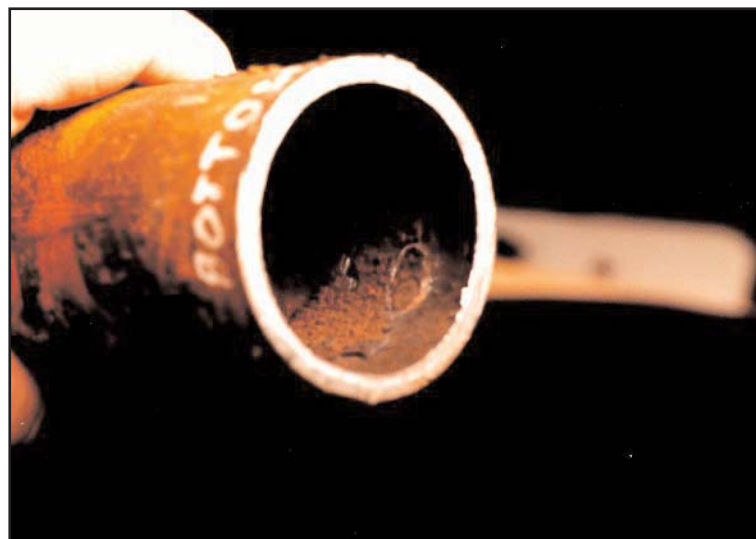
Two bulges formed within a localized area on the hot side of a boiler wall tube (Figure IX-17). The bulges occurred in a tube that was located near a burner. Internal deposition was light in all areas except at the bulges (Figure IX-18).

Figure IX-18: Localized Deposition at Bulge Site

All of the microstructural features at the bulges indicated that the tube wall at the bulge sites experienced mild, long-term overheating. Metal temperatures ranged from about 850° to 1,100°F (454° to 593°C) for a period ranging from several weeks to several months. Metals have decreased strength at high temperatures (Figure IX-22). Consequently, the tube wall bulged under stresses supplied by internal pressure. The localized nature of the bulging and internal deposition indicated that overheating was caused by excessive fireside heat input.

The most practical method of controlling overheating in this case would be through proper insulation of the external surfaces of the tubes in the location where the bulges formed. This may be provided by installing refractory or repairing damaged refractory at that location. If this cannot be accomplished, then excessive heat input should be prevented by decreasing firing rates and preventing localized channeling of hot gases to the zone of the bulged tube.

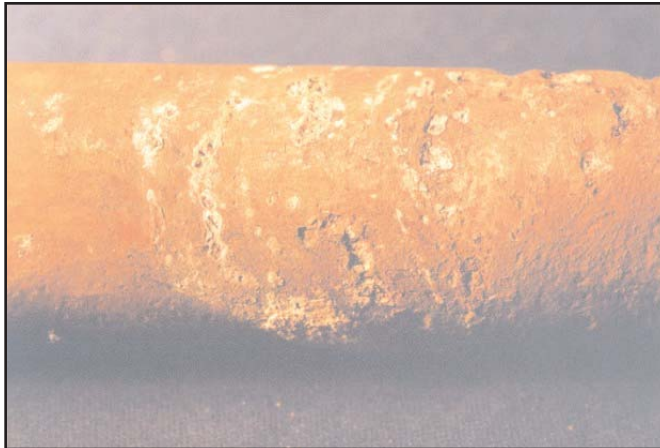
Numerous deep depressions formed on the external surfaces of several different economizer tubes (Figure IX-23). Thick layers and mounds of light-colored deposits covered the depressions and surfaces in the surrounding areas. Deep depressions were found beneath adherent deposits (Figure IX-24). These deposits tested acidic in a distilled water solution. Chemical analysis of the deposits revealed the presence of high concentrations of sulfate and volatile sulfur compounds. The presence of these deposits indicates that the fireside corrosion may have been caused in part by the condensation of sulfuric acid on the surfaces. When high sulfur content fuels are combusted, the sulfur is oxidized to sulfur trioxide, which combines with moisture in the furnace environment to form sulfuric acid.

Figure IX-23: External Surface Depressions and Acidic, Light-colored Deposits

- 1) Maintaining metal temperatures above the sulfuric acid dewpoint.
- 2) Reducing moisture content (lower moisture content fuels and minimization of soot-blowing).
- 3) Altering firing practice, by combusting fuel with lower excess air.
- 4) Feeding fuel treatment additives.

- 1) Removing corrosive acidic fireside deposits with high pressure water sprays followed by rinsing with a neutralizing lime wash spray.
- 2) Maintaining a dry fireside environment with the aid of dessicants.

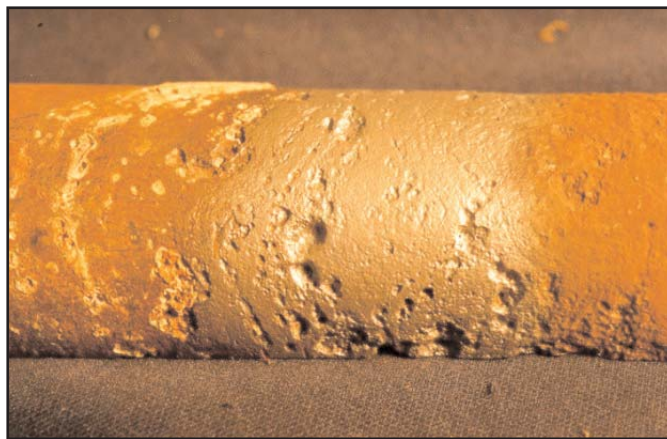
Figure IX-24: Deposits Removed to Reveal Depressions

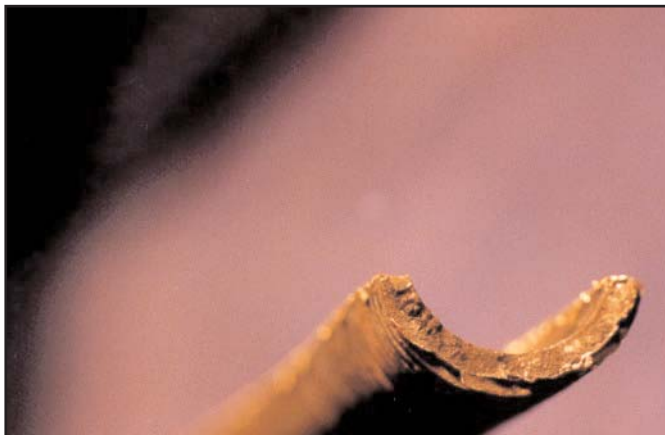
Approximately 200 heat exchanger tubes within the unit experienced sudden cracking failures (Figure IX-27). Metallographic analysis revealed the presence of deep, highly branched, intergranular cracks that penetrated from the internal, waterside surface (Figure IX-28). This mode of crack propagation is characteristic of stress corrosion cracking. Stress corrosion cracking of metals results from exposure to specific corrodents for the particular alloy while being subjected to applied and/or residual stresses. Residual stresses are supplied by original tube forming operations.

Figure IX-27: Wall of Admiralty Brass Heat Exchanger Tube Penetrated by a Crack

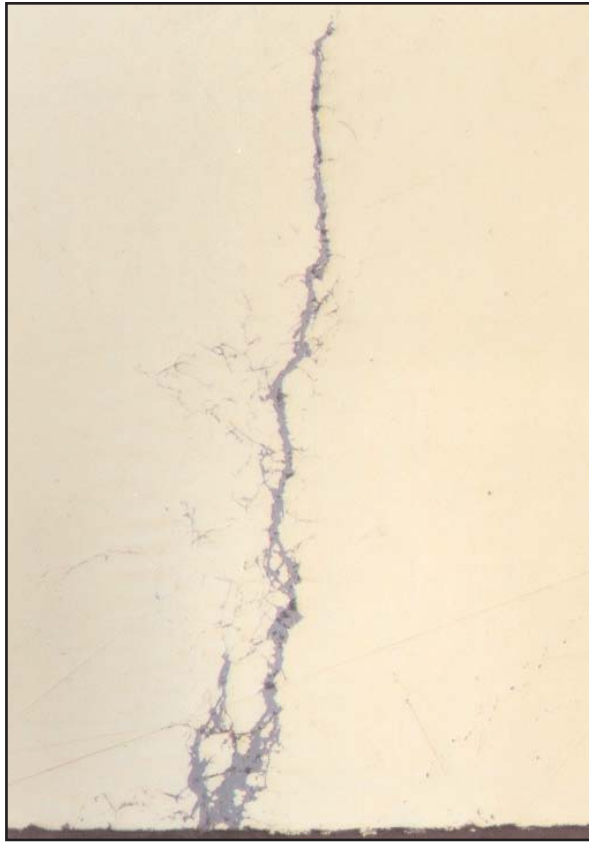
Metallographic cross sections revealed many tight, highly branched fissures indicative of Stress Corrosion Cracking (SCC) (Figure IX-31). The cracks propagated transgranularly into the tube microstructure (Figure IX-32). SCC of brass may be transgranular or intergranular. SCC of a susceptible alloy requires the simultaneous presence of sufficient tensile stress and a specific corrodent. The stress and corrodent interact synergistically to produce cracks on the surfaces exposed to the corrodent and propagate in response to the stress state. The transverse orientation of the cracks and multiple initiation sites along the circumference indicated that the tensile stresses responsible for cracking were uniaxial (longitudinally oriented). The tensile stresses required for cracking can be applied or residual. Residual stresses can be developed from fabrication and installation of the tubes.

Figure IX-31: Tight Branched Fissure Caused by Stress Corrosion Cracking

Stress corrosion cracking can be prevented by removing one of the requirements of cracking, (i.e., tensile stress, the corrodent or the susceptible alloy). In general, the propensity and severity of the cracking increases as stress levels rise. For many alloys, there is a threshold stress below which stress corrosion cracking will not occur (Figure IX-33). Threshold stress depends on many factors, including temperature, alloy composition and concentration of the corrodent. Reduction of the applied and/or residual stresses can reduce or eliminate cracking. Preventing contamination into the system of corrodents responsible for stress corrosion cracking will eliminate cracking. In addition, changing to a less susceptible material may also prevent cracking. Substitution of 70-30 cupronickel in place of admiralty or other copper-base alloys has been suggested as a preventative measure for stress corrosion cracking in refinery service.

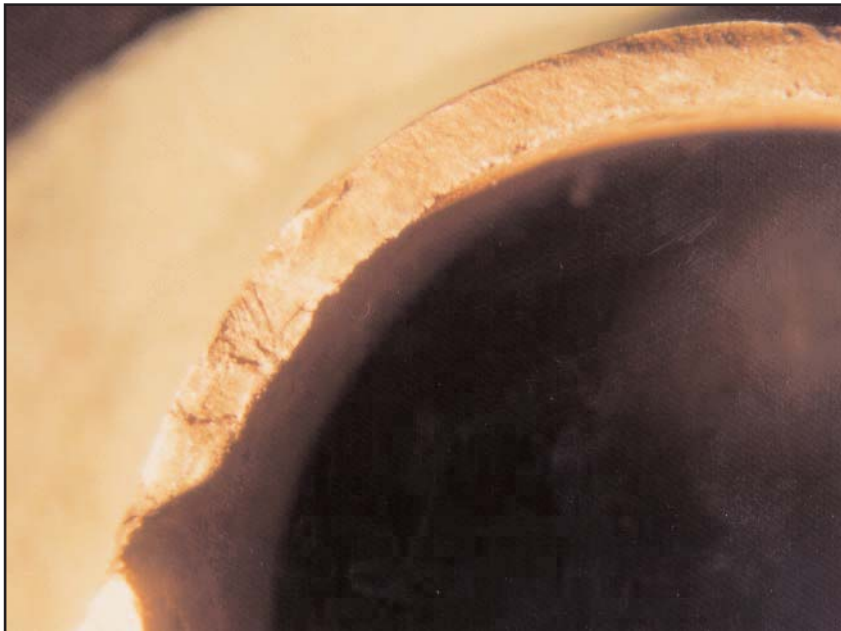
A crack-like failure occurred in a surface condenser tube (Figure IX-34). Scattered depressions formed on the internal surface (Figure IX-35). Metallographic analysis revealed that the surfaces of the depressions were covered with layers of metallic copper, indicating that dezincification, a form of dealloying, occurred (Figure IX-36). Dezincification occurred beneath occlusive deposit layers due to the concentration of chloride from the water solution by an ion concentration cell mechanism. The corrosion caused zinc to be preferentially removed from the copper-zinc matrix of the alloy. This left behind a weak, porous mass of pure copper on the corroded surface.

Figure IX-34: Cracking Failure

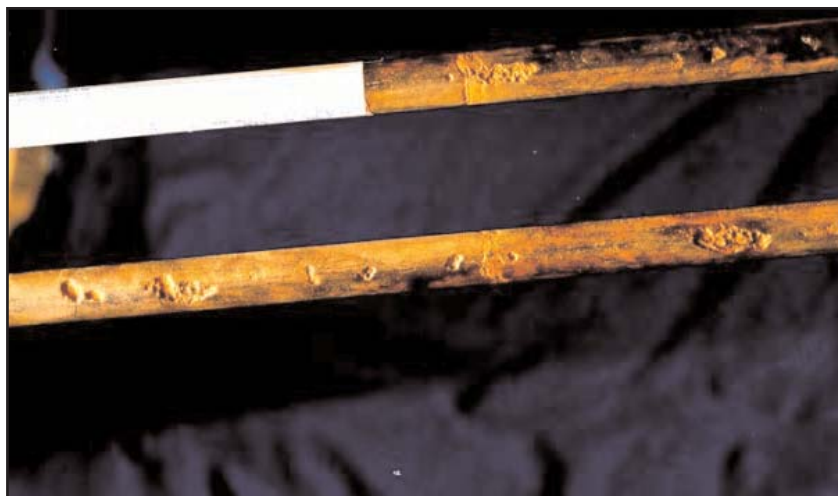
Clusters of mutually intersecting, deep depressions formed in scattered spots on the external surfaces of several tubes in the exchanger (Figure IX-38). The depressions were hemispherical in shape. In some locations, the depressions mutually intersected (Figure IX-39). The depressions were lined with iron sulfide corrosion products (Figure IX-40). It was reported that a gooey slime layer covered the external surface when the bundle was removed. Bacterial counts on tube surfaces were 5 million CFU/ml total, with 8,000 CFU/ml of sulfate reducing bacteria.

Figure IX-38: Scattered, Deep External Surface Depressions

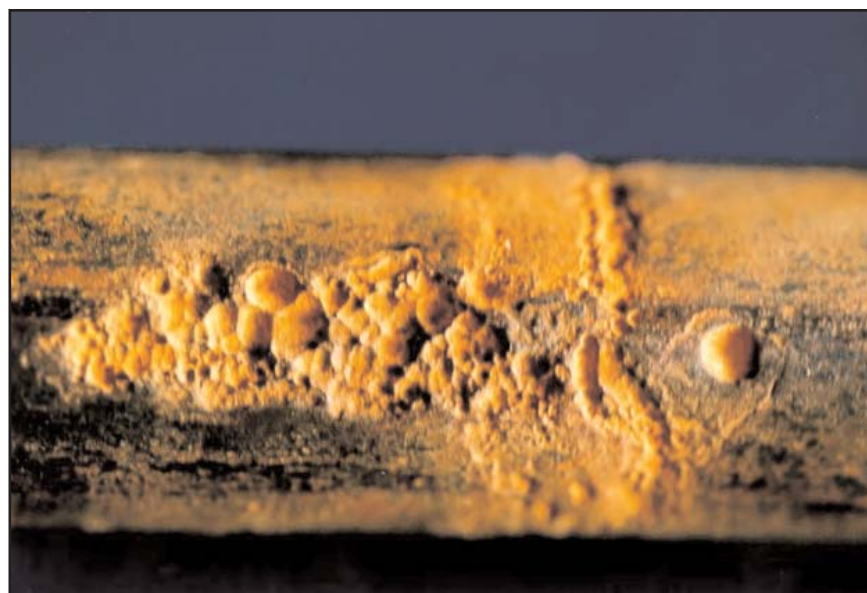
Figure IX-39: Clusters of Mutually-intersecting, Rounded Depressions

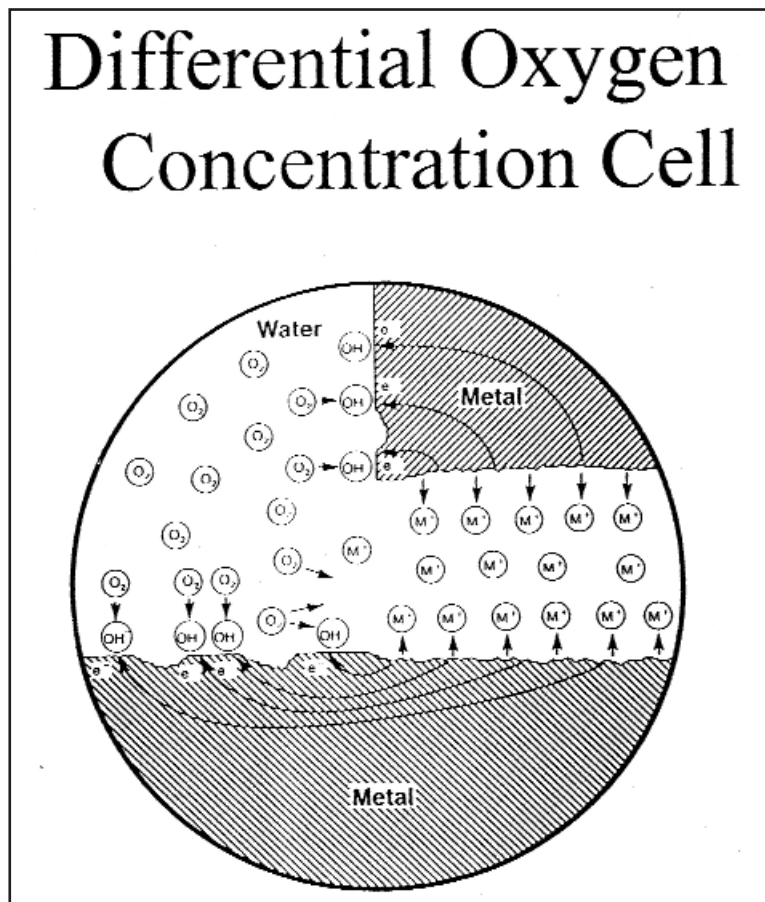
Figure IX-44:
 (Source: *The Nalco Guide to Cooling Water Systems Failure Analysis*)

Initial corrosion was caused by the formation of differential oxygen concentration cells beneath occlusive deposit layers. A diagram of a differential oxygen concentration cell between contacting metal surfaces is shown in Figure IX-44. The water beneath an occlusive deposit or corrosion product layer or within a tight crevice between contacting metal surfaces becomes depleted in oxygen concentration. Consequently, the cathodic reaction in the corrosion cell could only occur where oxygen concentrations were higher, such as at breaks in the deposit layer, and on the outer surfaces of iron oxide layers and tubercles. The anodic reaction in the corrosion cell occurs within the oxygen depleted zone to produce metal dissolution. Metal ion leaks out of the oxygen depleted zone into the zone where oxygen concentration is high to produce iron oxide corrosion products. By this process, iron oxide tubercles form.

Concentration cell corrosion may be controlled by maintaining clean metal surfaces, both mechanically and through proper water treatment and corrosion inhibition. Corrosion may also be controlled by minimizing or eliminating low or stagnant flow, and by decreasing concentration of aggressive anions. If these measures cannot be taken, and/or if corrosion cannot be controlled, then the use of alternate materials or coatings may be considered.

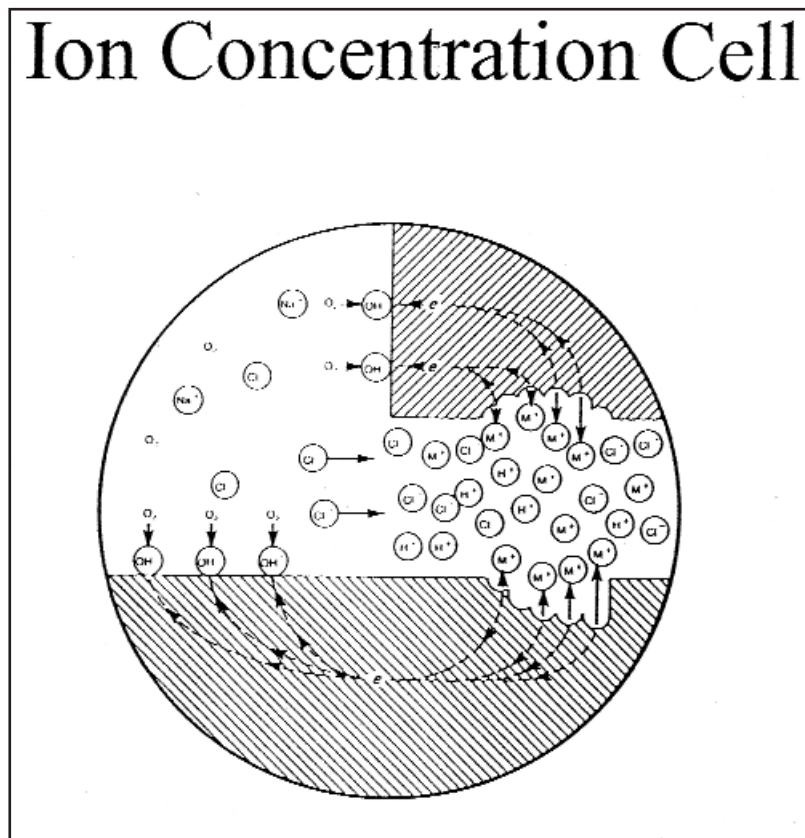
Figure IX-45:
 (Source: *The Nalco Guide to Cooling Water Systems Failure Analysis*)

Ion concentration cells also may form beneath occlusive deposit and corrosion product layers, tubercles and between crevices (Figure IX-45). The positively charged metal ions within the occluded zones attract aggressive anions such as chloride, sulfate, and sulfide. Aggressive anion concentration may become several times that in the bulk water to produce locally acidic and highly corrosive environments. The acidic environments dissolve protective corrosion product layers and then the metal itself to produce rough-surfaced, undercut pits and depressions. Acid corrosion significantly accelerates metal loss. The reactions and corrosion products that may occur within an iron oxide tubercle are shown in Figure IX-46.
