## RMS Titanic: A Metallurgical Problem

On 14 April 1912, at 11:40 p.m., Greenland Time, the Royal Mail Ship Titanic on its maiden voyage was proceeding westward at 21.5 knots (40 km/h) when the lookouts on the foremast sighted a massive iceberg estimated to have weighed between 150,000 to 300,000 tons at a distance of 500 m ahead. Immediately, the ship's engines were reversed and the ship was turned to port (left) in an attempt to avoid the iceberg. In about 40 seconds, the ship struck the iceberg below the waterline on its starboard (right) side near the bow. The iceberg raked the hull of the ship for 100 m, destroying the integrity of the six forward watertight compartments. Within 2 h 40 min the RMS Titanic sank.

Metallurgical examination and chemical analysis of the steel taken from the Titanic revealed important clues that allow an understanding of the severity of the damage inflicted on the hull. Although the steel was probably as good as was available at the time the ship was constructed, it was very inferior when compared with modern steel. The notch toughness showed a very low value (4 joules) for the steel at the water temperature ( $-2^{\circ}\text{C}$ ) in the North

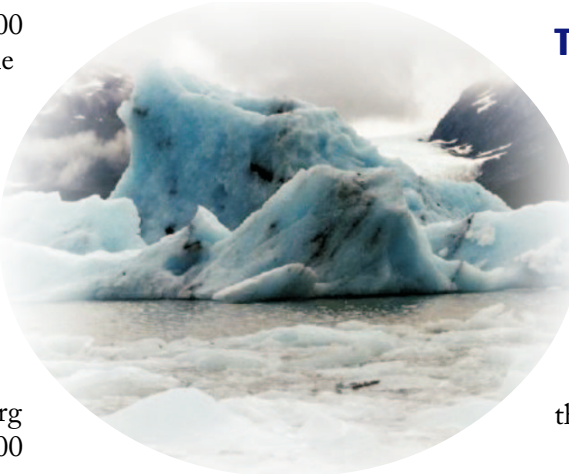
*The iceberg raked the hull of the Titanic for 100 m, cracking hull plates and popping rivets, thus destroying the integrity of the first six of 16 watertight compartments formed by the transverse bulkheads.*
